# **The Long-Term Evaluation of Mine Seals Constructed in Randolph County, WV in 1967**

**U.S. Bureau of Mines  
Pittsburgh Research Center  
Cochrans Mill Road, P.O. Box 18070  
Pittsburgh, PA 15236**

## **ABSTRACT**

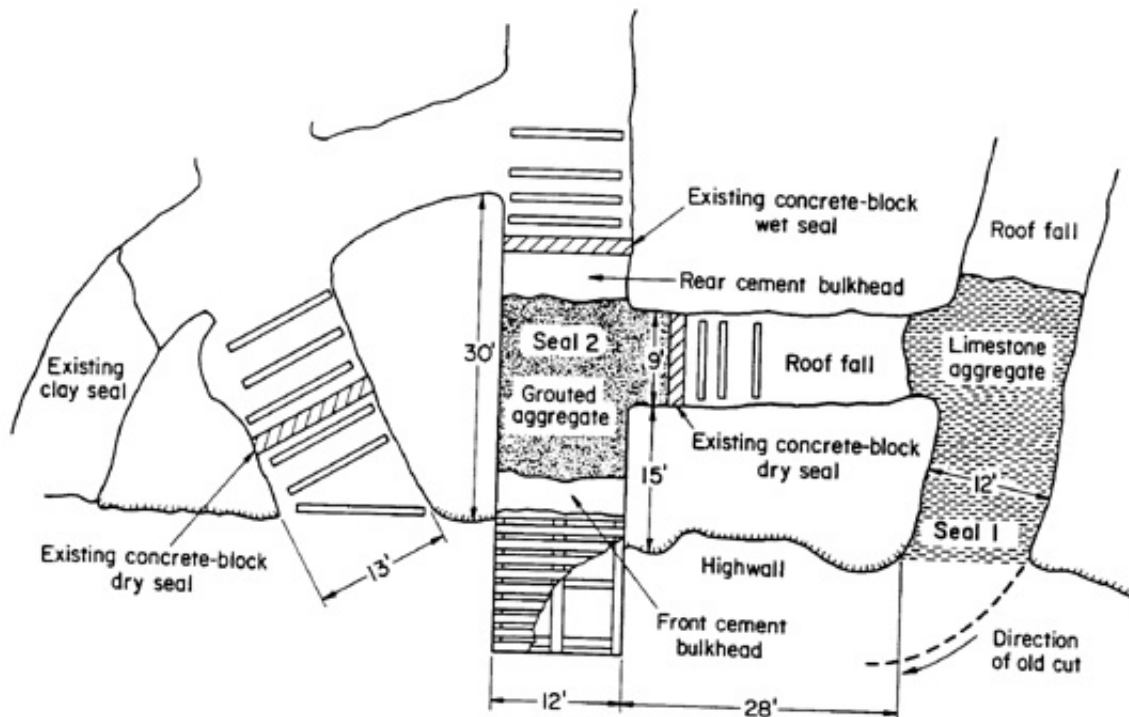
FIGURE 3. Cross section of seal 1, a permeable limestone seal, and seal 2, a double bulkhead hydraulic seal (6).

Seals 1 and 2 are located in adjacent entries. A block wet seal had been installed in entry 2 in 1967. (See Figure 3.) Two years later a double bulkhead seal was constructed in front of the existing wet seal. Subsequently, a seep developed in the adjacent opening (#1) due to pressure behind the seal. This entry was sealed with graded limestone. The purpose of this design was to force all exiting water through the limestone, and the resulting precipitates were intended to plug the seal.(4)

Seal 1 was covered by a highwall slide by the time of the 1980 report and the interior was not inspected for this 1990 study. There were two distinct seeps outside seal 1. About ninety-five percent of the flow occurred in the left seep. A smaller seep on the right contained yellowboy. Seal 2 appeared to be in a good structural condition in 1980 (6) and also in 1990. Flow from the opening was low. Iron precipitates appeared two to four meters in front of the seal. Flow for seal 2 has been recorded for each study year. In 1980, flow was recorded for both seals with 75% of flow exiting seal 2.(6) However, in 1990, the majority of water and pollutants exited seal 1. In order to compare with pre-seal data, results for 1980 and 1990 were flow weighted and the following data is presented for both seals. There was a decrease in total flow over time but the concentrations did not increase accordingly. The highest concentrations occurred in 1966 with the highest flows. Acidity went from 837 mg/L in 1966 to 305 mg/L in 1980 and 601 mg/L in 1990. Acidity load went from 291.7 kg/day in 1966 to 35.1 kg/day in 1990. Iron load decreased by 91 percent during this time with the majority of the decrease occurring by 1980. Manganese and pH were recorded only for 1980 and 1990 studies. Manganese concentration rose while load declined over ten years from 1.28 mg/L (0.2 kg/day) to 2.16 mg/L (0.1 kg/day) while the pH fell from 3.0 to 2.9.

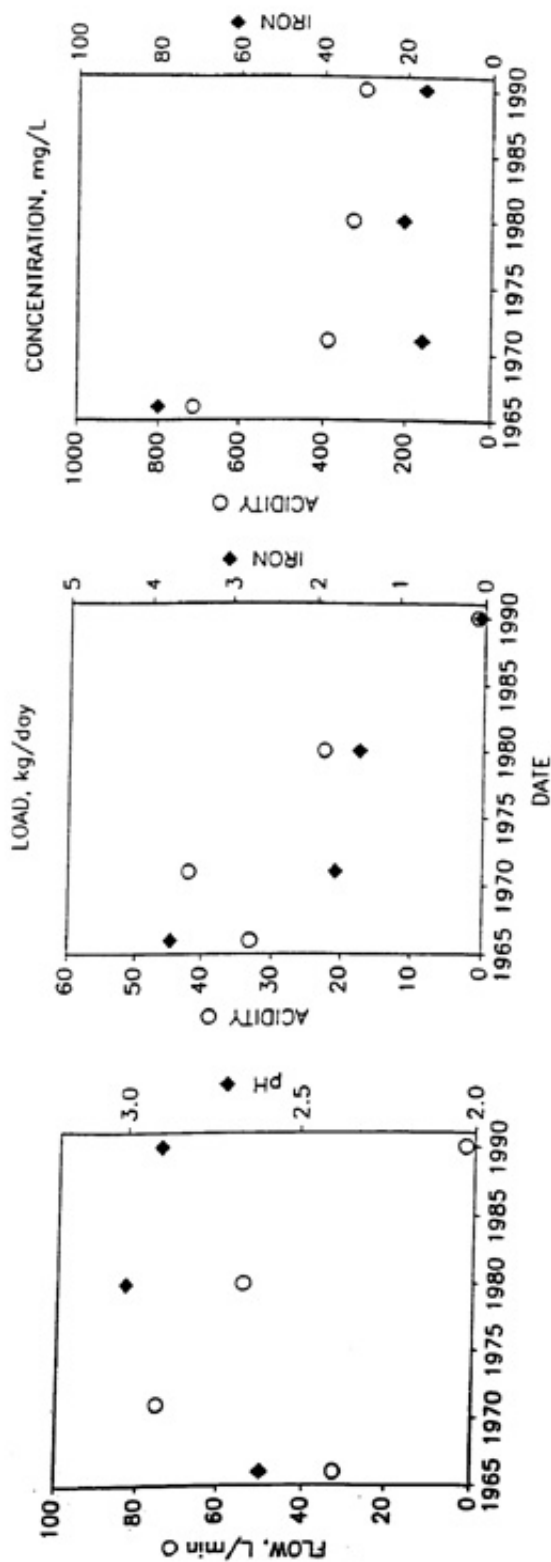
FIGURE 4. Flow, pH, acidity and iron concentrations and loads for seal 5 in 1966, 1971, 1980, and 1990.

Seal 5 is a wet seal. The portal area has experienced several falls and was not entered. There was no mention of falls in 1980 report so these must have occurred in the past decade. Flow increased 40 percent after sealing to 54.6 L/min then showed a sharp decrease in the 1990 sample period with a value of 2.2 L/min (Figure 4). Acidity dropped off from 712 mg/L to 328 mg/L in 1980 and remained about the same in 1990 with a concentration of 300 mg/L. Iron concentration showed the same trend with a pre-seal value of 80 mg/L which decreased to 20.6 mg/L and 15.7 mg/L in 1980 and 1990. Manganese concentrations of 2-3 mg/L have not changed in the past decade. The pH increased from 2.6 in 1966 to 3.0 in 1980 and was 2.9 in 1990.

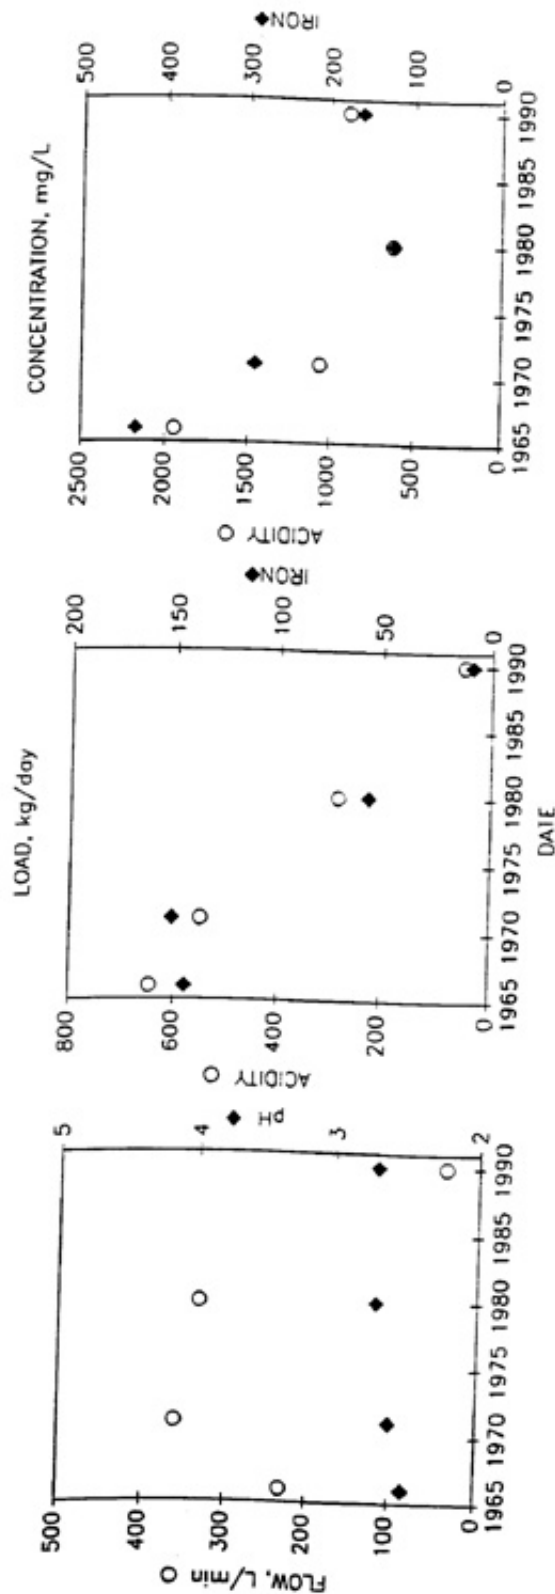
FIGURE 5. Flow, pH, acidity and iron concentrations and loads for seal 7 in 1966, 1971, 1980, and 1990.

Seal 7 is located at the end of Kittle Run. The mine opening was in poor condition as it was partially caved. Inside, the right coal rib and roof were caved to the extent that daylight could be seen. The weir may have been leaking but appeared to be in good shape except for some white precipitate buildup. The two openings at the base of the seal were blocked or partially blocked by precipitate or rocks, limiting flow. Flow increased from a 1966 reading of 231 L/min to 360 L/min in 1971 and then decreased to 332 L/min in 1980 and 39 L/min in 1990 (Figure 5). Acidity fell from 1942 mg/L (646 kg/day) in 1966 to 1060 mg/L (550 kg/day) in 1971 and 620.7 mg/L (283 kg/day) in 1980. The 1990 acidity values were 893 mg/L (50.2 kg/day). Iron also had an overall decrease from 434.5 mg/L (145 kg/day) in 1966 to a 1990 value of 161 mg/L (9.0 kg/day). Manganese was recorded only in the last two studies as 5.0 mg/L (2.1 kg/day) in 1980 and 12.5 mg/L (0.7 kg/day) in 1990. The pH increased from a 1966 value of 2.5 to 2.7 in 1980 and 1990.

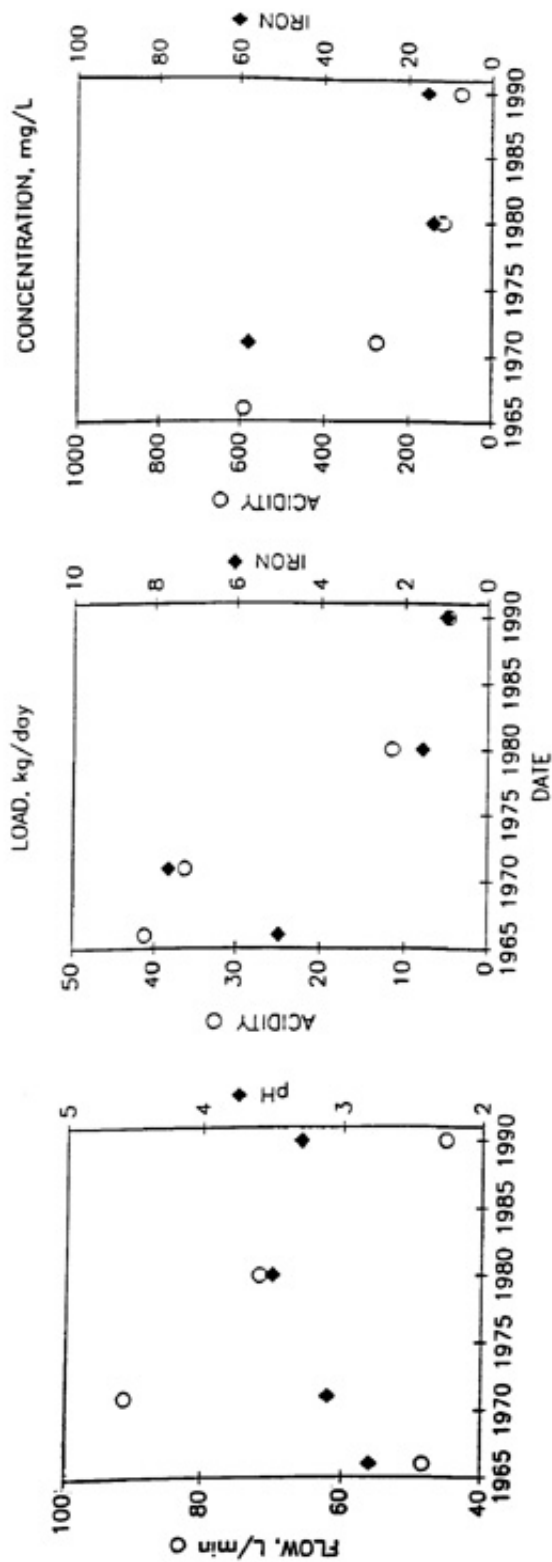
FIGURE 6. Flow, pH, acidity and iron concentrations and loads for seal 13 in 1966, 1971, 1980, and 1990.

Seal 13 was built in the entrance of a small, isolated mine. An attempt was made to seal all openings. This was not entered due to the iron precipitate which filled the opening half way to the roof. The weir could not be seen and the only structure visible was the back wall. The exterior was in good condition. Flow was measured by a drainage pipe about 100 feet

downstream. Flow increased after sealing to 91.5 L/min in 1971 and 71.8 L/min in 1980 but returned to the 1966 value of about 45 L/min in 1990 (Figure 6). Although pre-seal (1966) and 1990 flows were similar, acidity values fell from 591 mg/L to 73.3 mg/L and acidity load from 41.2 kg/day to 4.8 kg/day. The iron concentration was 58 mg/L in 1971 but has decreased to 14-15 mg/L for 1980 and 1990. Iron load went from 7.6 kg/day to 1.6 in 1980 and 1.0 in 1990. Manganese was reduced from 8.0 mg/L (0.8 kg/day) in 1980 to 5.7 mg/L (0.4 kg/day) in 1990. The pH increased from a 1966 value of 2.8 to 3.3 in 1990.

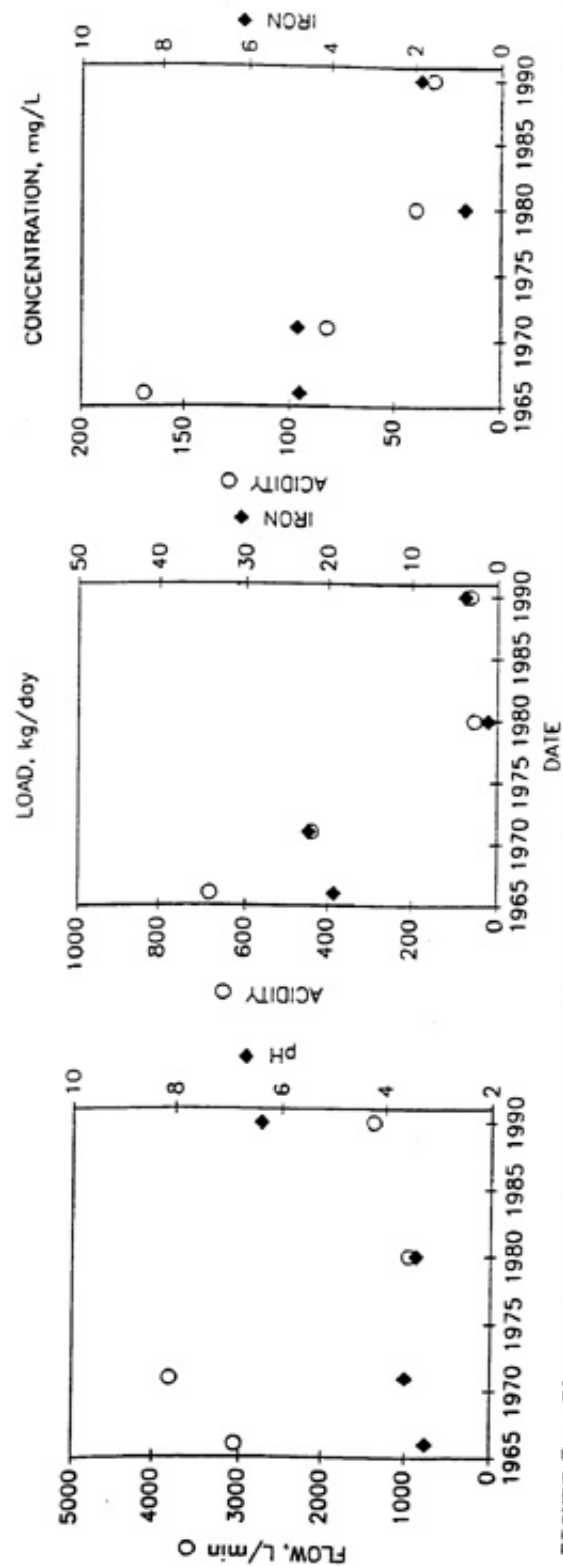
FIGURE 7. Flow, pH, acidity and iron concentrations and loads for the gauging station in 1966, 1971, 1980, and 1990.

The gauging station is located on the northern branch of Flat Bush Run, a major tributary of Roaring Creek. The effluent from seal 13 flows into the stream on which the station is located. One quarter of the Flat Bush watershed land had been surface mined, and all mined land was reclaimed and revegetated.(6) Flow at this point has always been high with annual averages between 3800-4300 L/min during 1966-71 (Figure 7). The reading in 1990 was 1393 L/min, an increase of 30 percent from the 1980 value of 966 L/min. Acidity has gradually decreased over time with 169 mg/L (682 kg/day) in 1966, 82 mg/L (439 kg/day) in 1971, 39.3 mg/L (52.7 kg/day) in 1980, and 31.1 mg/L (62.4 kg/day) in 1990. Iron concentration went from highs in 1966 and 1971 of about 4.8 mg/L to 0.8 mg/L in 1980 and 1.9 mg/L in 1990. Manganese concentrations were 3.5 mg/L in 1980 and 3.1 mg/L in 1990 with a 26 percent increase in load. This location had the highest pH for all field samples with a 1990 measurement of 6.4, compared to a reading of 3.3 for pre-sealing and 3.4 in 1980.

Most pH values increased slightly over time and three locations showed significant pH increases. Of these, seals 6 and 14 showed decreases in acidity and flow, but the gauging station had increased flow since 1980 as well as increased acidity, sulfate, and iron loads. There was also a significant amount of calcium in the gauging station water. There may be alkaline water mixing with the AMD because dilution alone can not explain the 3 unit change in pH.
