Mitigation of Environmental Impacts Resulting from Mine Pool Build-up: A Case History

Ronald Mullenex, CPG, CGWP^a

Sr. Vice President, Marshall Miller & Associates

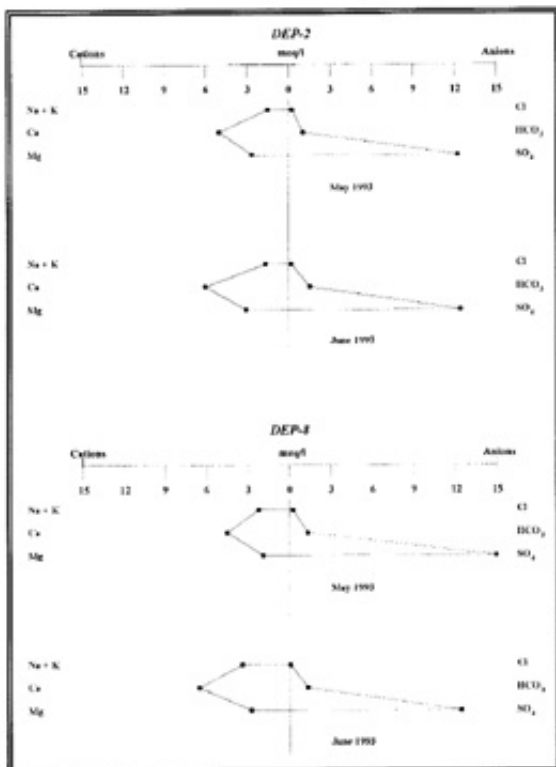
Figure 3
Mine Discharge Water Quality

Water discharge from old "house coal" mine adits and from seeps along the downdip outcrop exhibits a calcium-sulfate dominance. Sampling stations DEP-2 and DEP-8 are mine outflows with water representative of oxidation of sulfide minerals and calcium-bearing strata in the area.

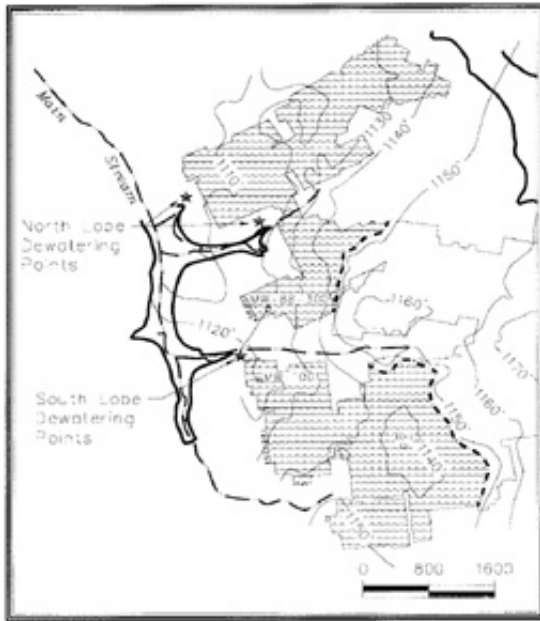
Figure 5
Geologic Structure and Mine Pool

During the initial investigation, the mine pool was sampled three times at three different locations (monitoring wells BH, MW-1001, and MW-88-300, *see Figure 5*). Results of these analyses reveal some interesting and significant circumstances concerning the nature of the pool. Evaluation of dominant ionic character shows that this character is different from one sampling location to another; and at one of the locations, it also changes with time, apparently in response to recharge from precipitation.

Well BH, located in the southern mine lobe, is consistently a calcium-sulfate water, with relatively high sodium levels. This well is situated in a local depression in the mine floor, where water is collected and contained, but is also within the main pool of the southern lobe. Its characteristics are similar in all three pre-dewatering sampling events, and are representative of essentially stagnant mine pool conditions. MW-1001, also in the southern lobe, showed very similar ionic characteristics to BH in May, 1993; but in the June, 1993 sample, it exhibited much lower sulfate levels, a bicarbonate anionic dominance, and lower levels of total dissolved solids in general. The June sampling event occurred a few days following an extremely heavy rain (1.86 inches), followed by other small-magnitude rains. The dramatic change in water quality in MW-1001, including lower dissolved solids, sodium, sulfate, and calcium than previously and increased dissolved oxygen reflects an apparent impact of recharge by precipitation runoff waters. The impact is that of dilution of "typical" mine pool water (as represented at monitoring point BH) by surface runoff apparently entering through subsidence fractures.

Well MW-88-300, in the northern mine lobe, has exhibited characteristics indicative of significant surface-water infiltration in all sampling events. These characteristics include high dissolved oxygen contents (6 to 11 mg/l) and low dissolved solids.

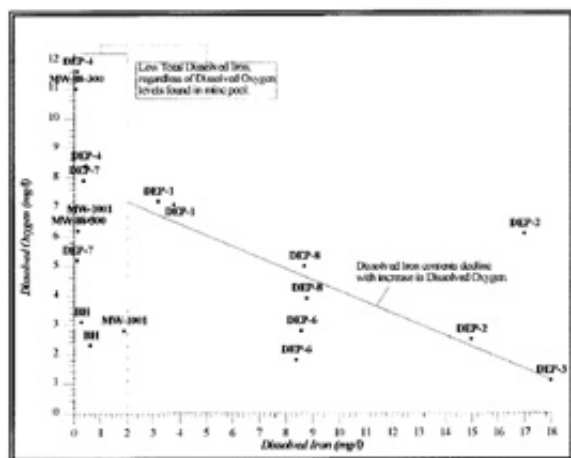
Figure 6
Dissolved Iron vs. Dissolved Oxygen

Results of sample analyses also confirm the expected relationship between dissolved oxygen and dissolved iron contents (and between dissolved oxygen and iron species). As shown on *Figures 6 and 7*, the presence of increased amounts of dissolved oxygen result in conversion of dissolved ferrous iron to ferric iron, with subsequent precipitation of the iron and drop in total dissolved iron levels. Again, this circumstance has important implications for remediation, in that the iron, in particular, appears to respond quickly and effectively to

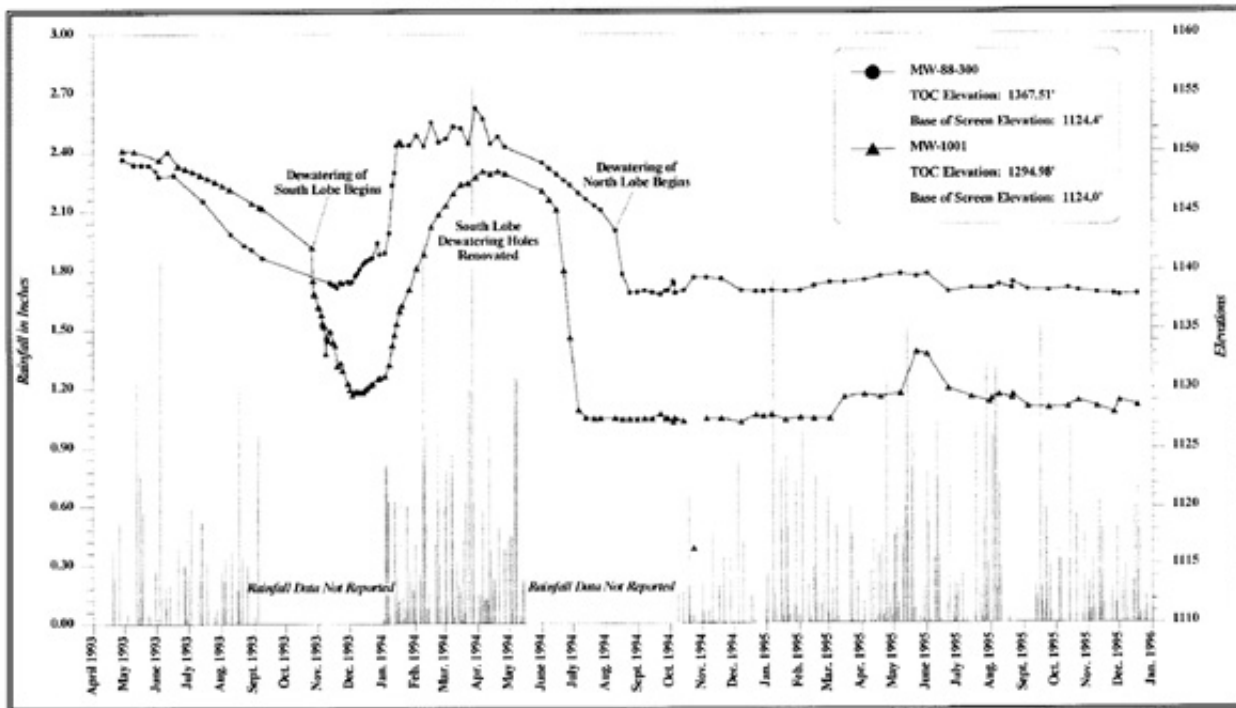
Figure 8
Mine Pool Fluctuations and Precipitation Data

Dewatering was undertaken first at the south lobe mine pool, in the autumn of 1993. Two horizontal borings were advanced through the barrier at the lowest-elevated point of that lobe of the mine. The pool level, as monitored via an observation well, responded immediately, showing about 12 feet of decline in head over the first two months. At that time, however, a combination of partial caving and blockage of the dewatering ports in the subsurface and a period of heavy rain and snowfall drove the pool back to its original levels (*see Figure 8*).

In the summer of 1994, the south lobe dewatering ports were renovated, and the desired lowering of the pool was fully achieved within a few weeks' time. Shortly thereafter, similar horizontal borings were installed into the north lobe pool, at two different locations. One location is at the lowest elevation of that pool, but because of extensive pillar extraction in that area, there are questions as to the permeability of the workings there. In order to achieve more effective and more timely results, dewatering portals were also installed at a more updip location where no pillar extraction had occurred which could impede flow through the workings. As can be seen on *Figure 8*, the initial response to these installations was rapid. However, the only available monitoring well in the north lobe lies in a sublobe that is prevented by the structural dip from fully draining. Consequently, the continued decrease in pool level in the north lobe cannot be directly monitored below a certain point, as is reflected in *Figure 8*. Discharge rates at the two dewatering locations in the north lobe indicate that full reduction of the mine pool was probably achieved in the autumn of 1995.

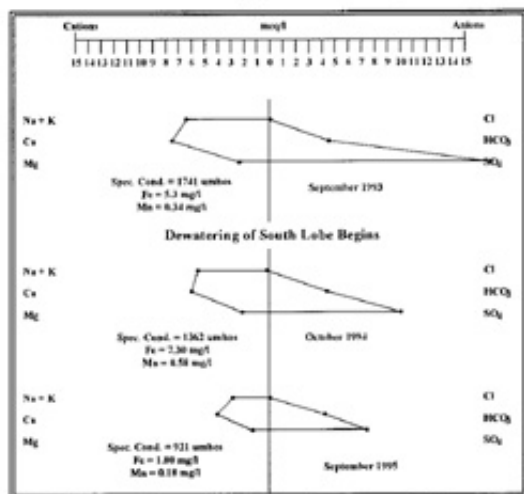
Figure 9
Stiff Diagrams
Autumn-Season Samples/Monitoring Well BH

The diminished impact is not, however, attributable merely to reduced flow rates on the downdip side of the mine. Substantial improvements in water quality have also occurred, both in the mine pool itself and at the seepage points which continue to exhibit some discharge. A comparison of temporal water quality changes in monitoring well BH, which is situated in a localized structural depression within the mine that retains water but which is subject to "flushing" as transient water moves downdip through the mine, demonstrates the improved quality within the mine pool itself. As shown on the following notated Stiff diagrams representing samples collected in the autumn season of three successive years, the pool has undergone significant decreases in total dissolved solids (as evidenced by specific conductivity analysis), iron, manganese, and sulfates since dewatering was undertaken. Sampling in May, 1995, when more recharge to the pool was occurring (and therefore more dilution), dissolved mineral content was even lower than any of these autumn-season samples. While the water is still a calcium-sulfate type, bicarbonate content has increased proportionately while sulfate has decreased. Monitoring well MW-1001, located near the south lobe dewatering ports, exhibits a similar decrease in sulfate and total dissolved solids, and proportional increase in bicarbonate. Water discharging from the south lobe dewatering ports is similar in character, but with even less iron and manganese. The decreased contact time has, as anticipated, resulted in less overall mineralization, and significantly less dissolution of iron sulfides within the mine workings.

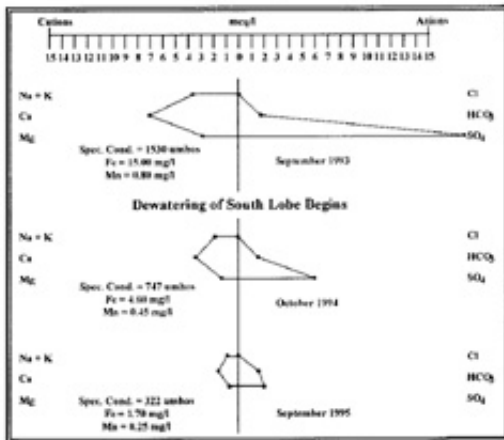
Figure 10
Stiff Diagrams
Autumn-Season Samples/Seep DEP-8

The two seeps formerly identified as directly influenced by the south lobe pool, DEP-6 and DEP-8, now show distinct differences in quality. DEP-6, situated more down-dip, continues to reflect the general quality characteristics of the mine pool (strongly calcium-sulfate dominated, with relatively high iron concentrations), but exhibits a general decrease in iron, manganese, and sulfate since dewatering began. However, in contrast, water quality at DEP-8, located updip of the present pool elevation, has changed dramatically since dewatering began, such that it now exhibits little similarity to the mine pool water. The following diagrams and data show the dramatic change in quality of seep DEP-8 since dewatering began; and also provide comparison of present conditions at DEP-8, where the discharge is no longer influenced by water held in storage in the mine pool, to those at DEP-6, where some relatively minor pool retention remains.

The substantial decrease in iron, manganese, and sulfate levels at DEP-8 reflect the lack of mine pool contribution to that discharge under current conditions, a circumstance directly attributable to lowering of the head in the mine pool. As long as the pool is prevented from rebuilding, DEP-8 will cease to be a point of concern for the operation.

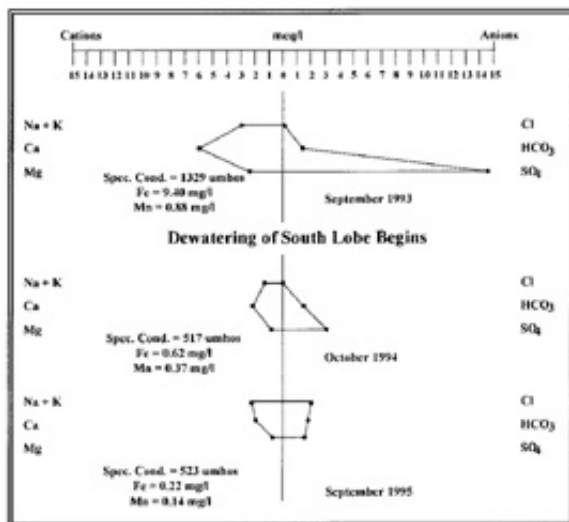
Figure 12
Stiff Diagrams
Autumn-Season Samples/Stream Location SW-10

Station SW- 10 is on the main trunk of the stream, at a point just downstream of the inflow from DEP-8 (see Figure 4). Comparison of SW-10 characteristics in the low-flow seasons of 1993 (before south lobe dewatering) and 1994 and 1995 (after dewatering) reveals a continual decline in the calcium and sulfate dominance that so strongly characterized the stream prior to mine dewatering, and an increase in bicarbonate. (The present increased levels of sodium and chloride at SW-10 suggest possible contribution by septic system effluent from a nearby residence.) SW-10 now appears to be completely unimpacted by water from the mine pool.

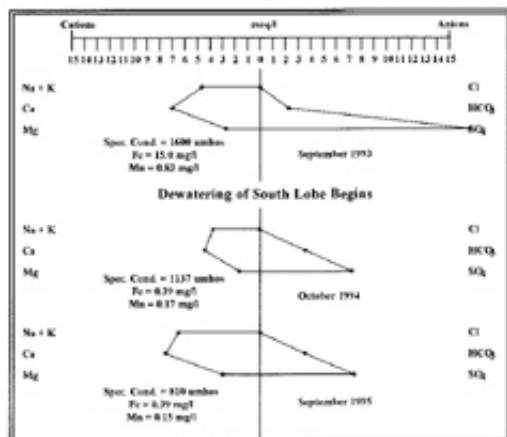
Figure 13
Stiff Diagrams
Autumn-Season Samples/Stream Location SW-11

SW- 11, located in the unnamed tributary downstream of DEP-6 and the south lobe dewatering ports, also exhibits an increase in bicarbonate constituency, but with less diminution of the calcium-sulfate dominance, as it still reflects direct influence by the remaining (but improved-quality) mine pool.

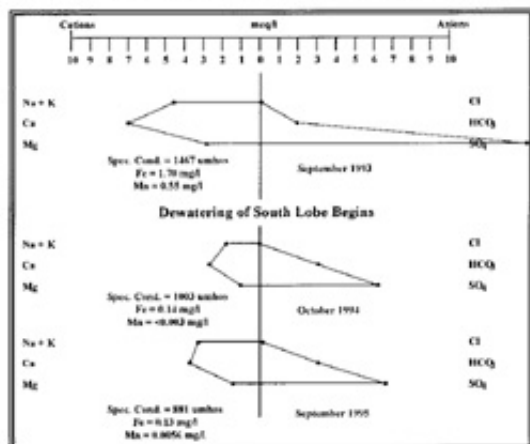
Figure 14
Stiff Diagrams
Autumn-Season Samples/Stream Location SW-17

and just below, respectively, the tributary which was formerly fed by seeps DEP-2 and DEP-3 and is currently fed by the outfall from the north pond. Although calcium and sulfate remain as dominant components, there is an overall decrease in their concentrations and an increase in bicarbonate. The impact of sodium hydroxide treatment of the north pond outfall in September, 1995, is clearly seen at S W- 18.
