#### Crossville Coal Passive Treatment System

Redesign of a non-functioning iron and manganese treatment system

Rick Mann, PG, OSMRE LFO Adam Ramsey, PE, OSMRE LFO Wesley Smith, PG, OSMRE LFO

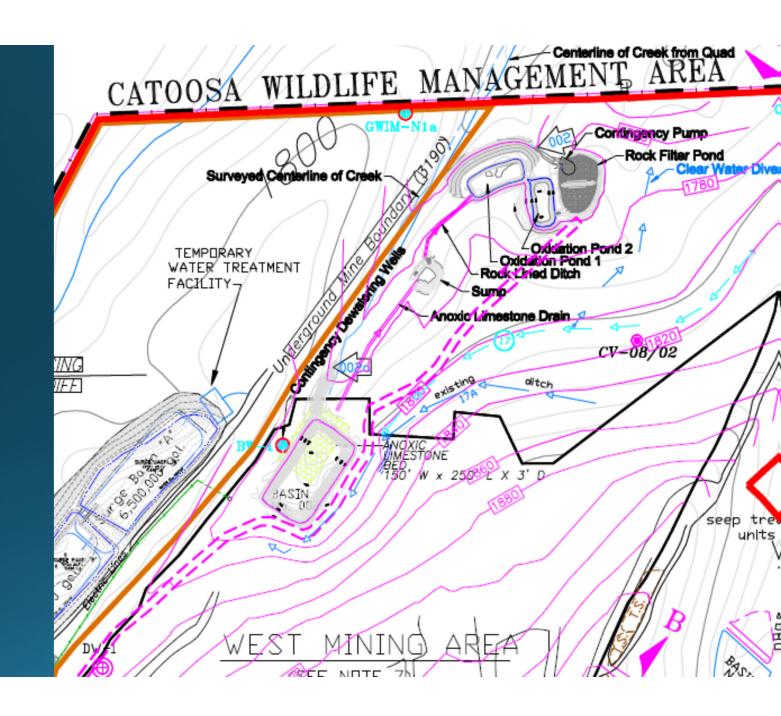
#### Previous Treatment System

- Completed in 2014
- Started failing
  1 year after
  completion.

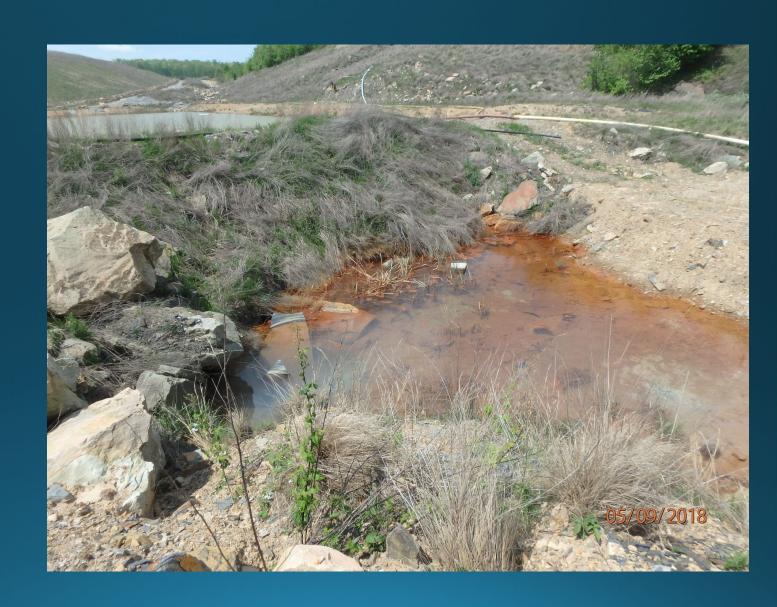
# Conditions inherited by OSMRE at bond forfeiture

Artesian discharge from chimney drain due to plugged ALD.

- DO <1 mg/L
- pH 6.20
- Alkalinity 50 mg/L
- Fe 30 mg/L
- Mn 18 mg/L

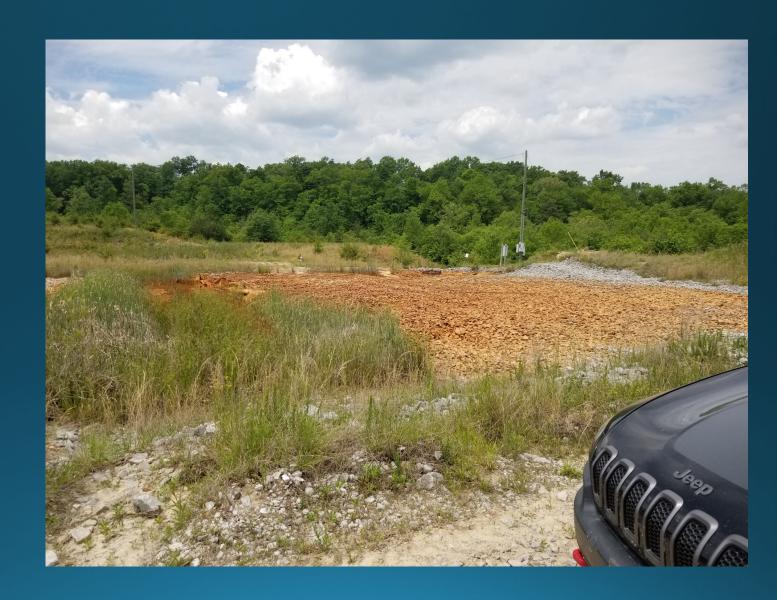
# Conditions inherited by OSMRE at bond forfeiture

- Iron precipitate had coated rock in the manganese bed.
- Non-complaint discharges.
- Nonfunctioning Mn bed.
- Extensive pump back and chemical treatment system (non-working).

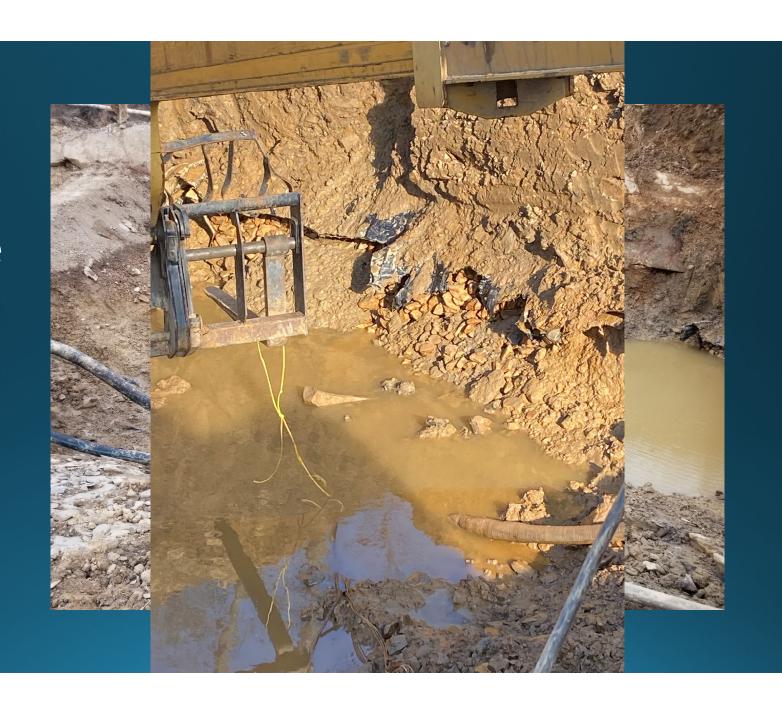
# Conditions inherited by OSMRE at bond forfeiture

- ALD excavated and plugged.
- Iron precipitate found in ALD.
