Characteristics and Treatment of Mine Drainage in the Anthracite Region of Pennsylvania

Roger J. Hornberger, Daniel J. Koury, Charles A. Cravotta III,
Todd Wood, and Keith B.C. Brady

27th West Virginia Mine Drainage Task Force Symposium

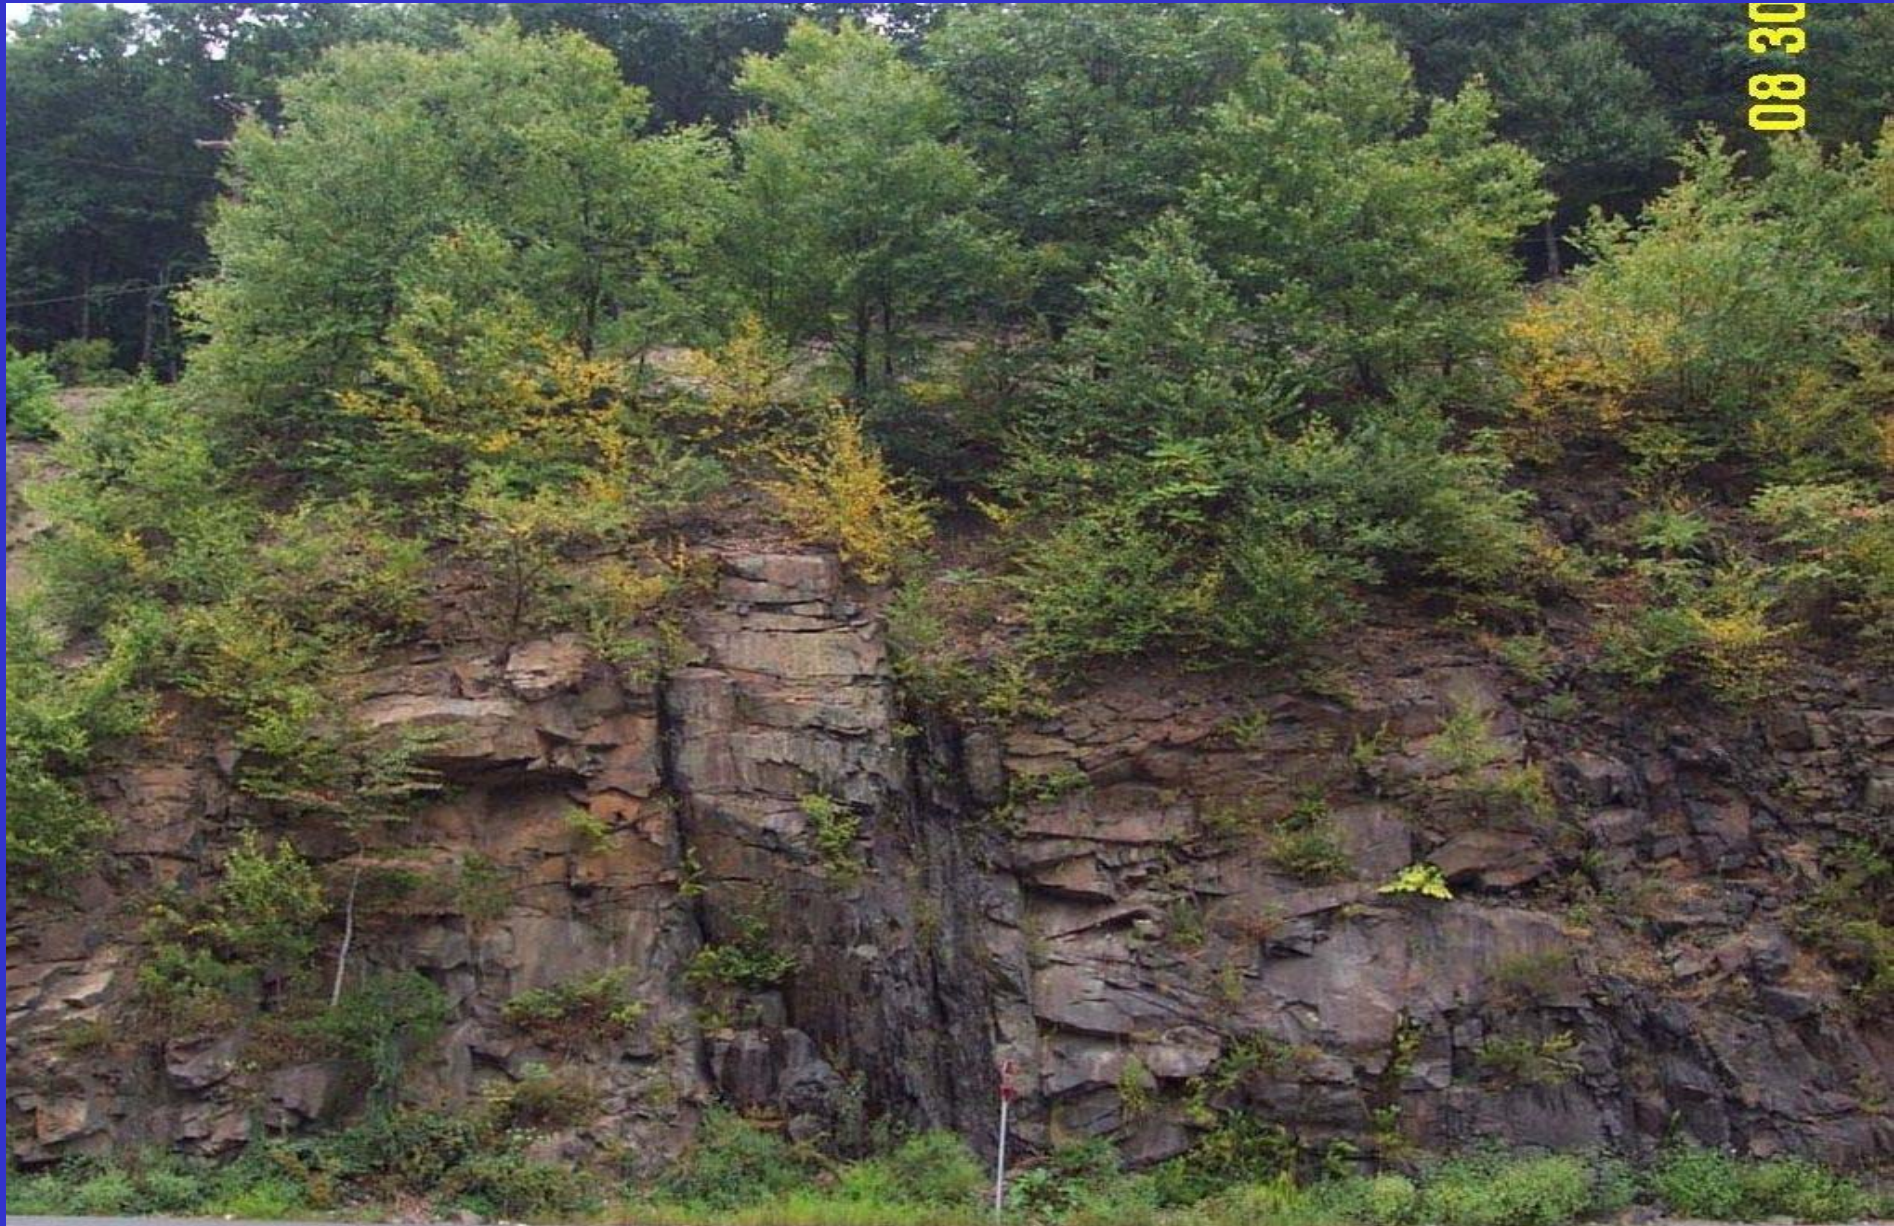
Pottsville Formation Type Section (Rt. 61)

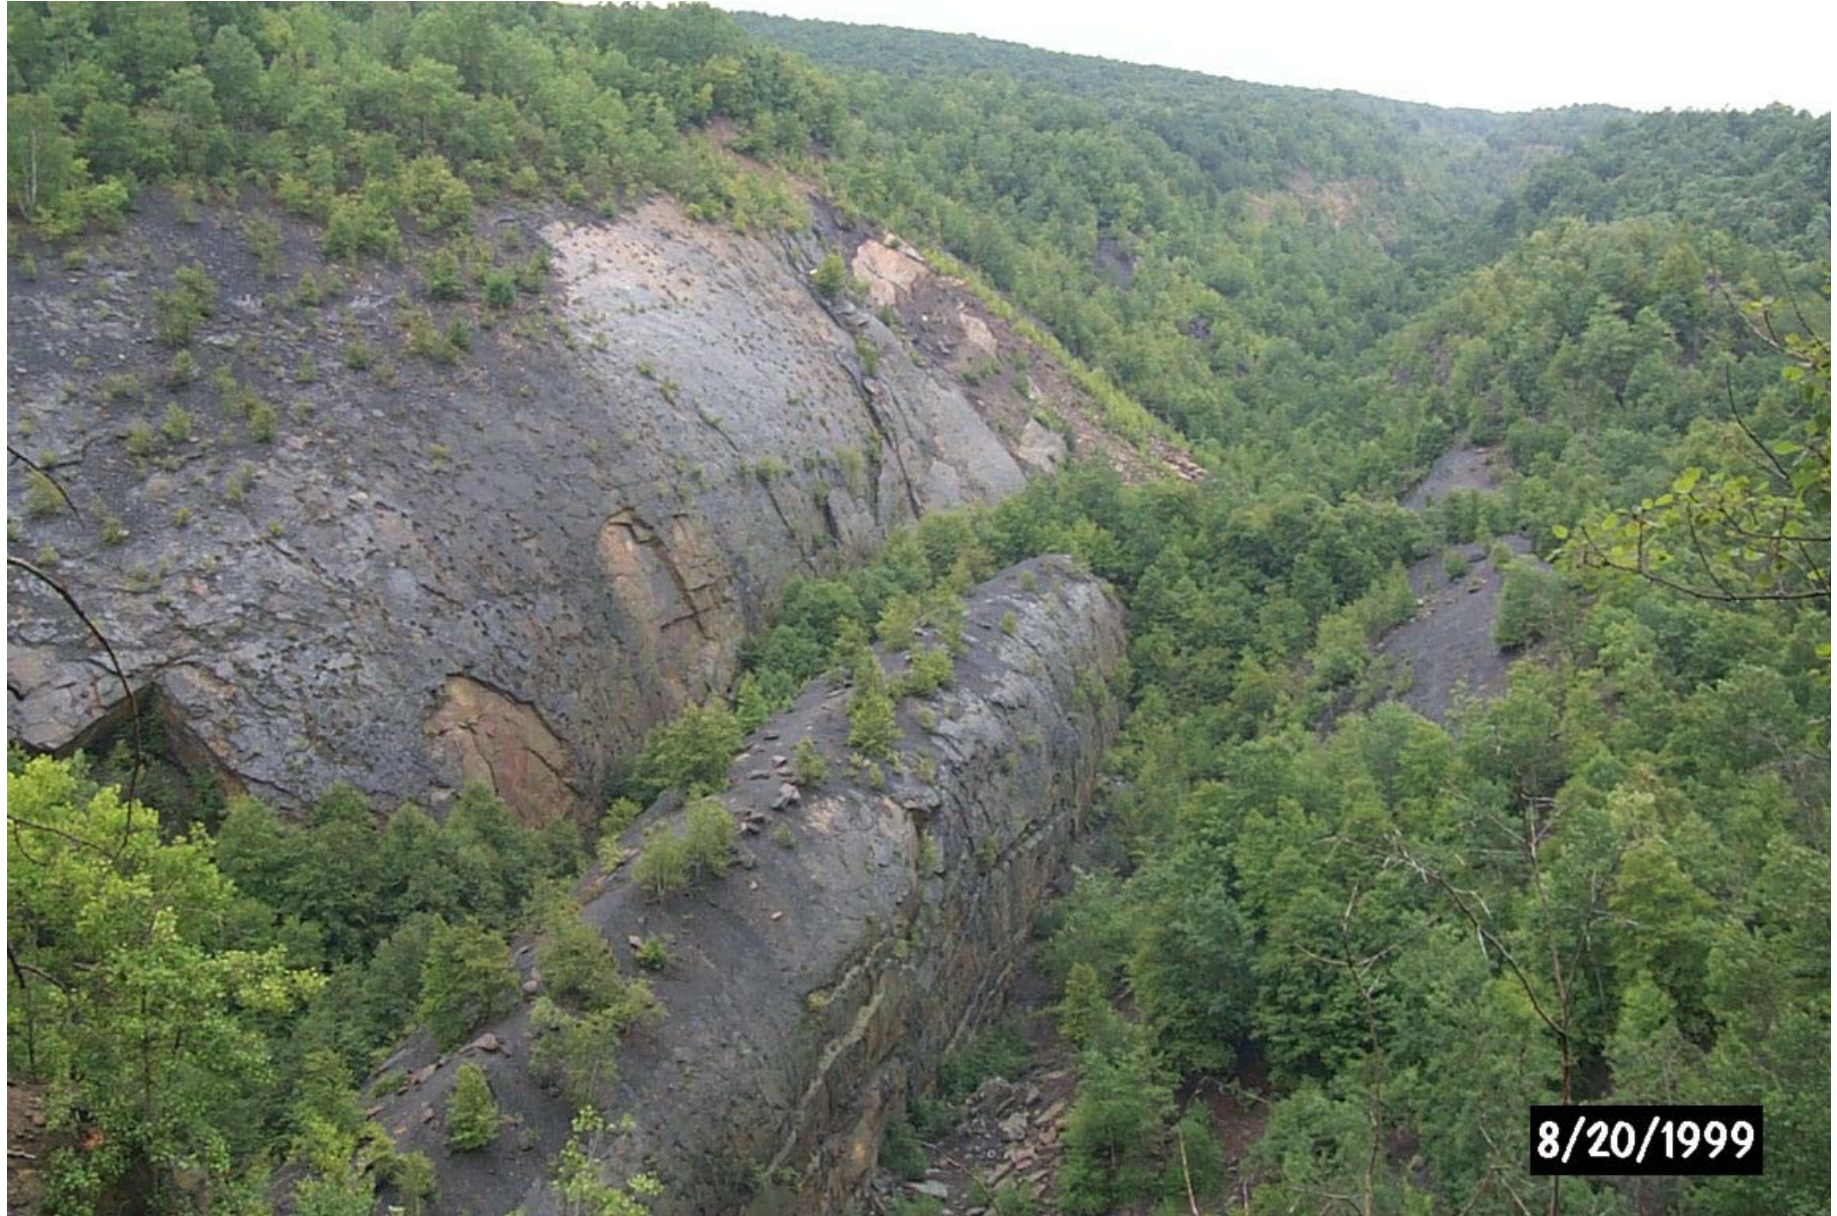
Regional Geology (Whaleback near Shamokin)

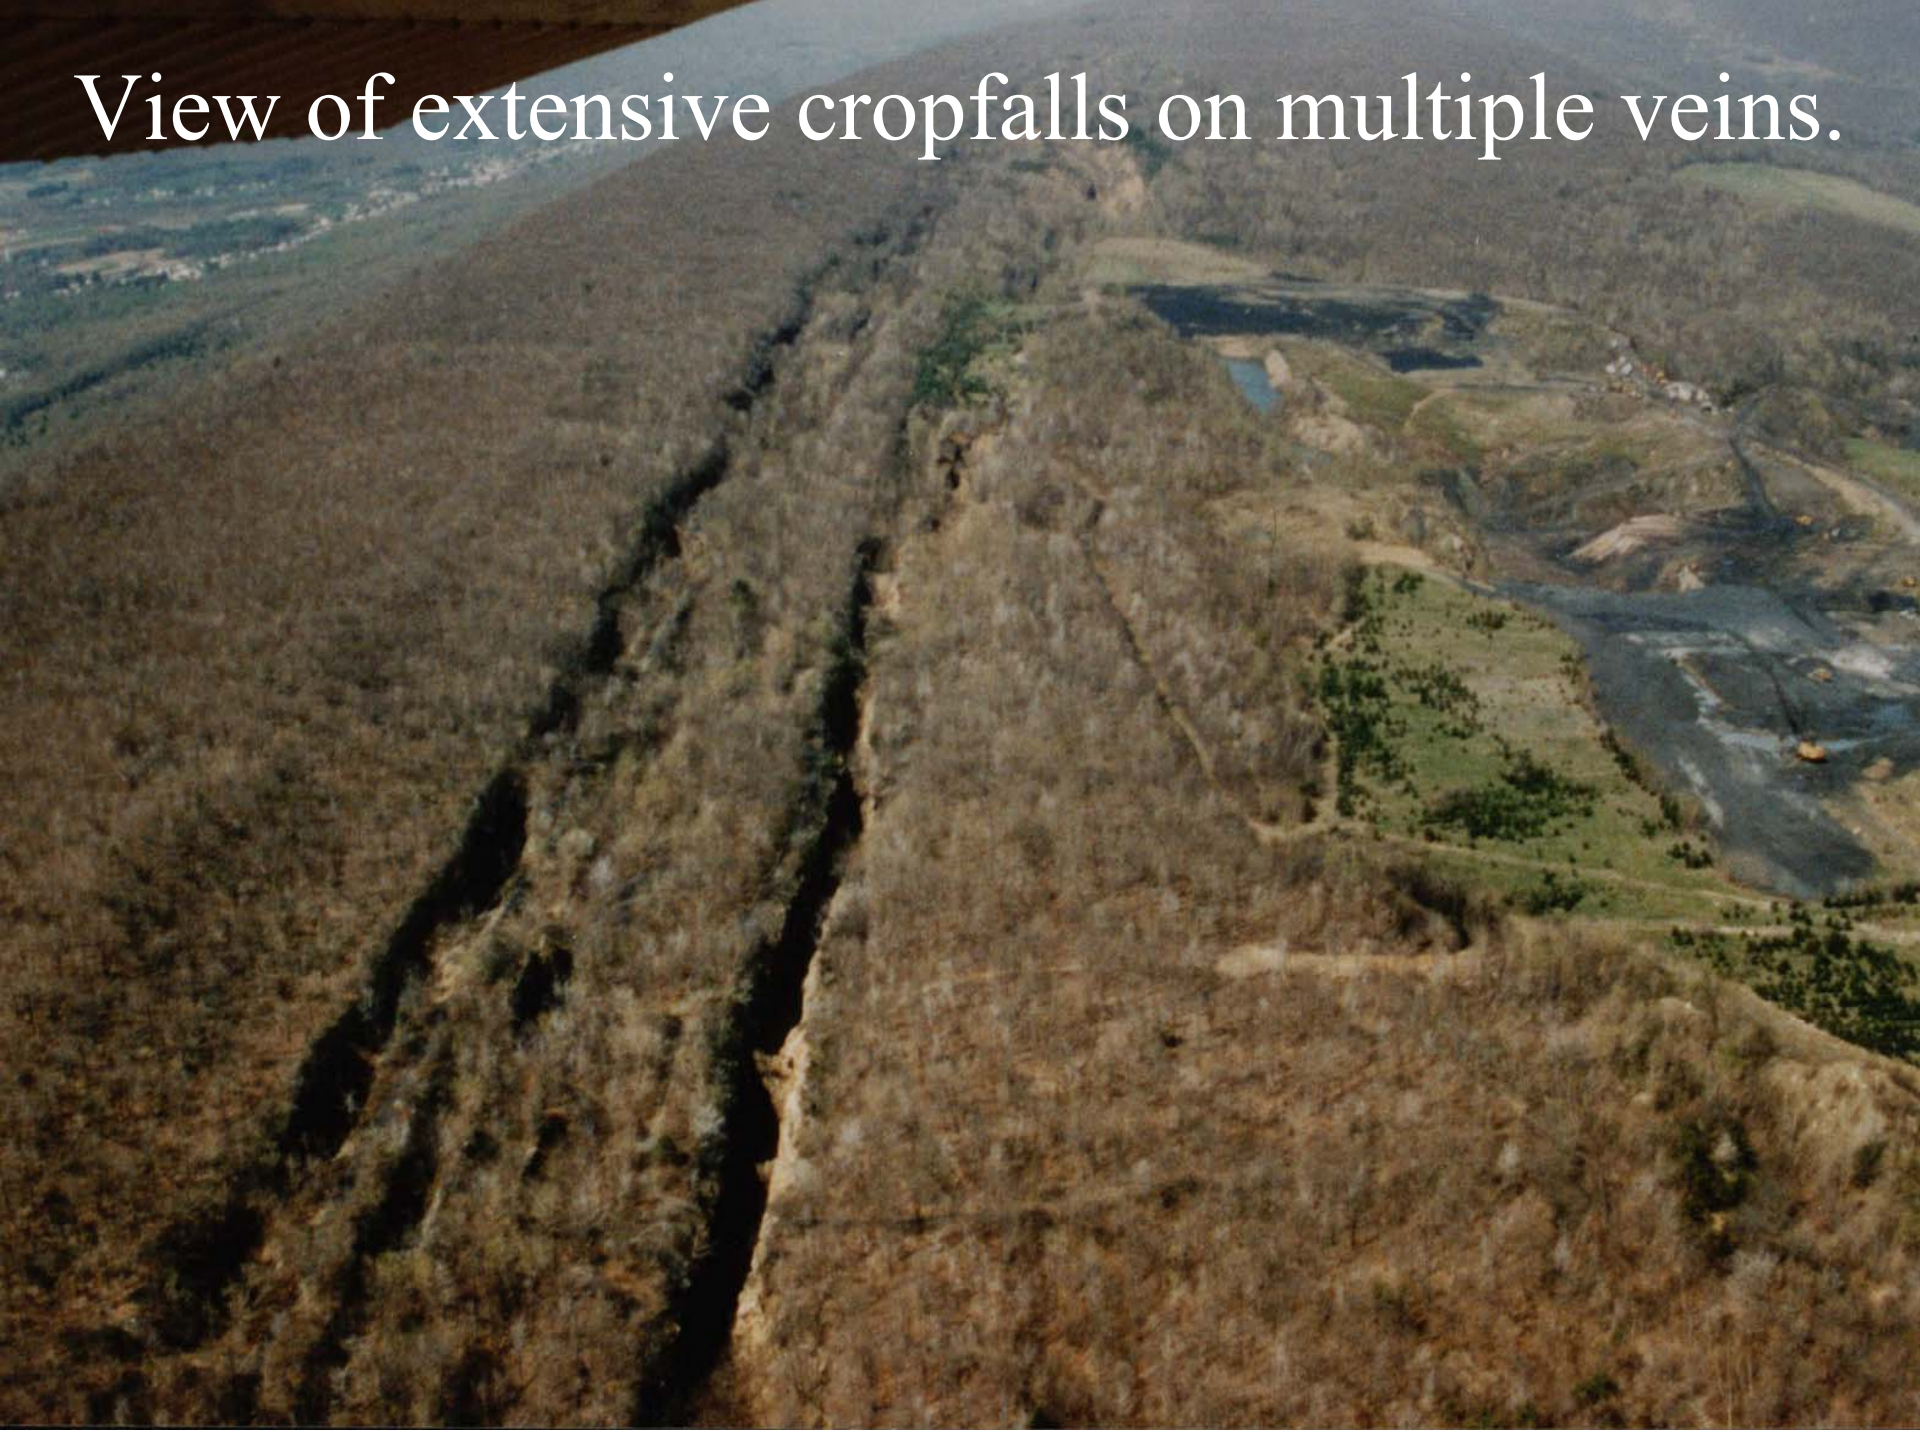
View of extensive cropfalls on multiple veins.

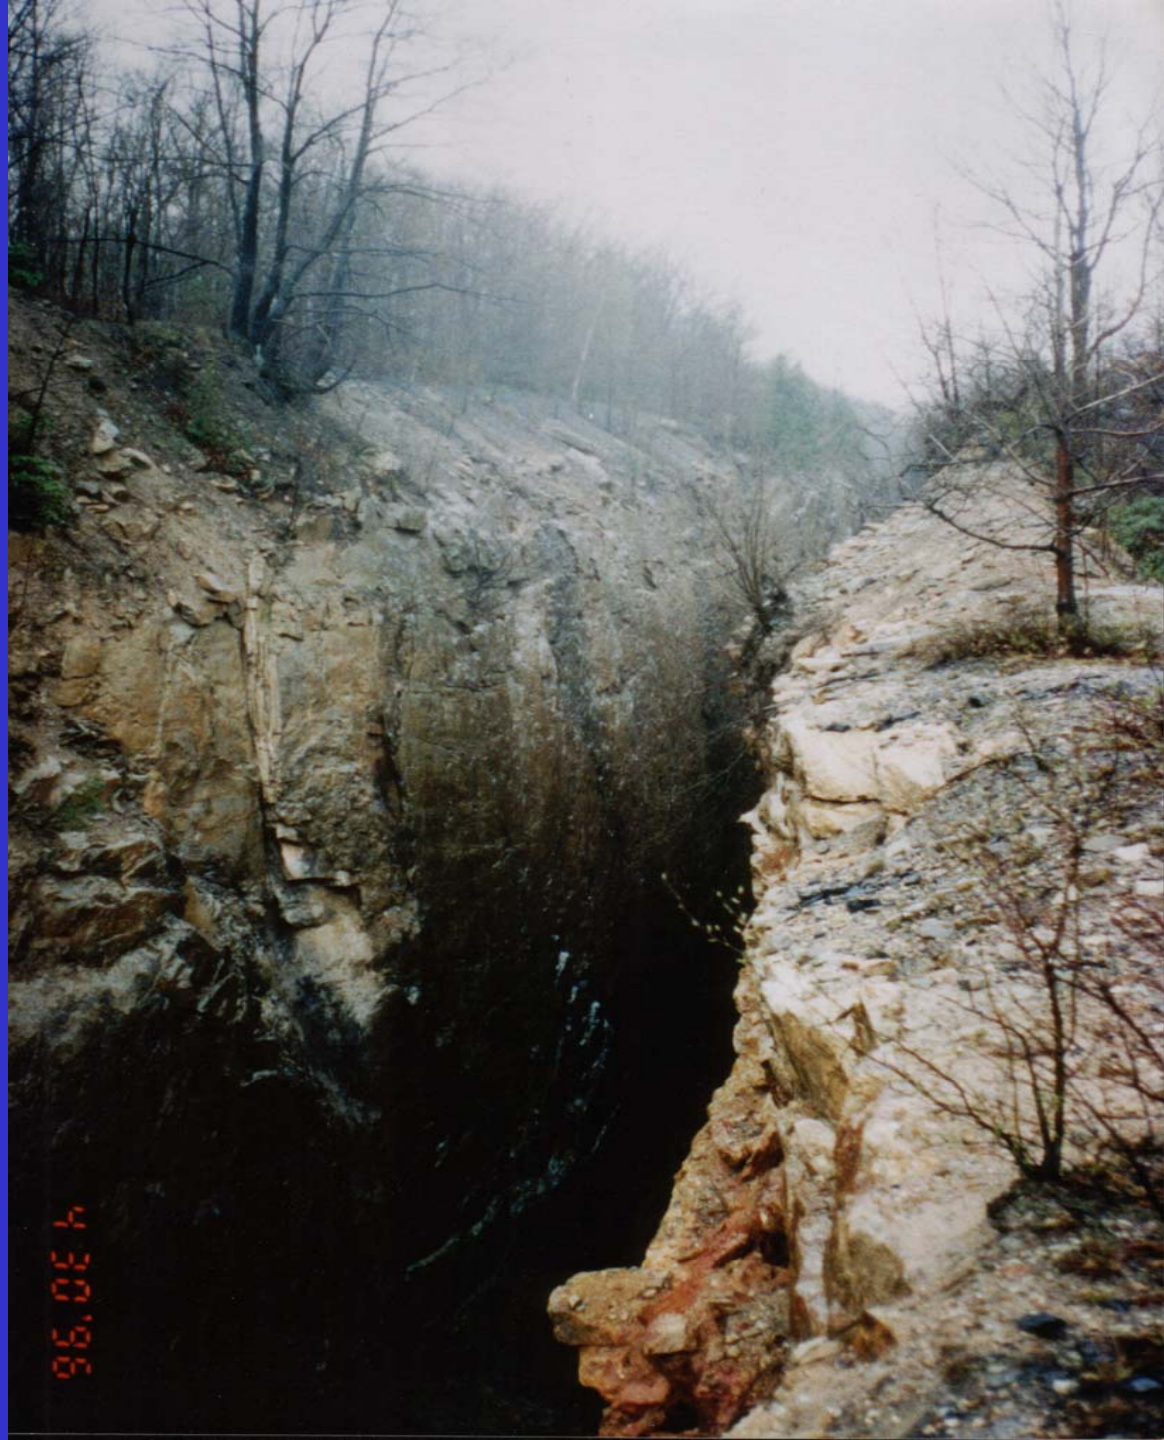
Narrow cropfall

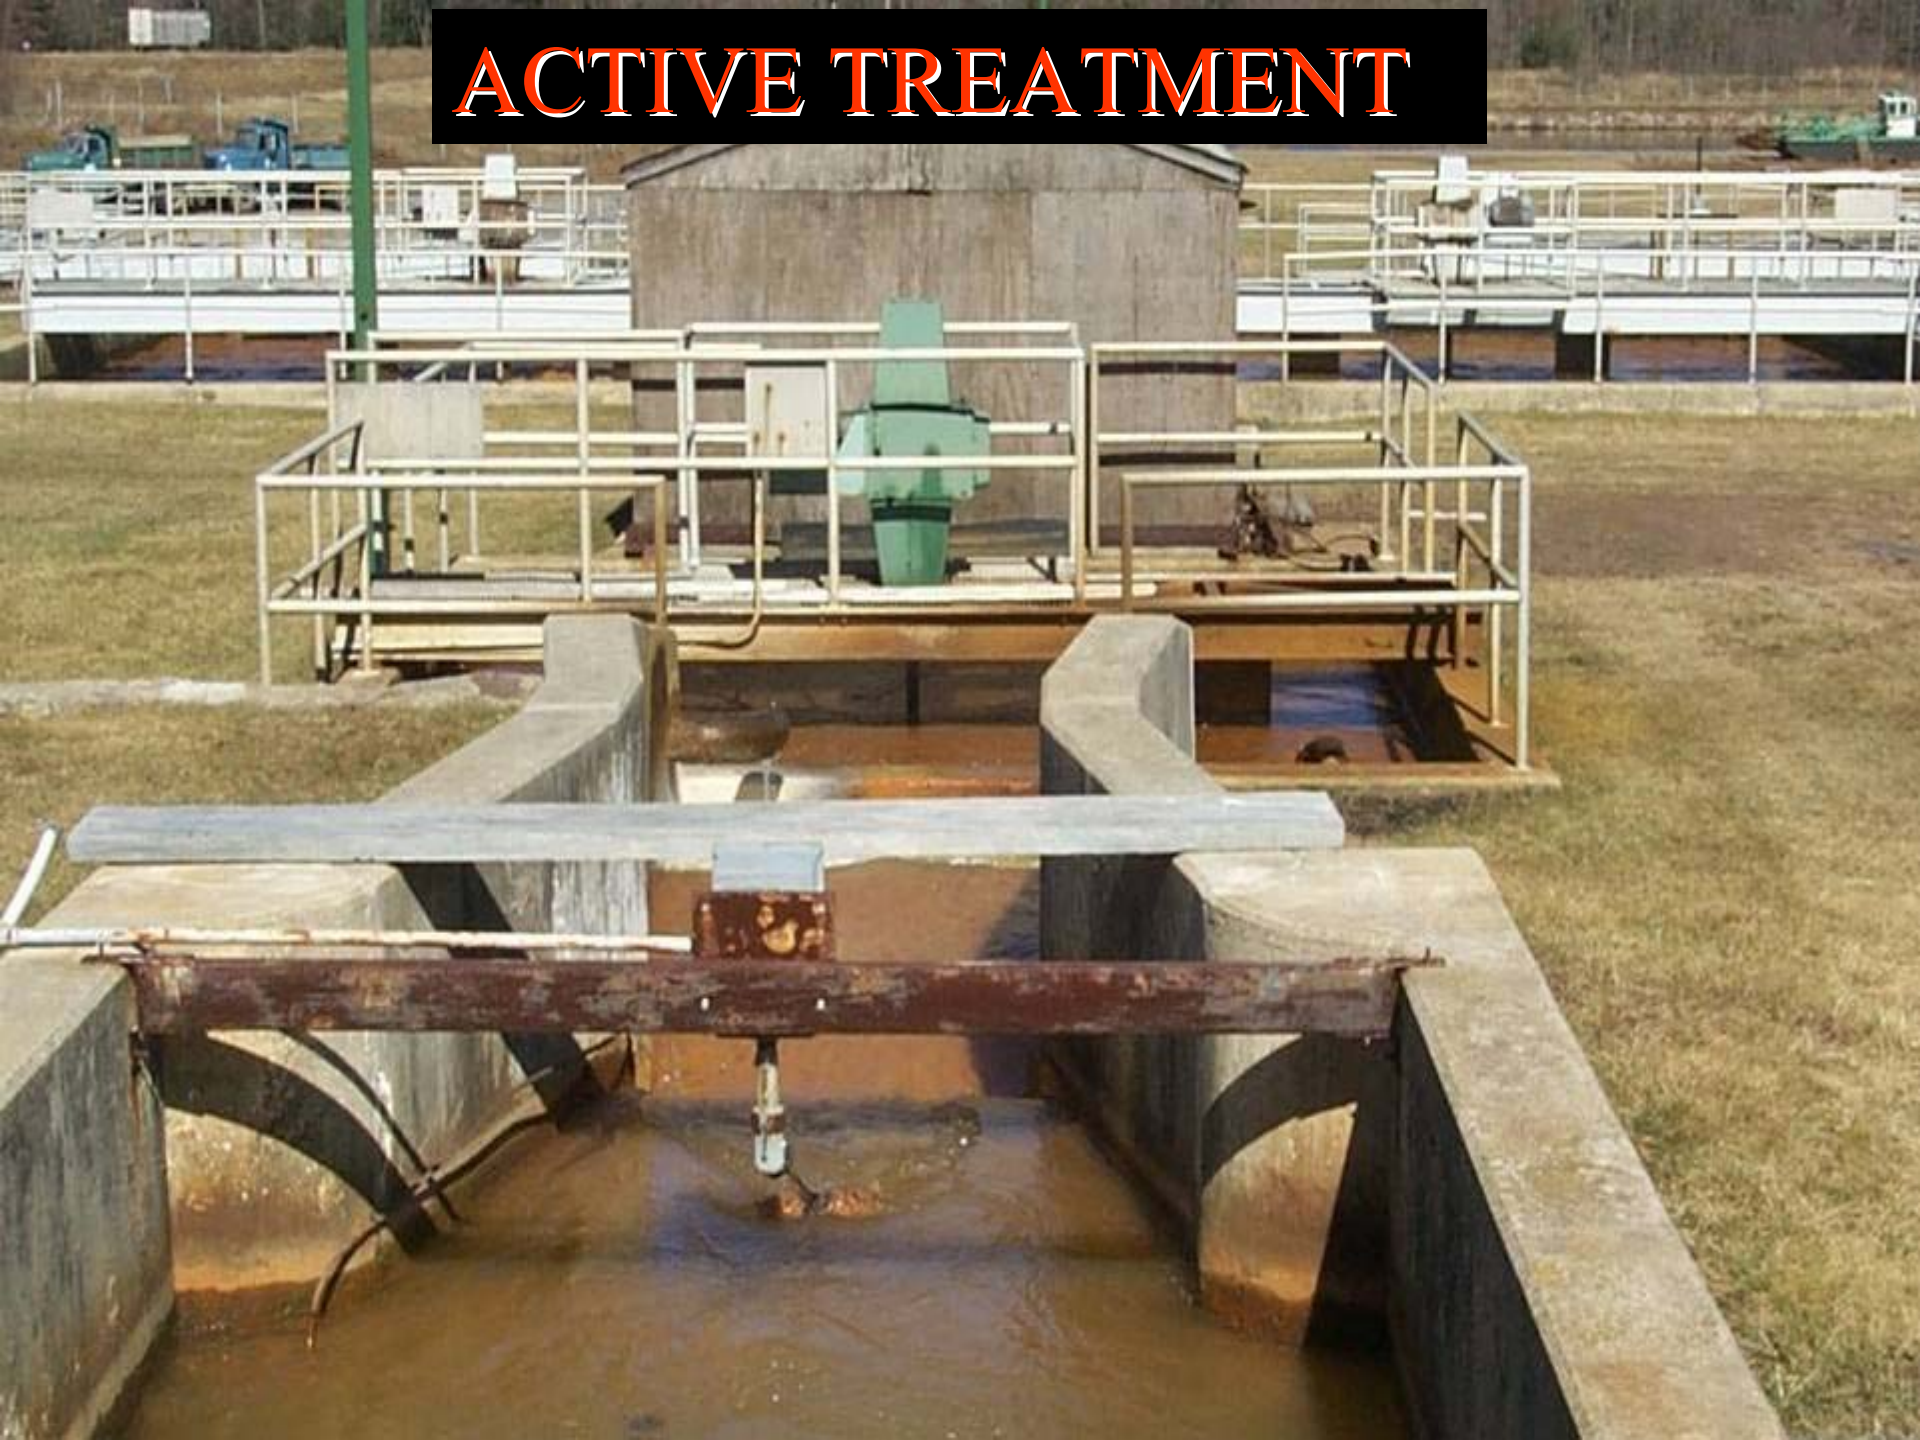
ACTIVE TREATMENT

- 1) **pH adjustment** – neutralize acidity to promote metals precipitation, prevent dissolution of metals in adjacent materials
- 2) **Aeration** – promotes formation of various metal hydroxides and allows them to precipitate.
- 3) **Solids Removal** – filter out solids

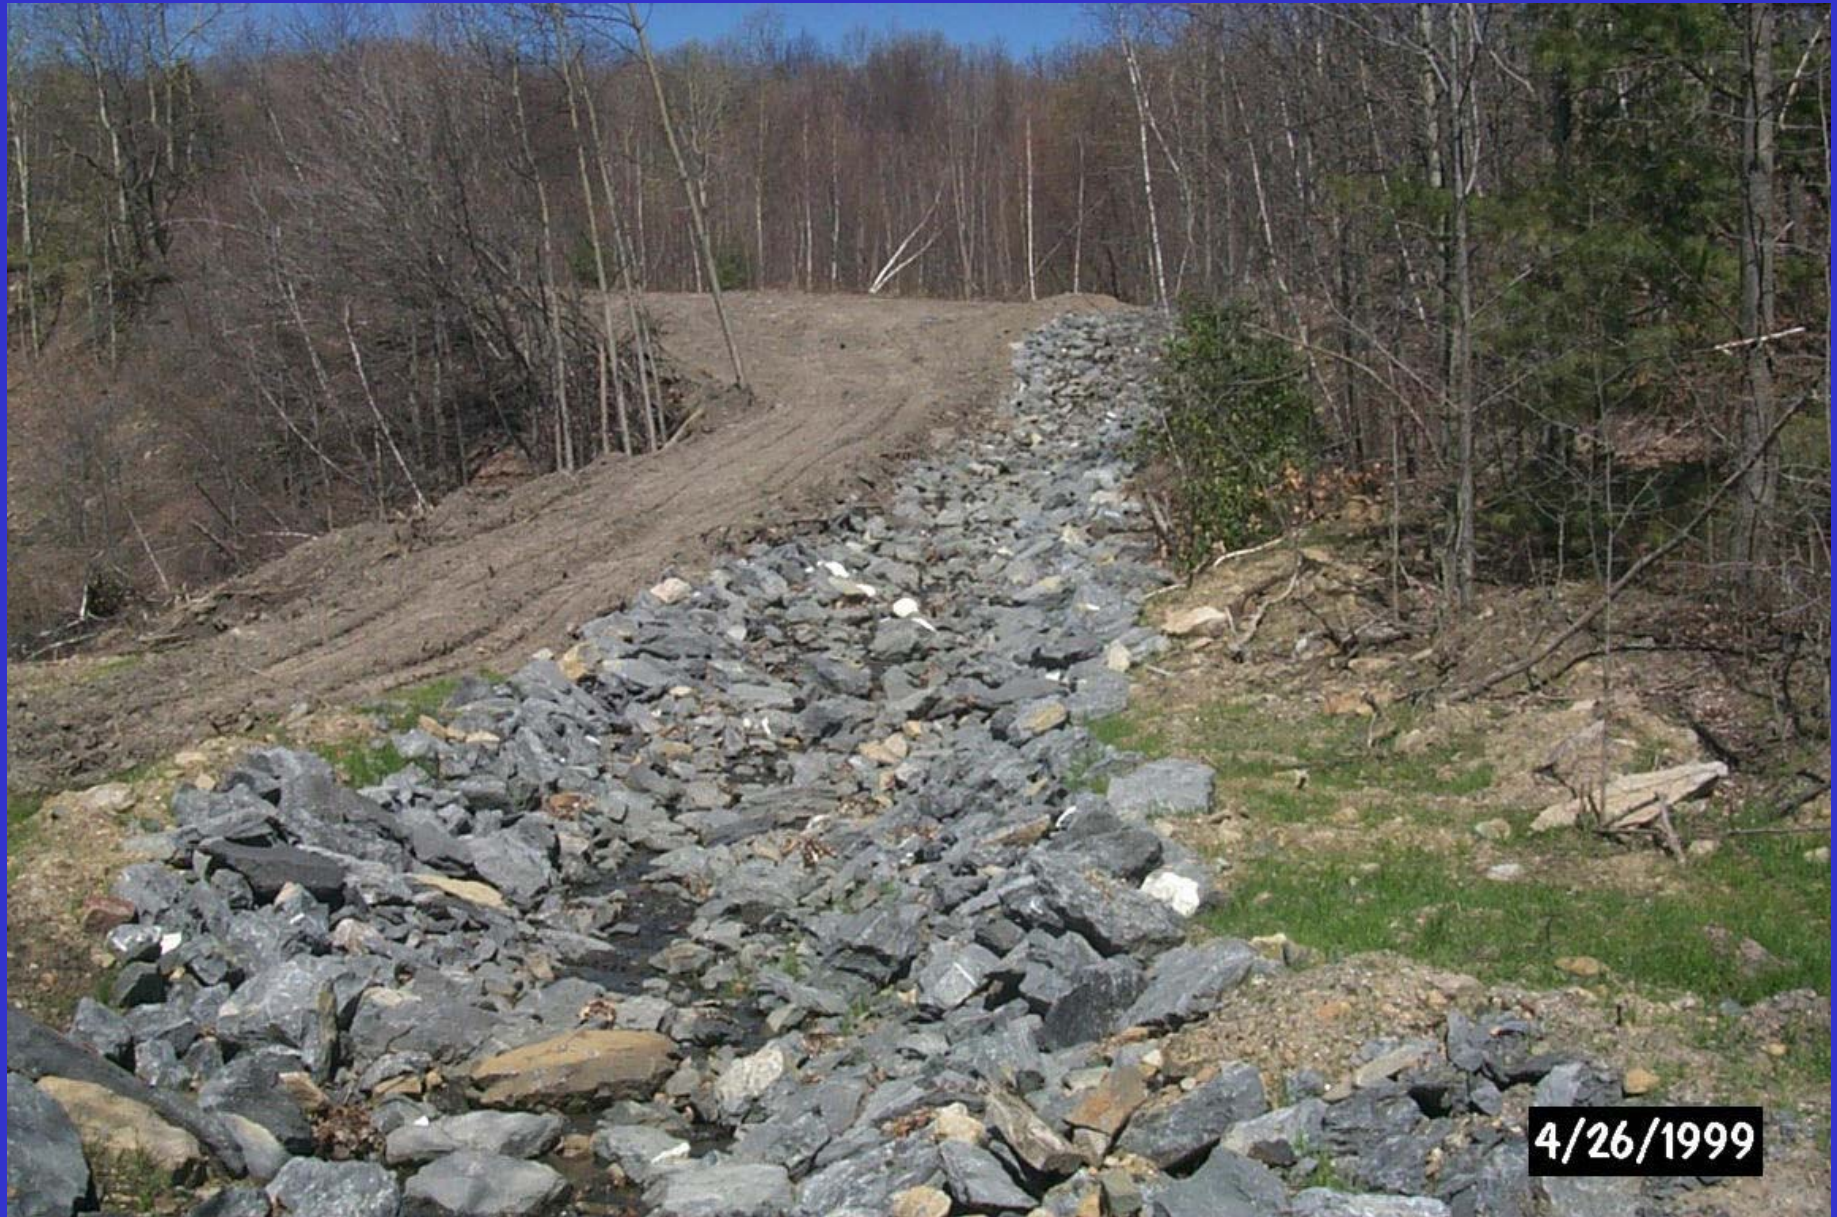
Limestone Channels

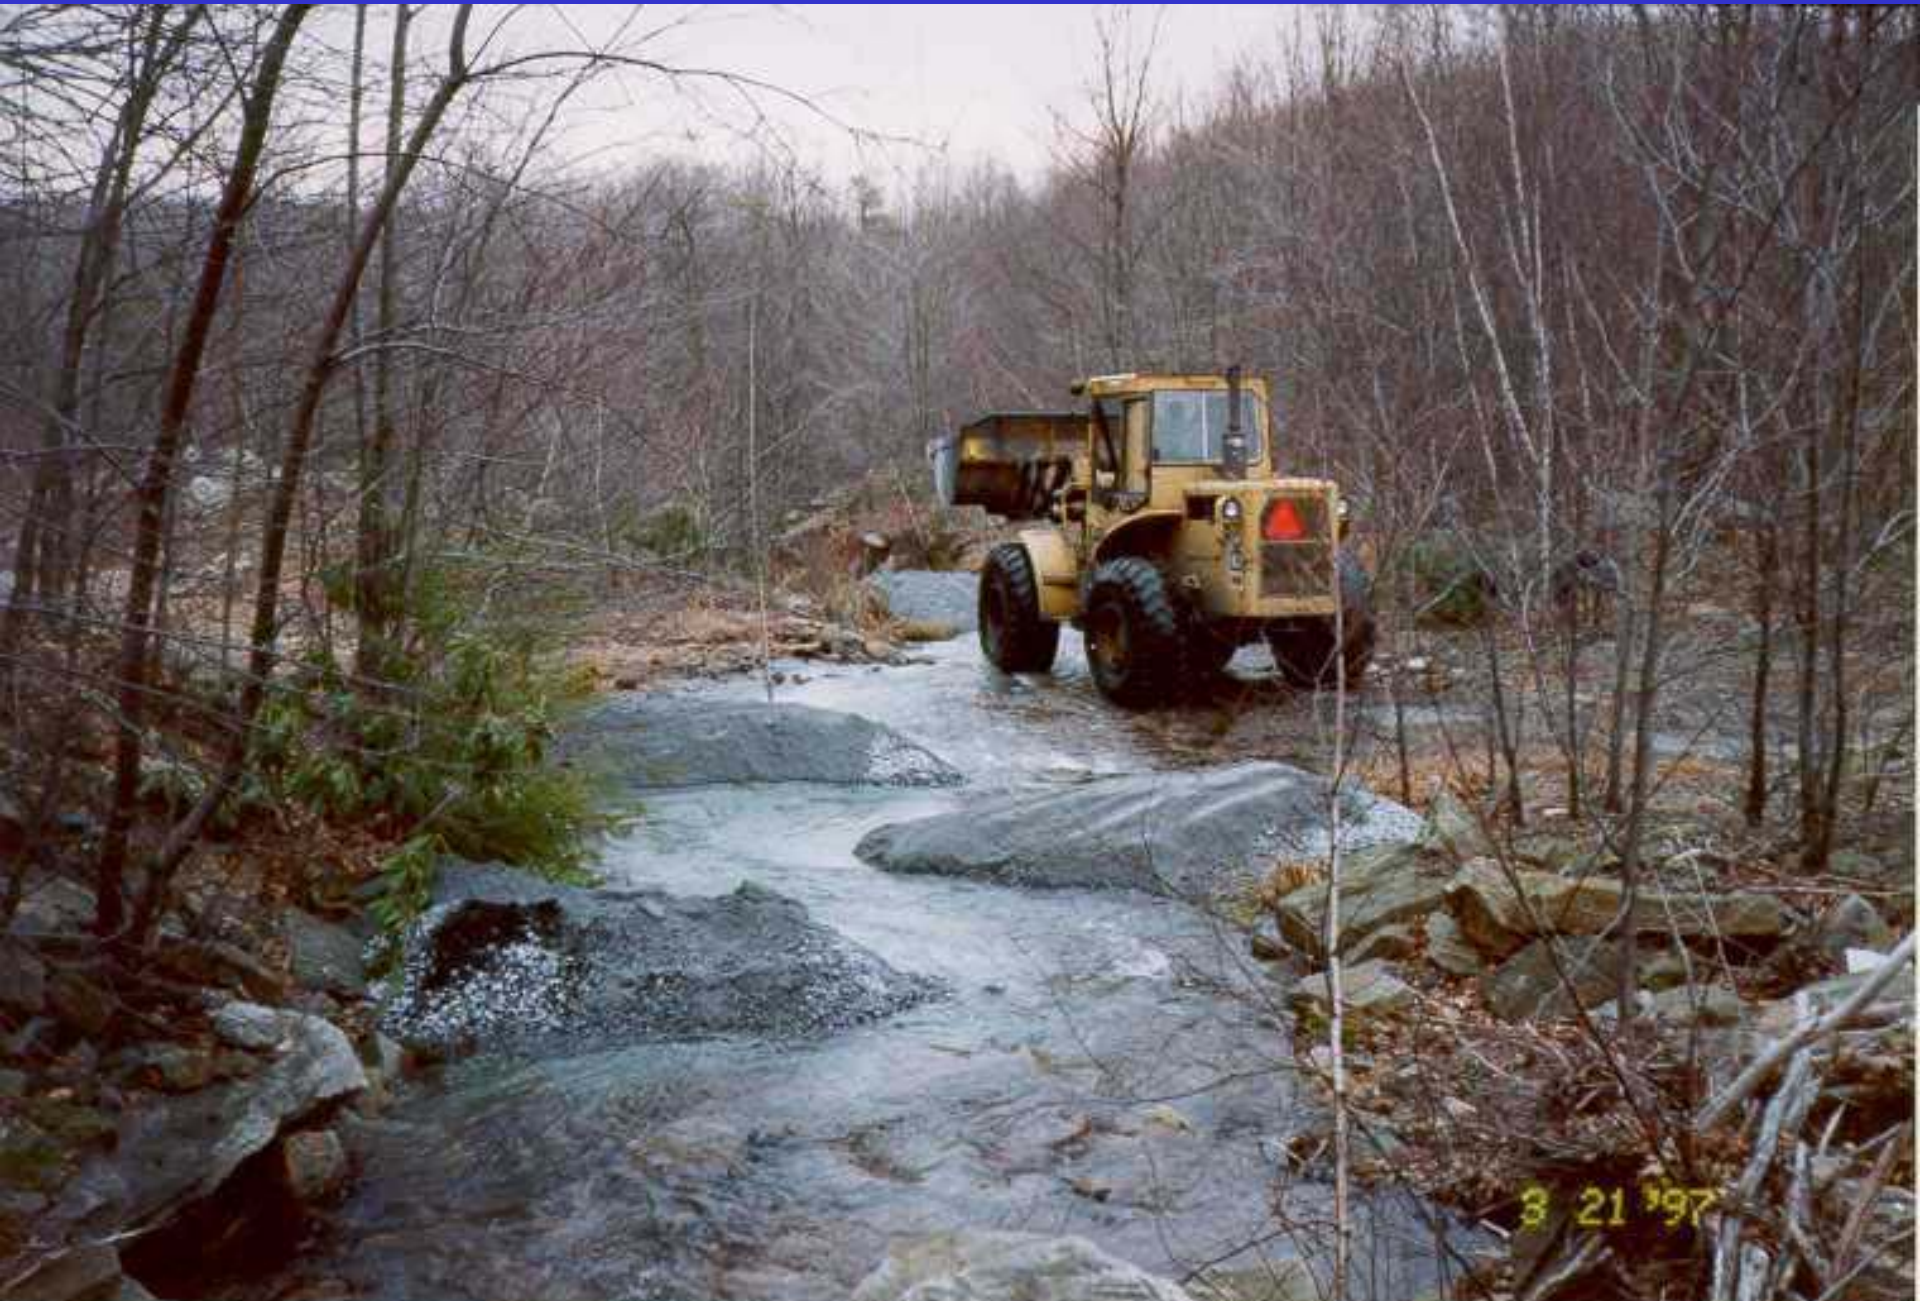
Open Limestone Channel/Sand Dosing

B. Open Limestone Channel

Limestone, 1 1/4 - 3 inch (66 tons)

Limestone sand, < 1/2 inch (44 tons)

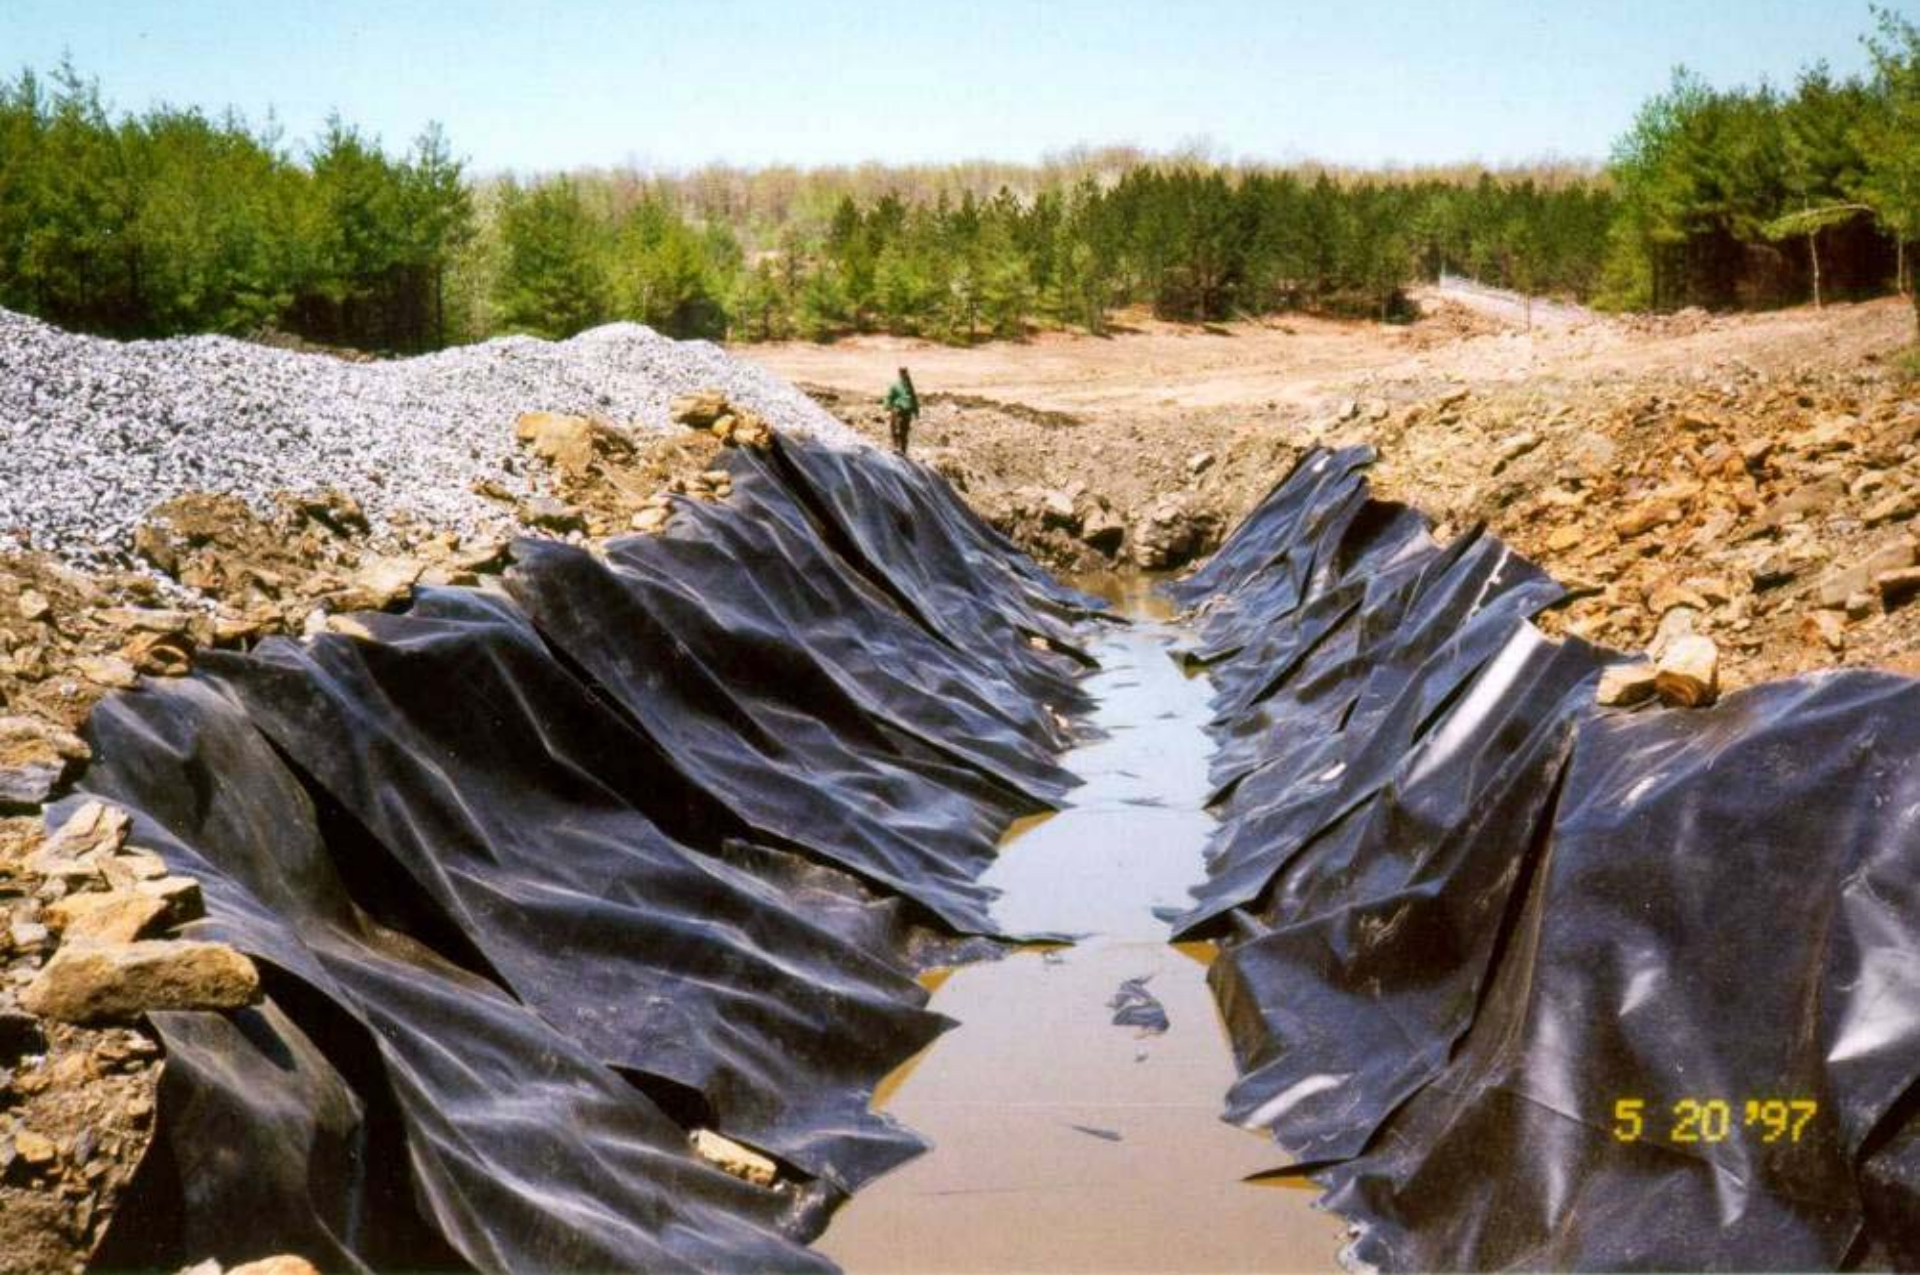
Buck Mtn. Anoxic Limestone Drain

A. Anoxic/Oxic Limestone Drain

▲▲▲ Limestone, 1 1/4 - 3 inch

■ Limestone, <2 inch

— Landfill liner

(total 400 tons = 1.5 tons/yd³ x 270 yd³)

(All piping within drain is perforated)

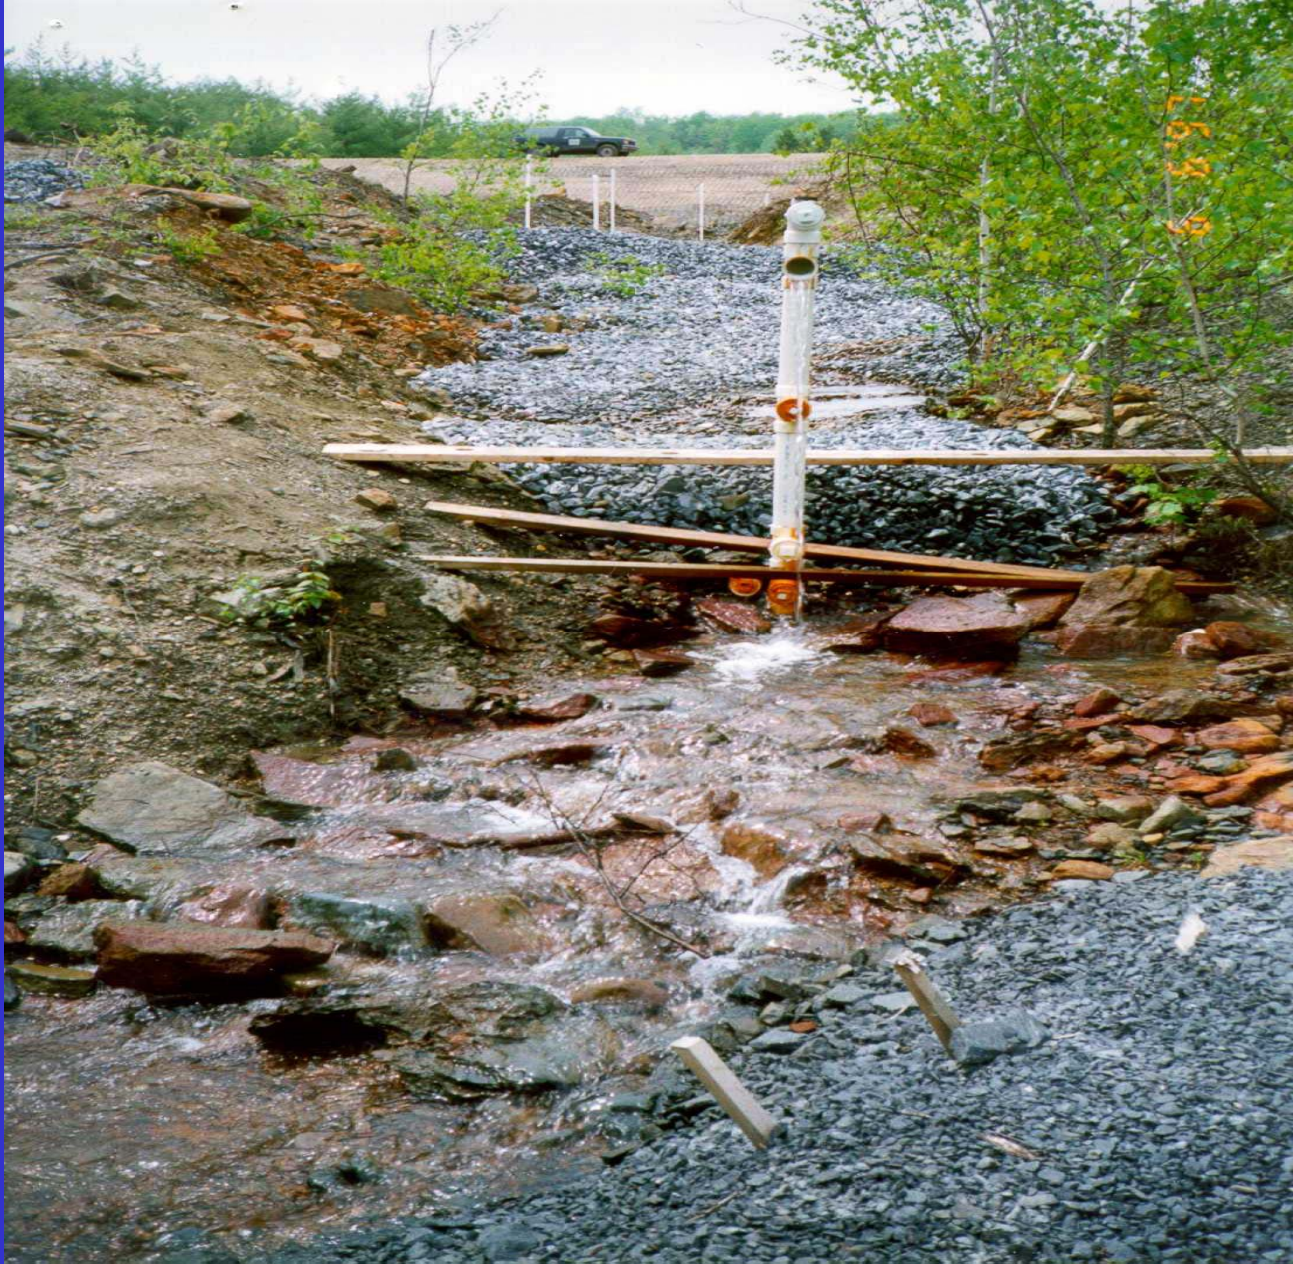
Anoxic Limestone Drain Discharge
