Characteristics and Treatment of Mine Drainage in the Anthracite Region of Pennsylvania

Roger J. Hornberger, Daniel J. Koury, Charles A. Cravotta III,
Todd Wood, and Keith B.C. Brady

27th West Virginia Mine Drainage Task Force Symposium

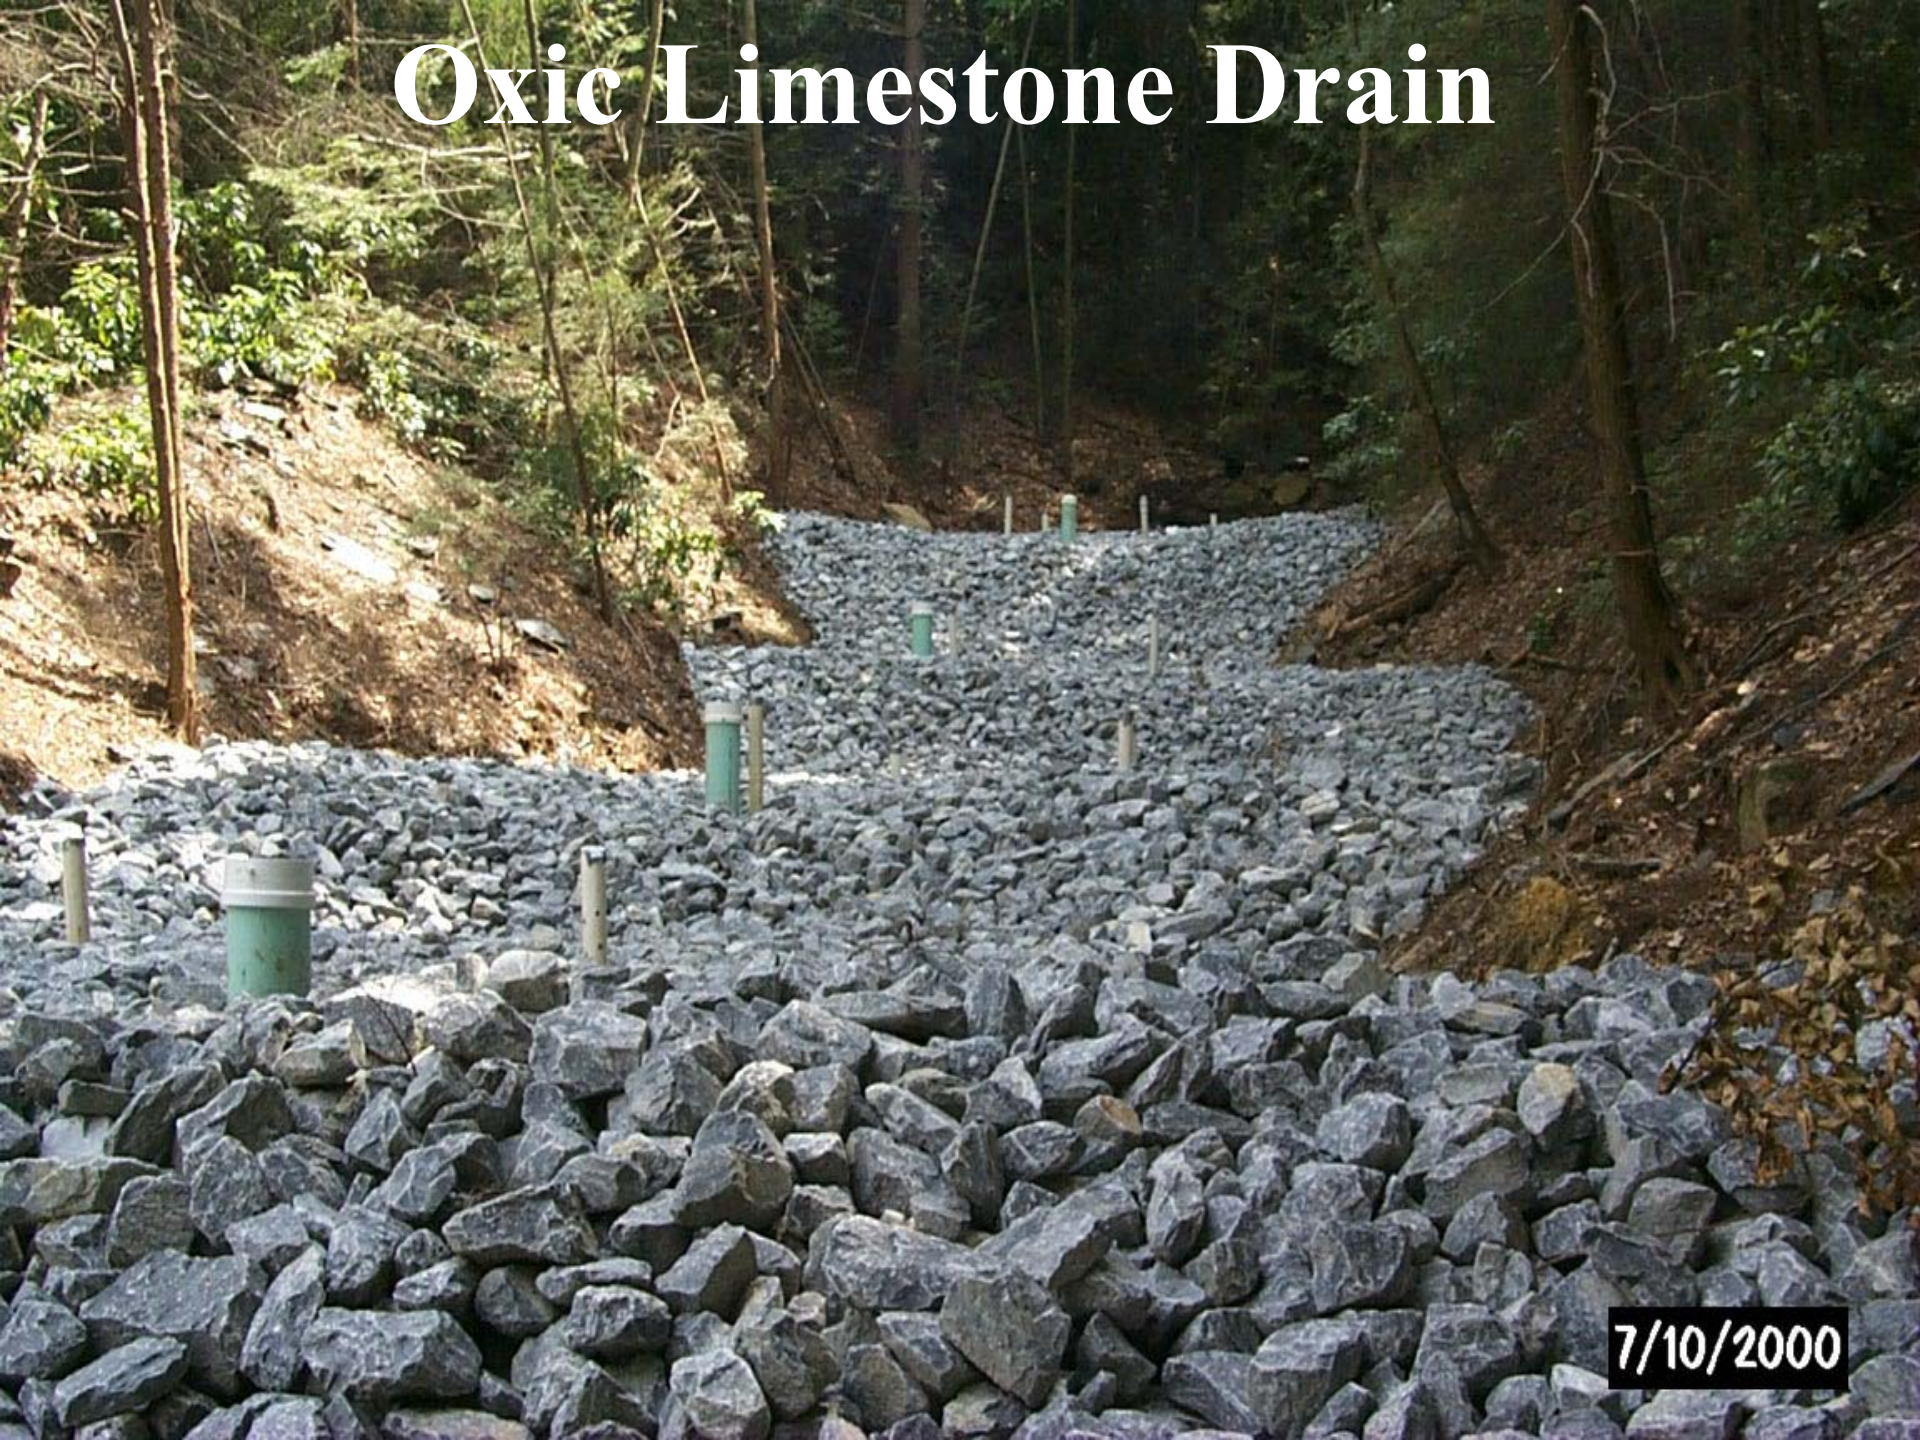
Oxic Limestone Drain

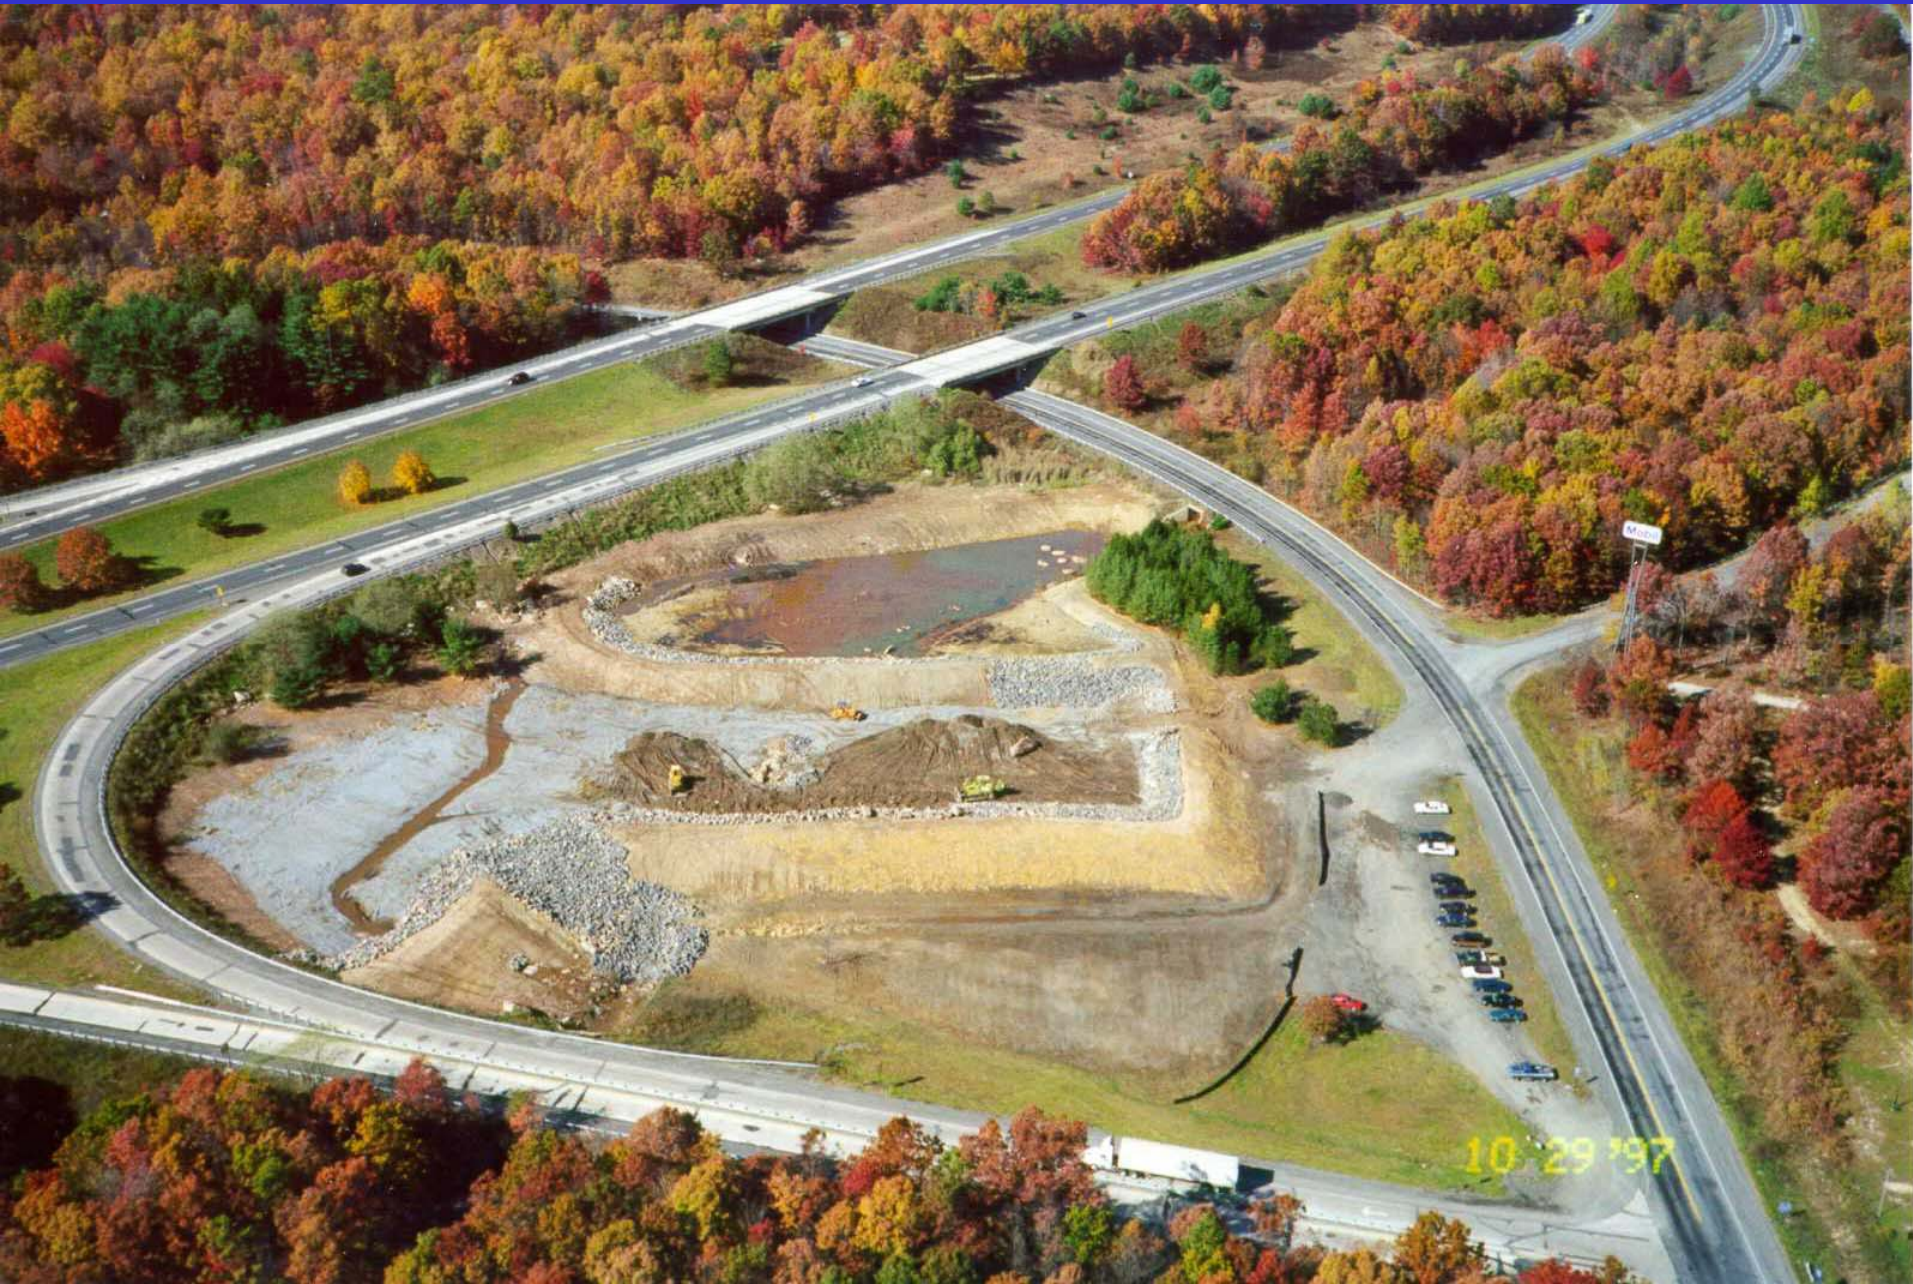
Limestone –Compost Wetland

D. Limestone-Compost Based Wetland

Mushroom compost

Limestone, 8 - 16 inch (R4)
