# Hydrologic Characterization of Multiple Seam Underground and Surface Mining in Northern Appalachia

# Background

# Major Tasks

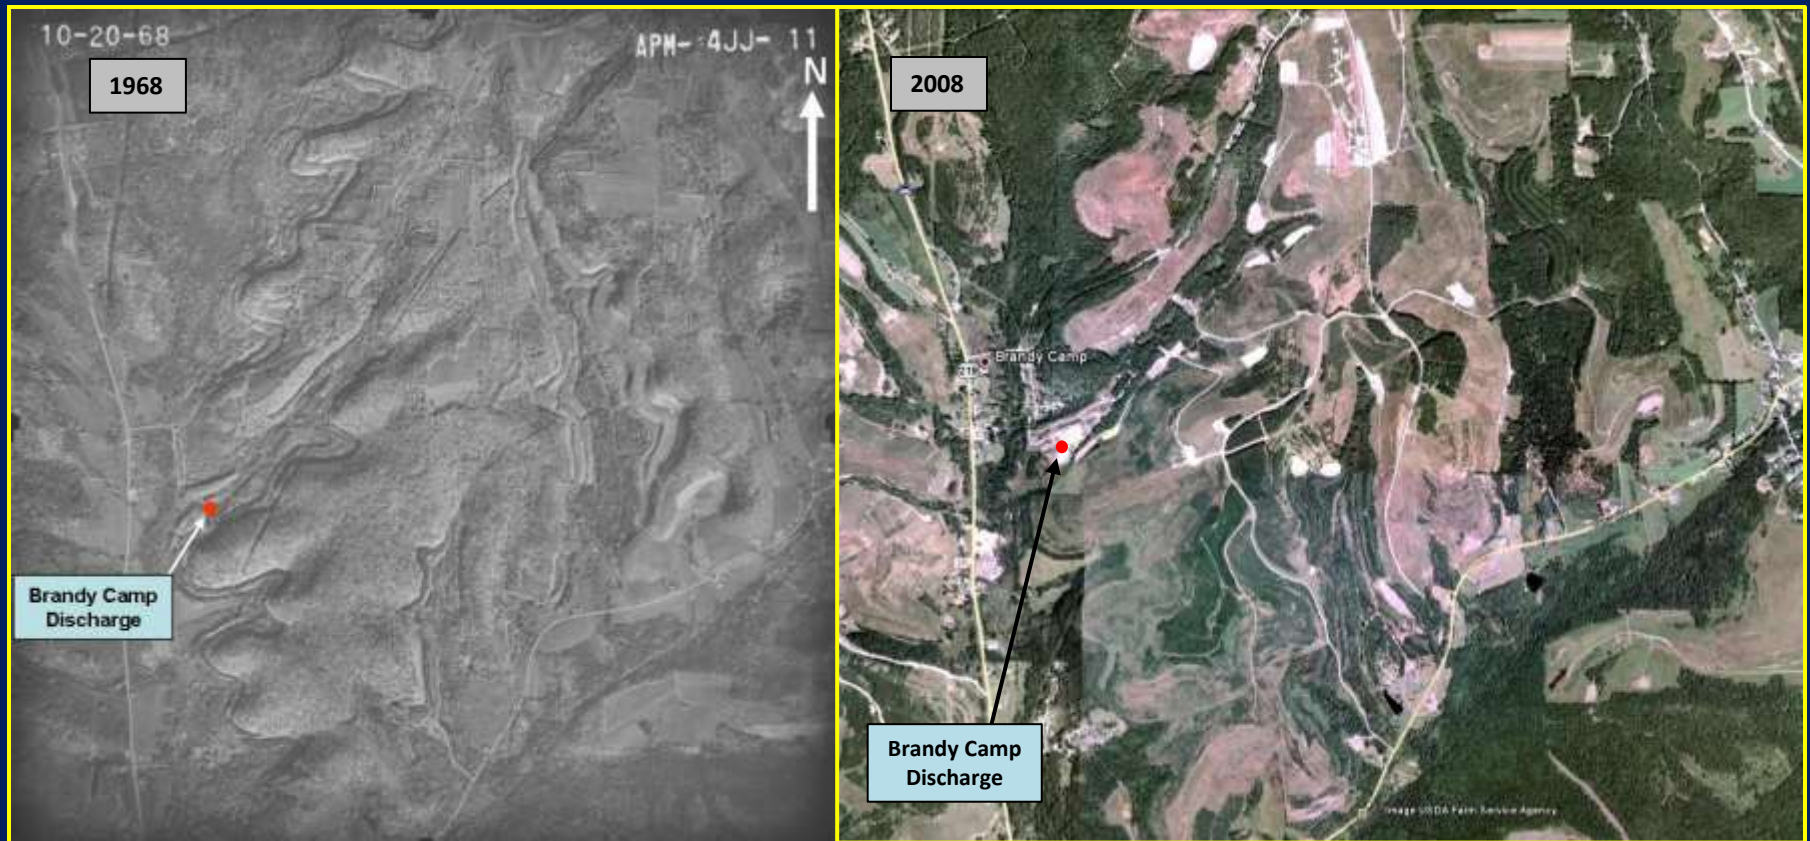
**Approximately 85% of the recharge area  
was surface mined and reclaimed**

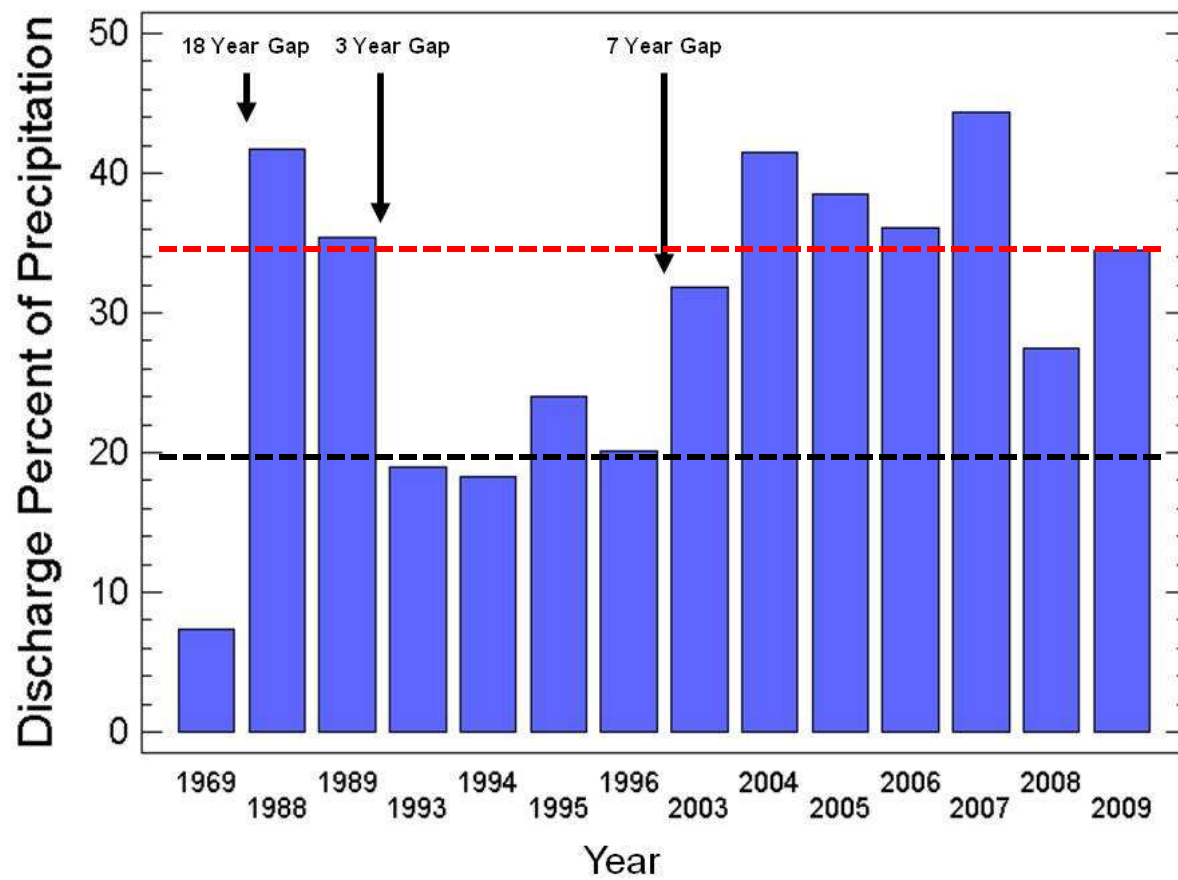
# Precipitation

- The discharge rate clearly tied to antecedent precipitation.
- Precipitation during the background sampling and subsequently was well within the normal range.
- The discharge percentage of precipitation increased markedly since the large scale surface mining and reclamation has occurred.

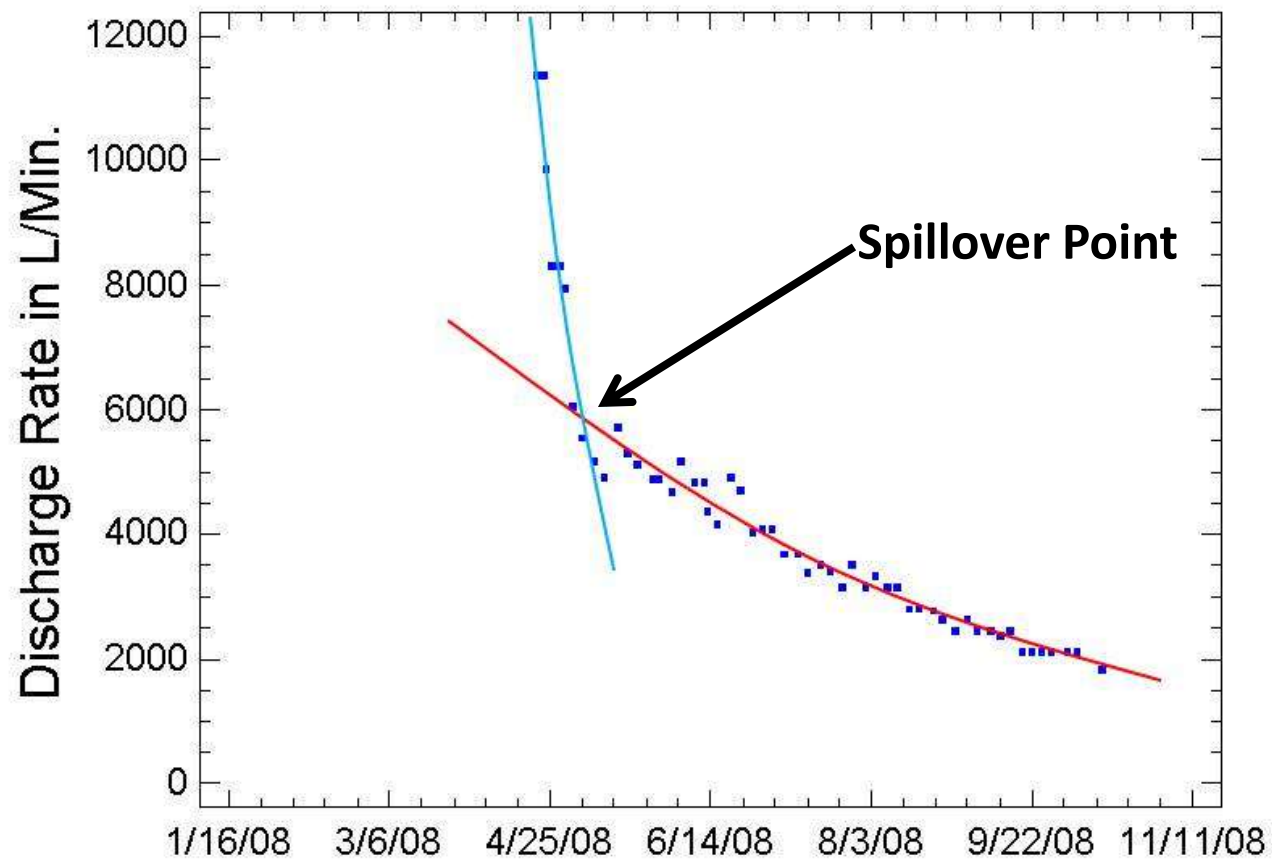
# Spring of 2008 Flushing Event

- Between March 15 and April 5, 2008 the discharge increased from 4,000 L/min (1,000 gpm) to greater than 11,350 L/min (3,000 gpm).
- Concentrations of metals, acidity and sulfate likewise increased.
- Melting of a thick snowpack with more than 13.5 cm (5.3 inches) of rain.
- A distinct break in the slope of the regression hydrograph indicated a significant change in the recharge rate and flow into the lower mine.

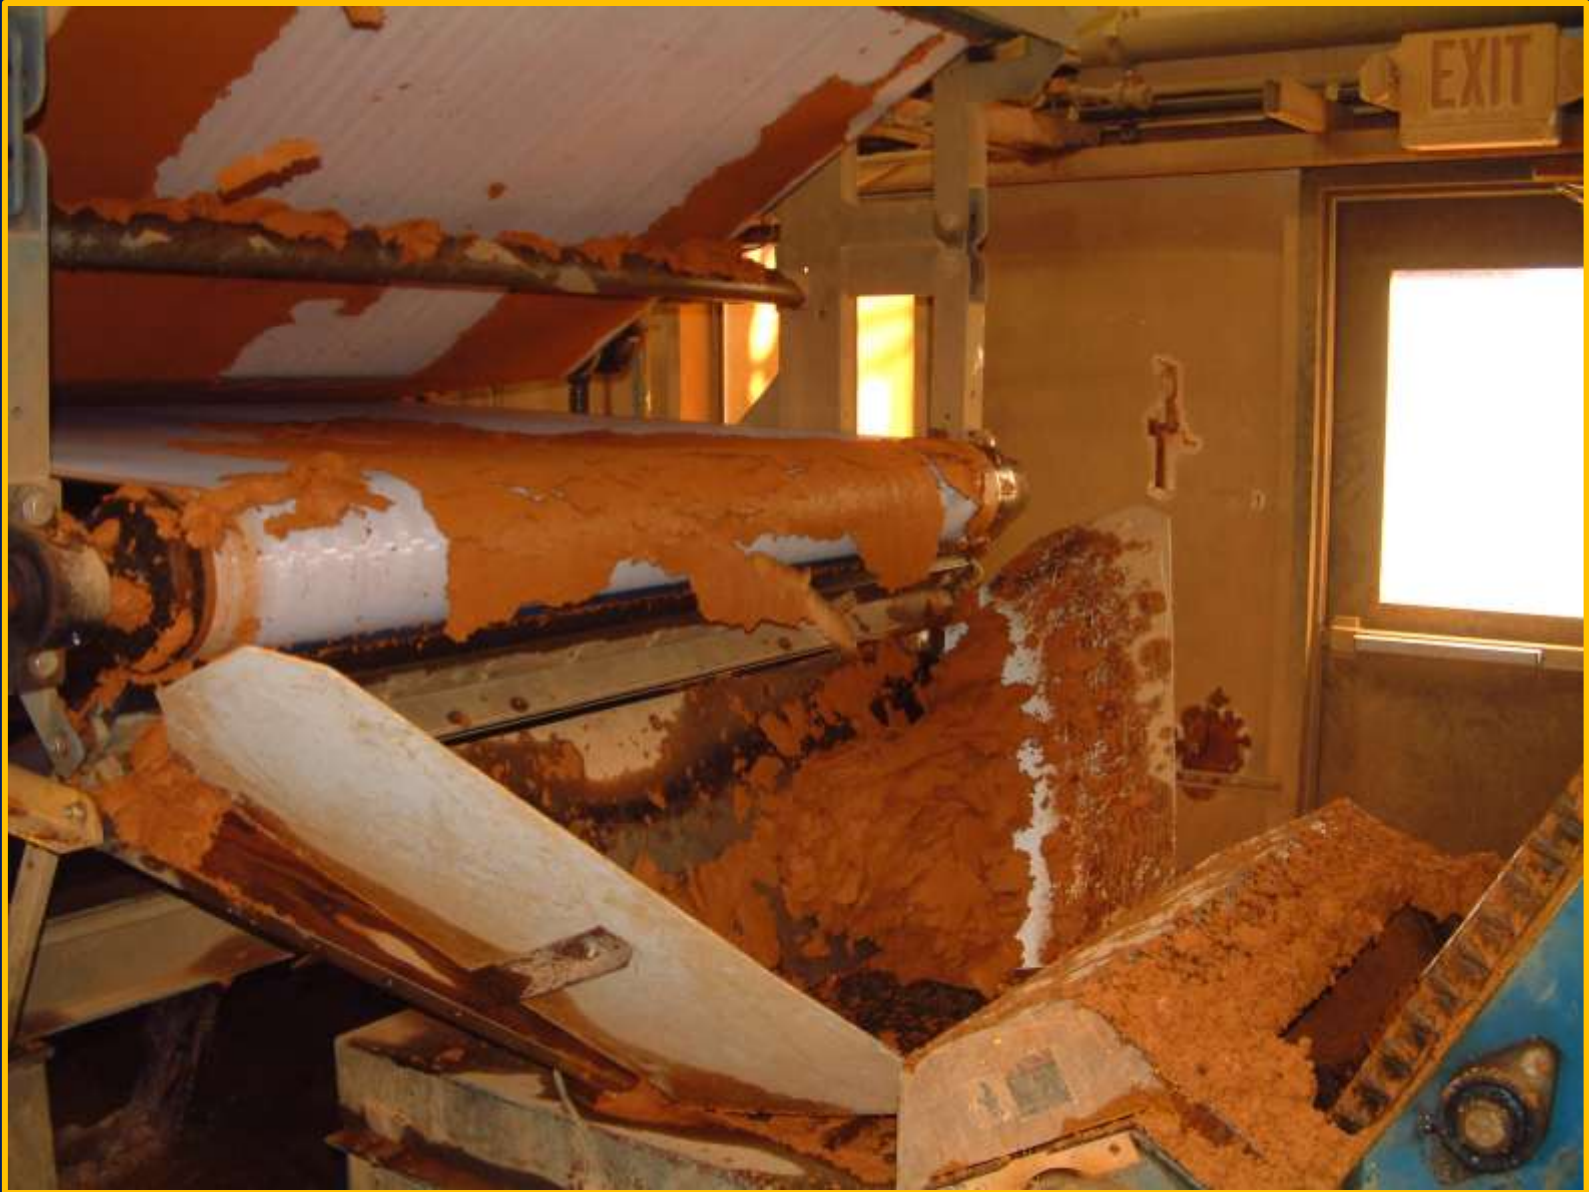
# Disposal of the Iron Hydroxide Sludge by Injection

- Vertical hydraulic conductivity was calculated for the interburden between the mines ( $1.0 \times 10^{-7}$  m/s) which supports the perched mine pool.
- The water quality of the MK is less likely to redissolve the iron. The pH averages 5.9.
- Mains and other entries are open enough to permit sufficient storage for a long time. Average opening was 1.9 meters.
- Water levels in monitoring wells indicate that there is one pool, so the works are openly connected.

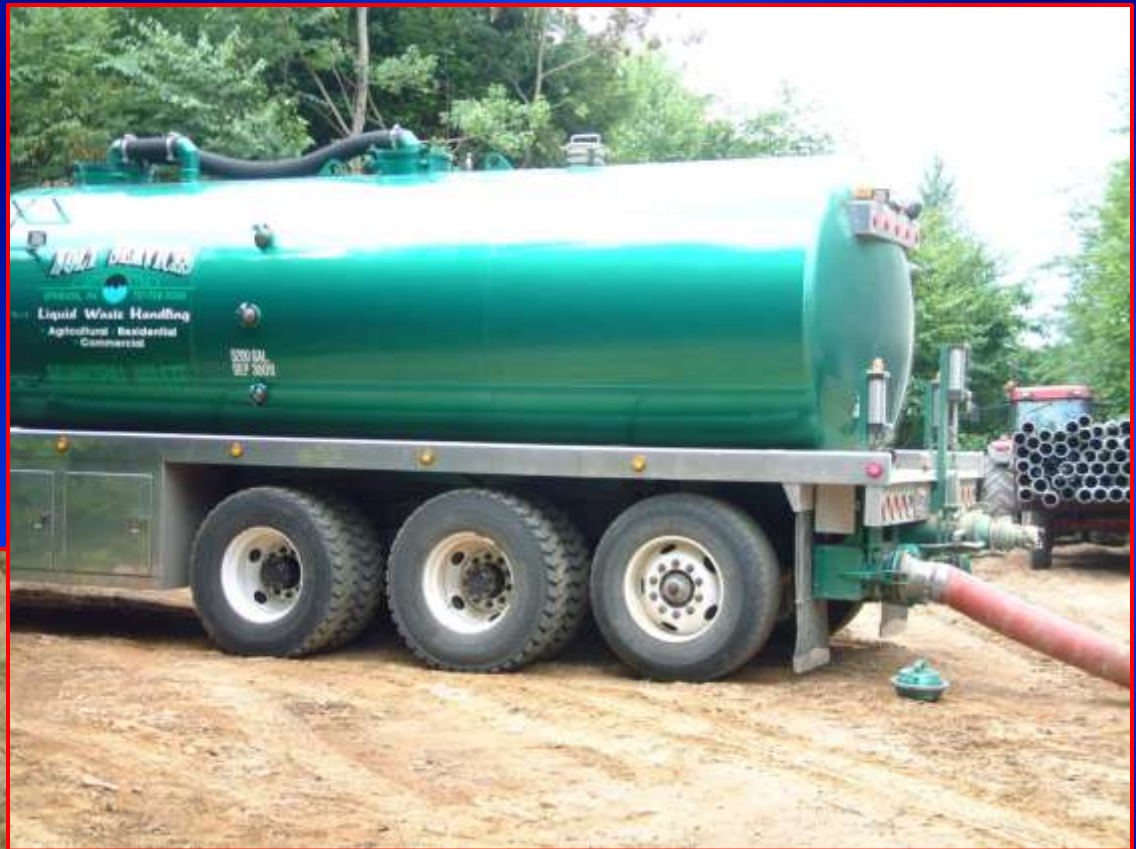
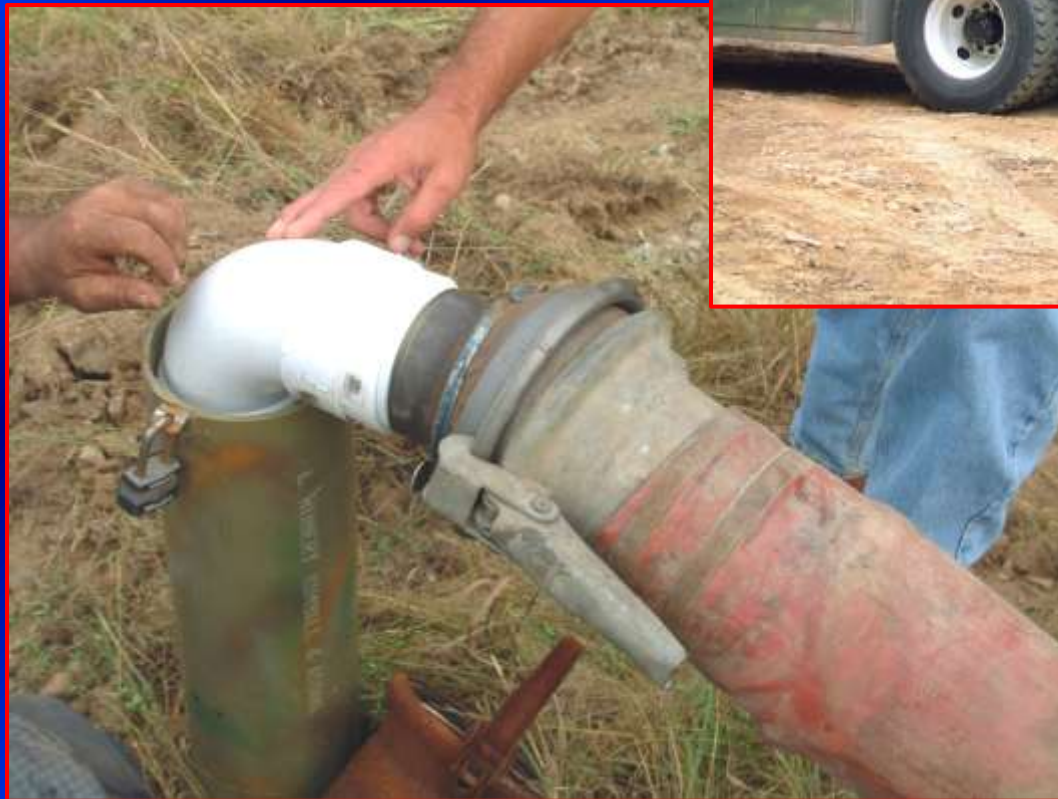
# Mid-July 2010 sludge injection test

- 2.8 million liters (740,000 gallons) of iron hydroxide sludge was injected into the MK mine over a three day period.
- The iron sludge averaged 2.43% solids.
- No change in the mine pool level was observed.
- No increase in the iron concentration at the discharge was noted.
