# Recovery of Deckers Creek from Acid Mine Drainage

Martin Christ

Friends of Deckers Creek

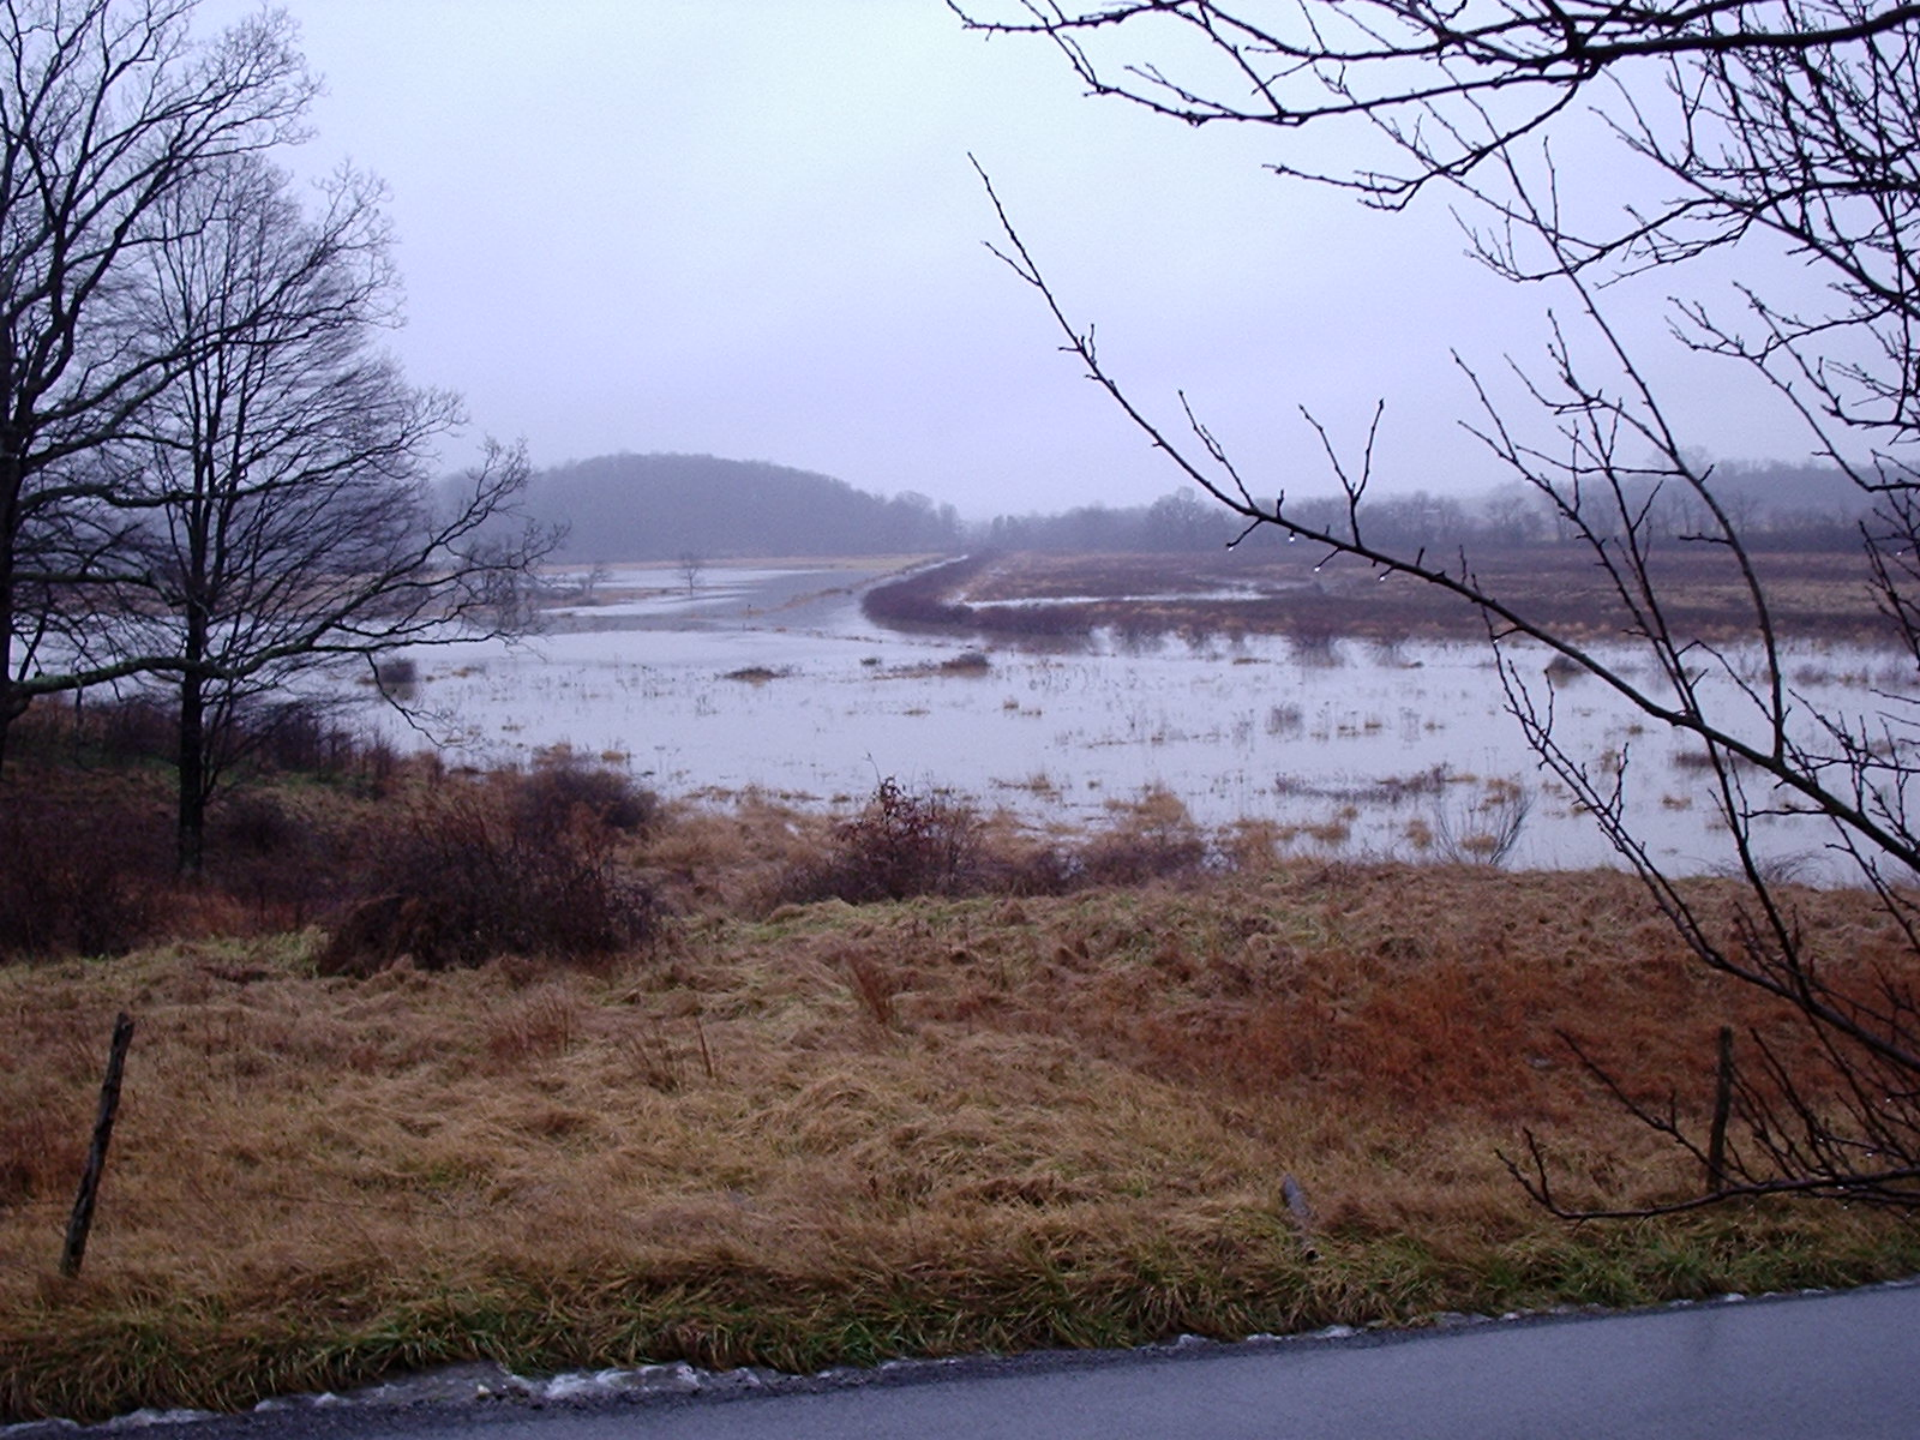
# Segment 3

Segment	Location	Setting	Condition
3	Kanes Creek to Masontown	Flat, mostly channelized, several tribs with mining	Improved from acidic to neutral in last five years

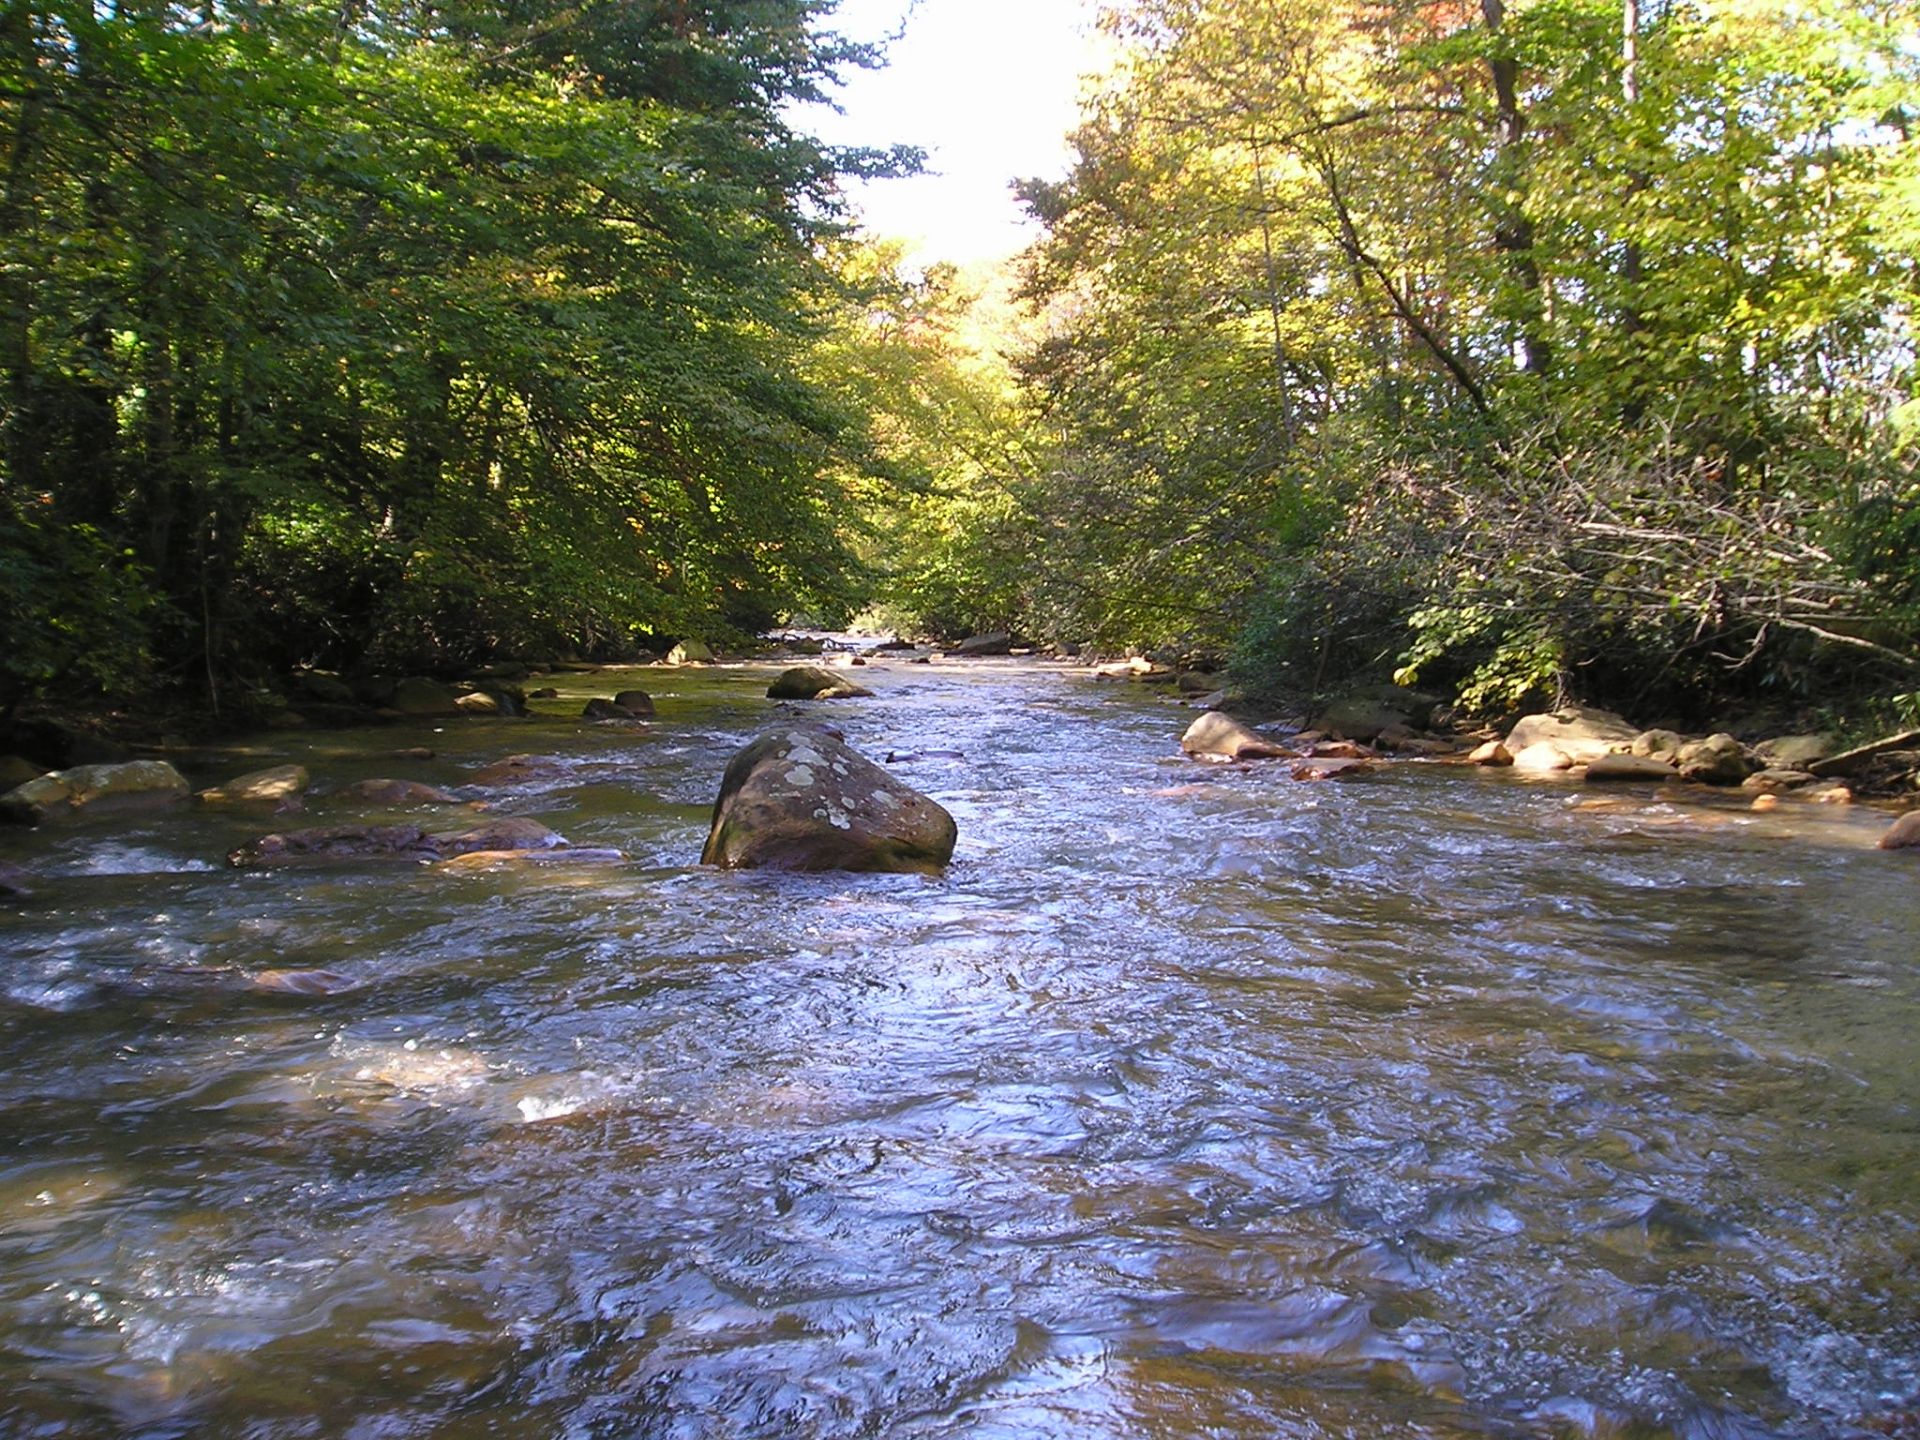
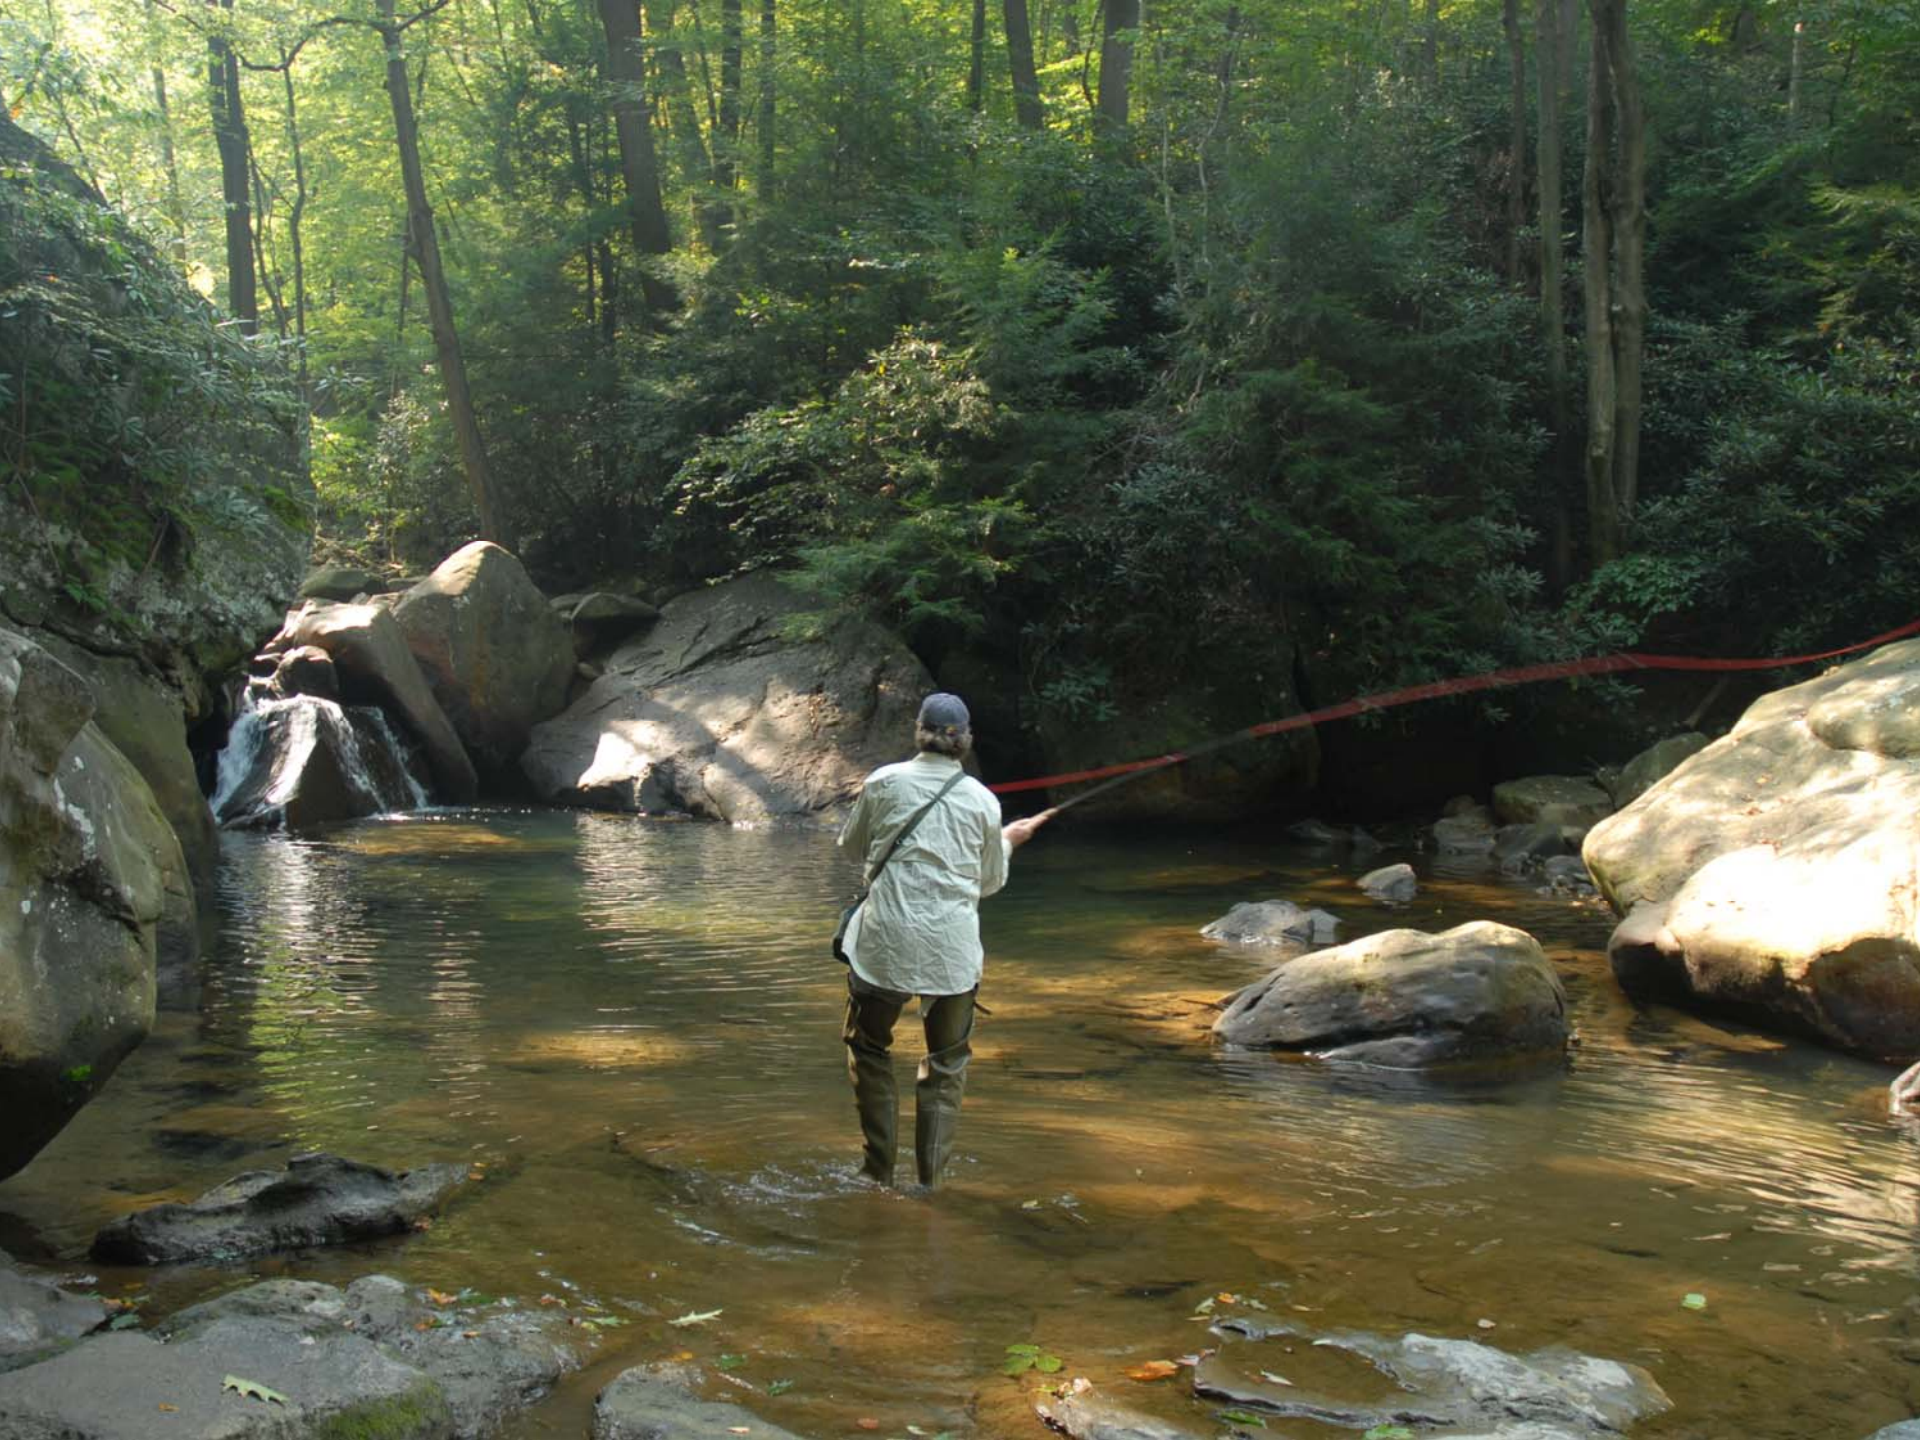
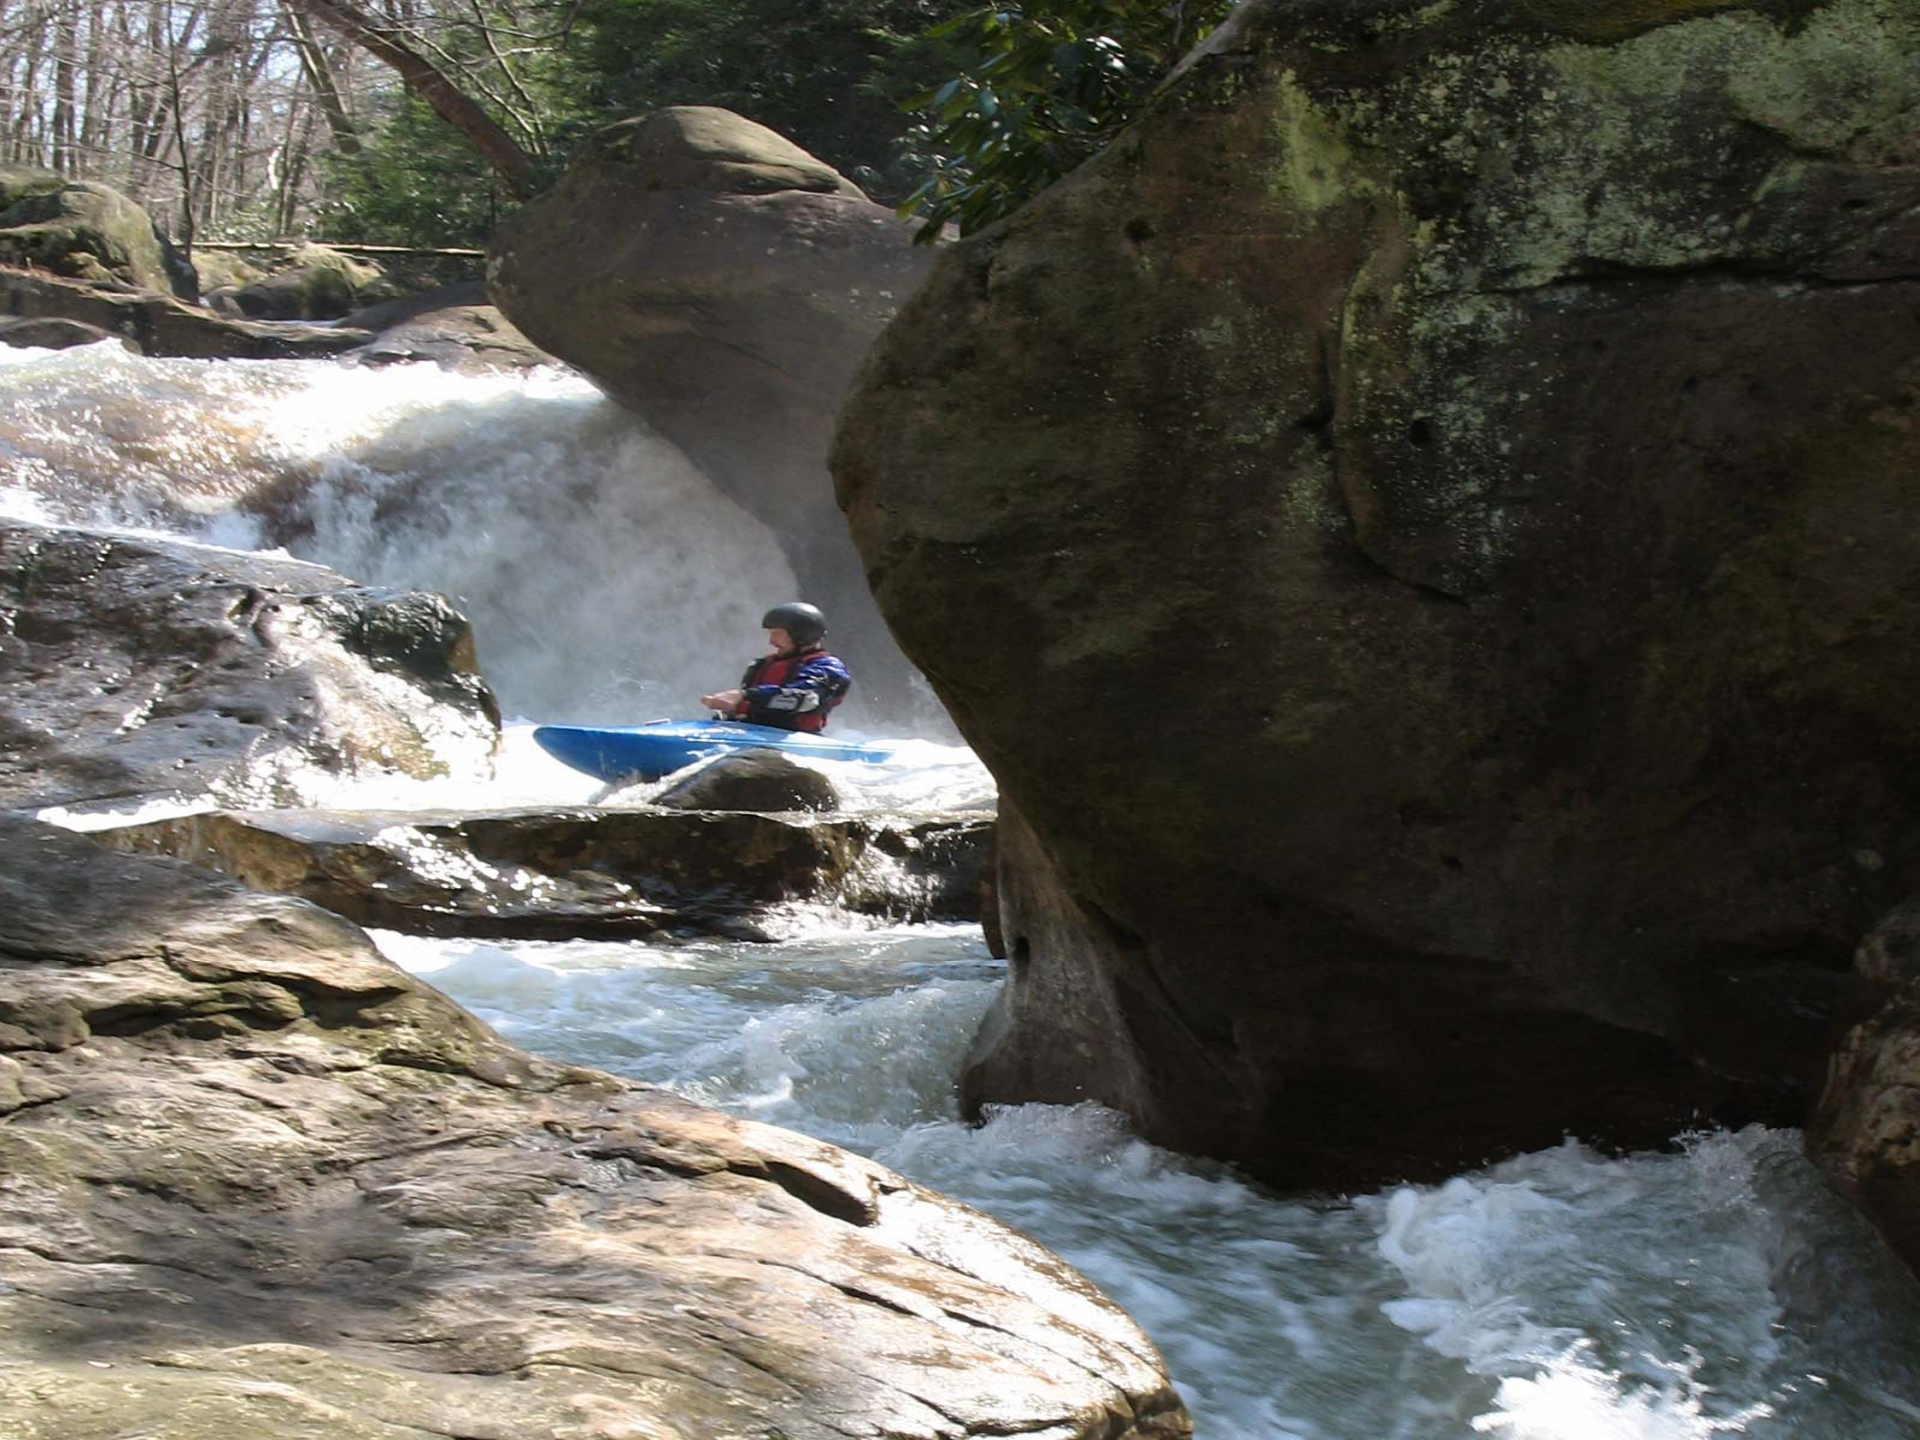
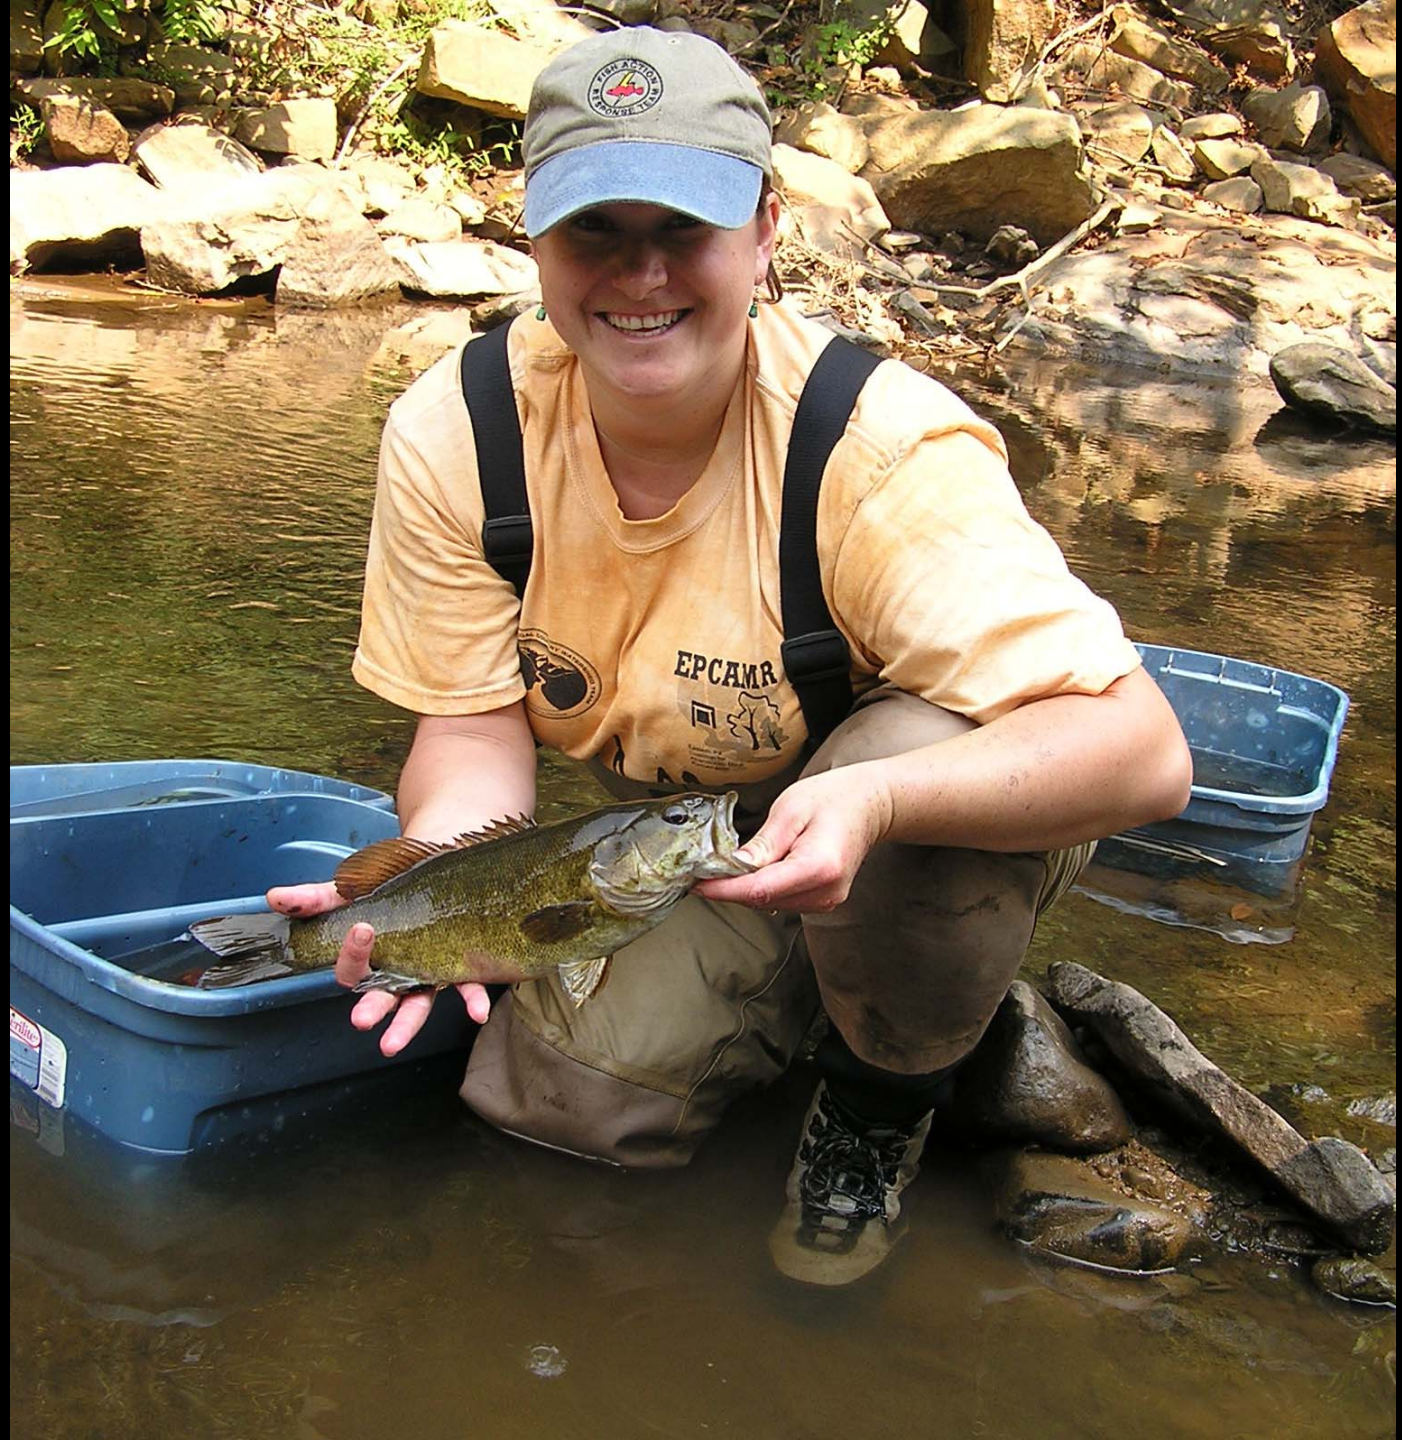
# Segment 4 & 5

Segment	Location	Setting	Condition
4	Masontown to Greer	Steep	Masontown sewage treatment plant drastically reduced bacteria pollution
5	Greer to Dellslow	Steep, well-known whitewater kayaking destination	Water quality is currently excellent

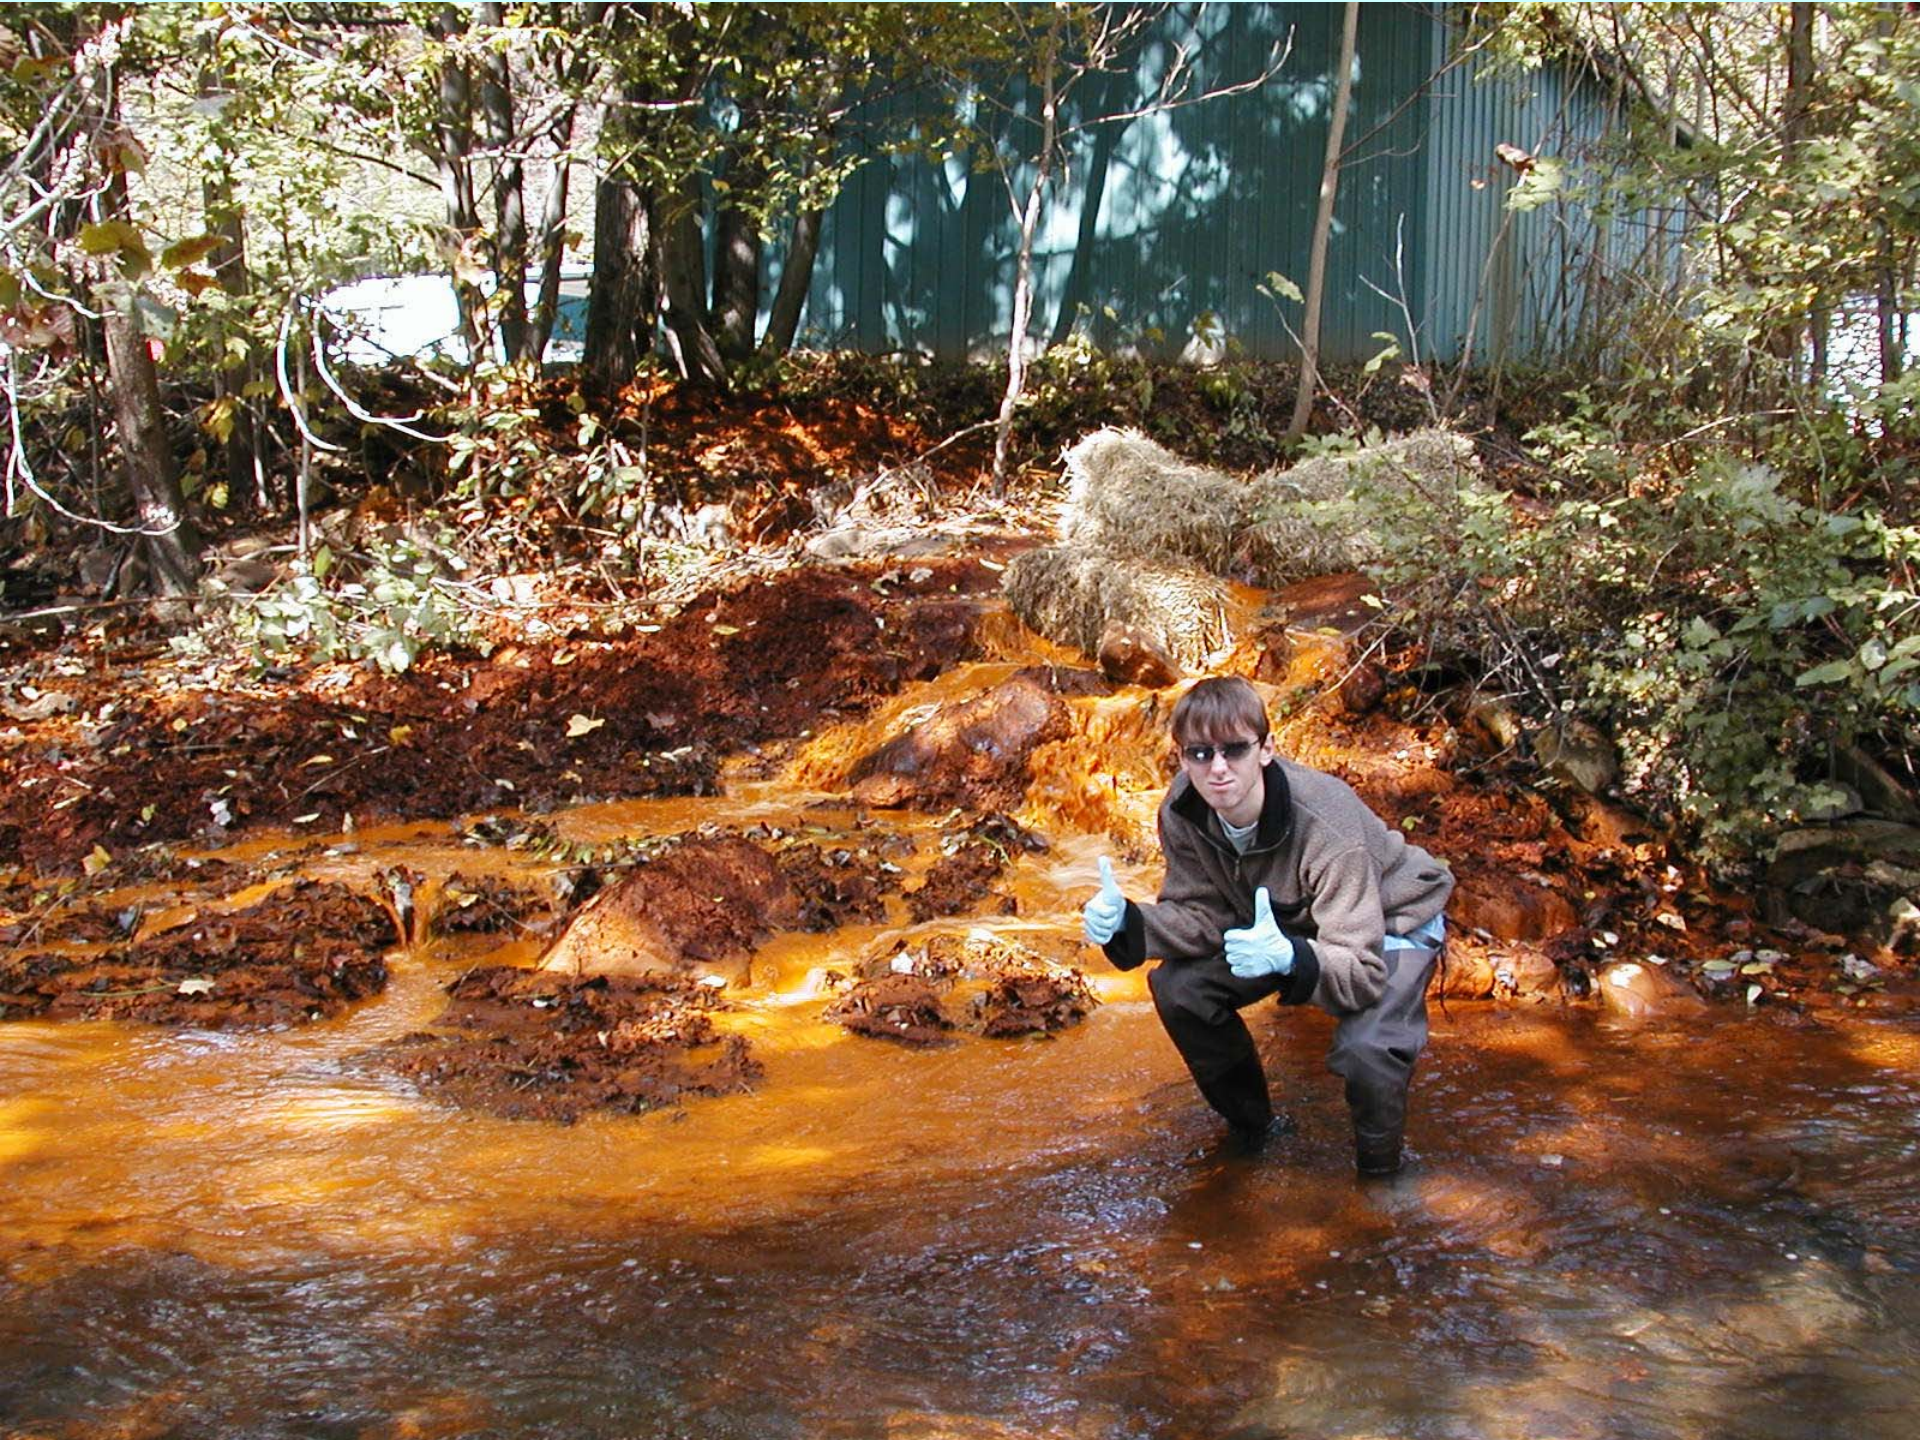
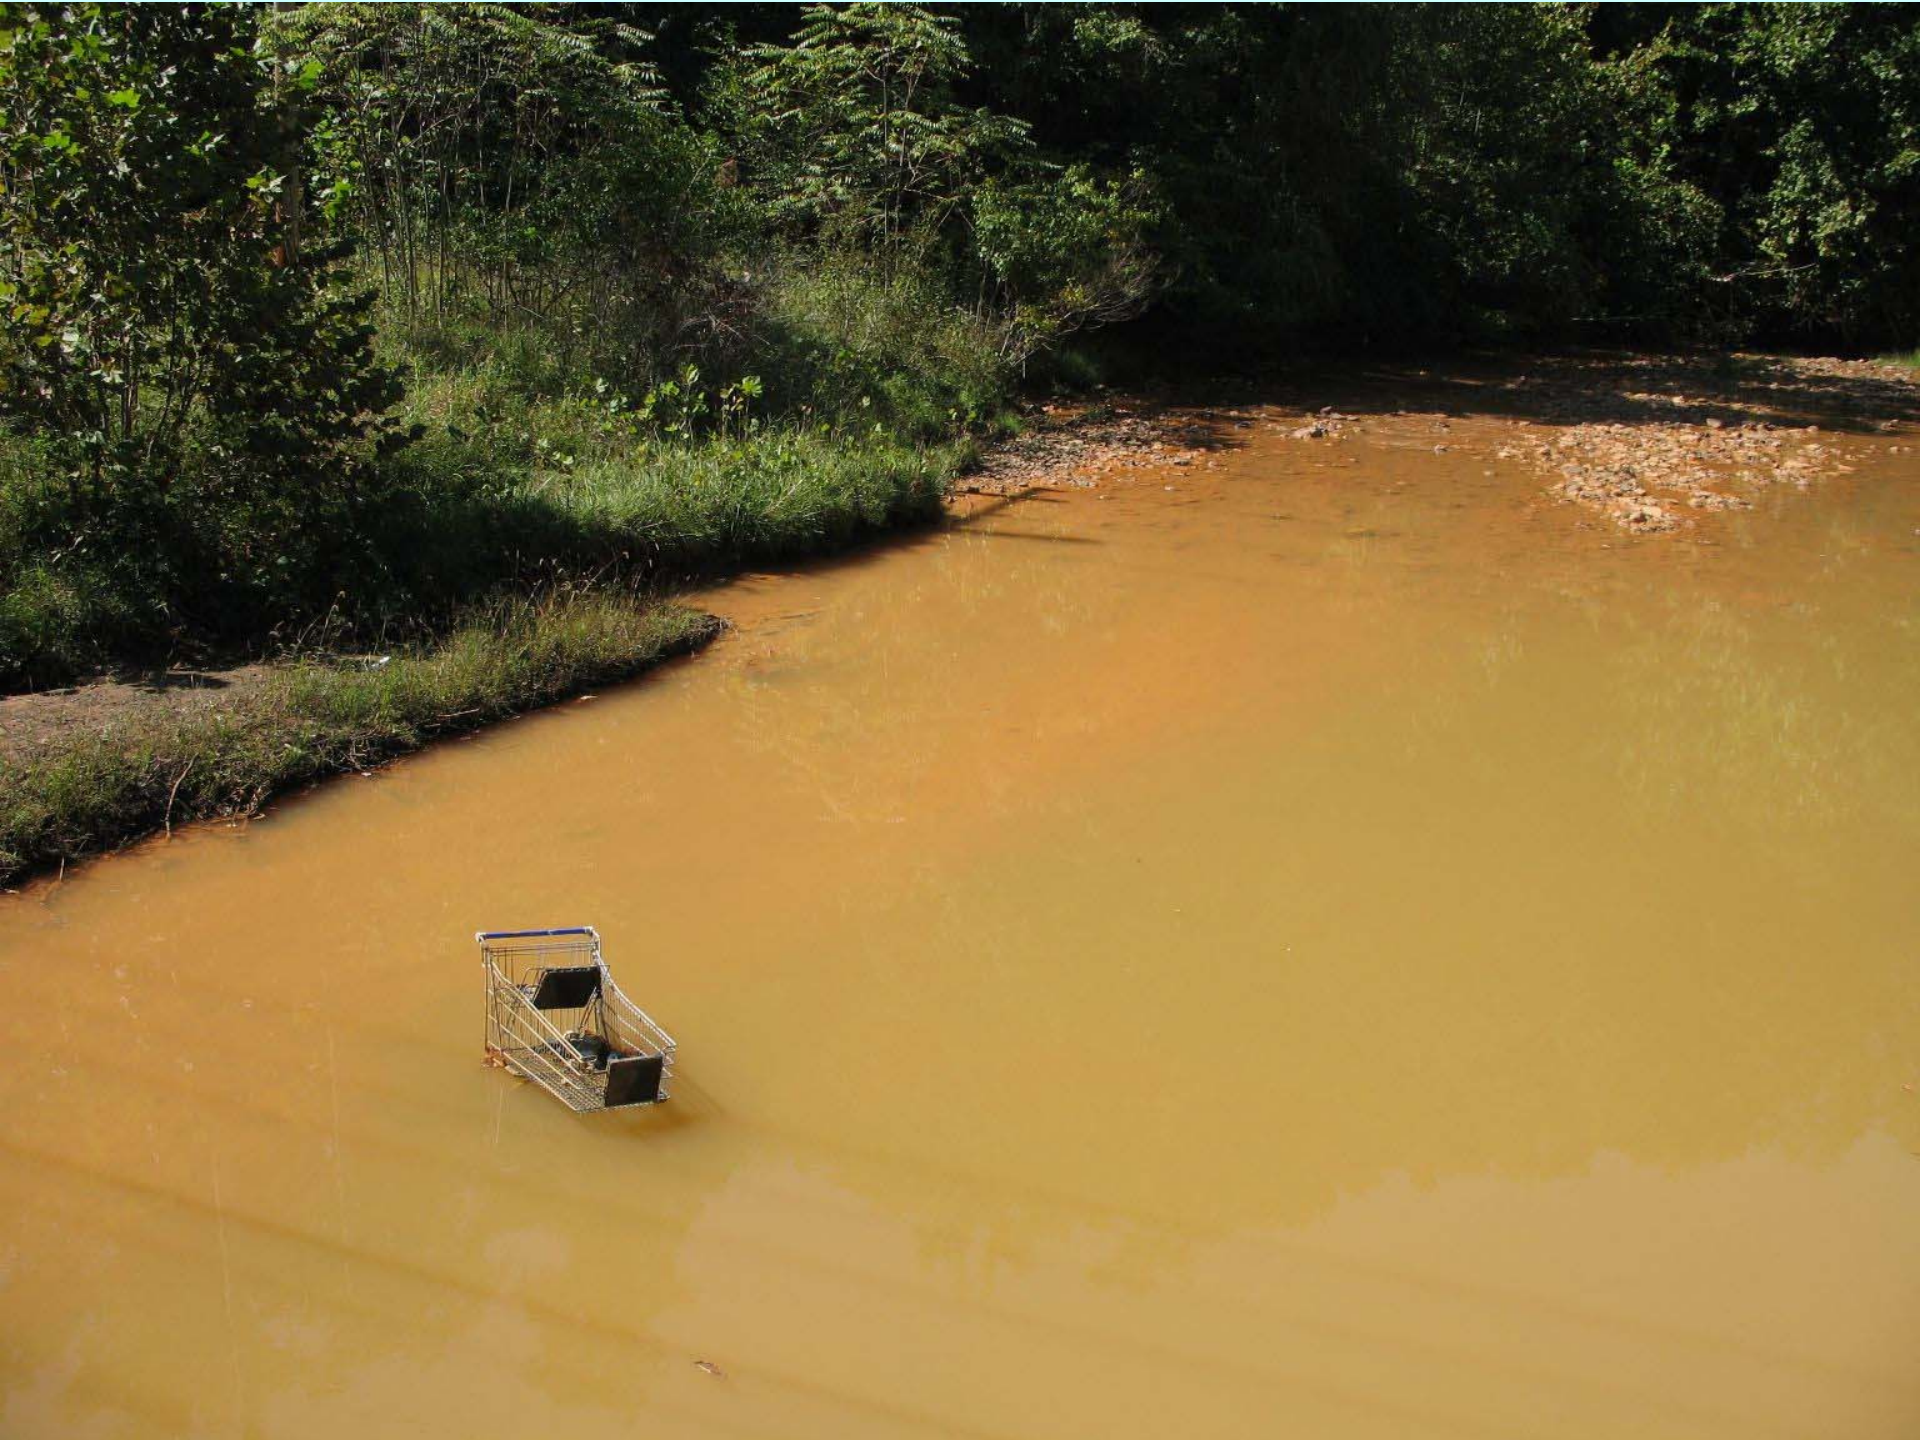
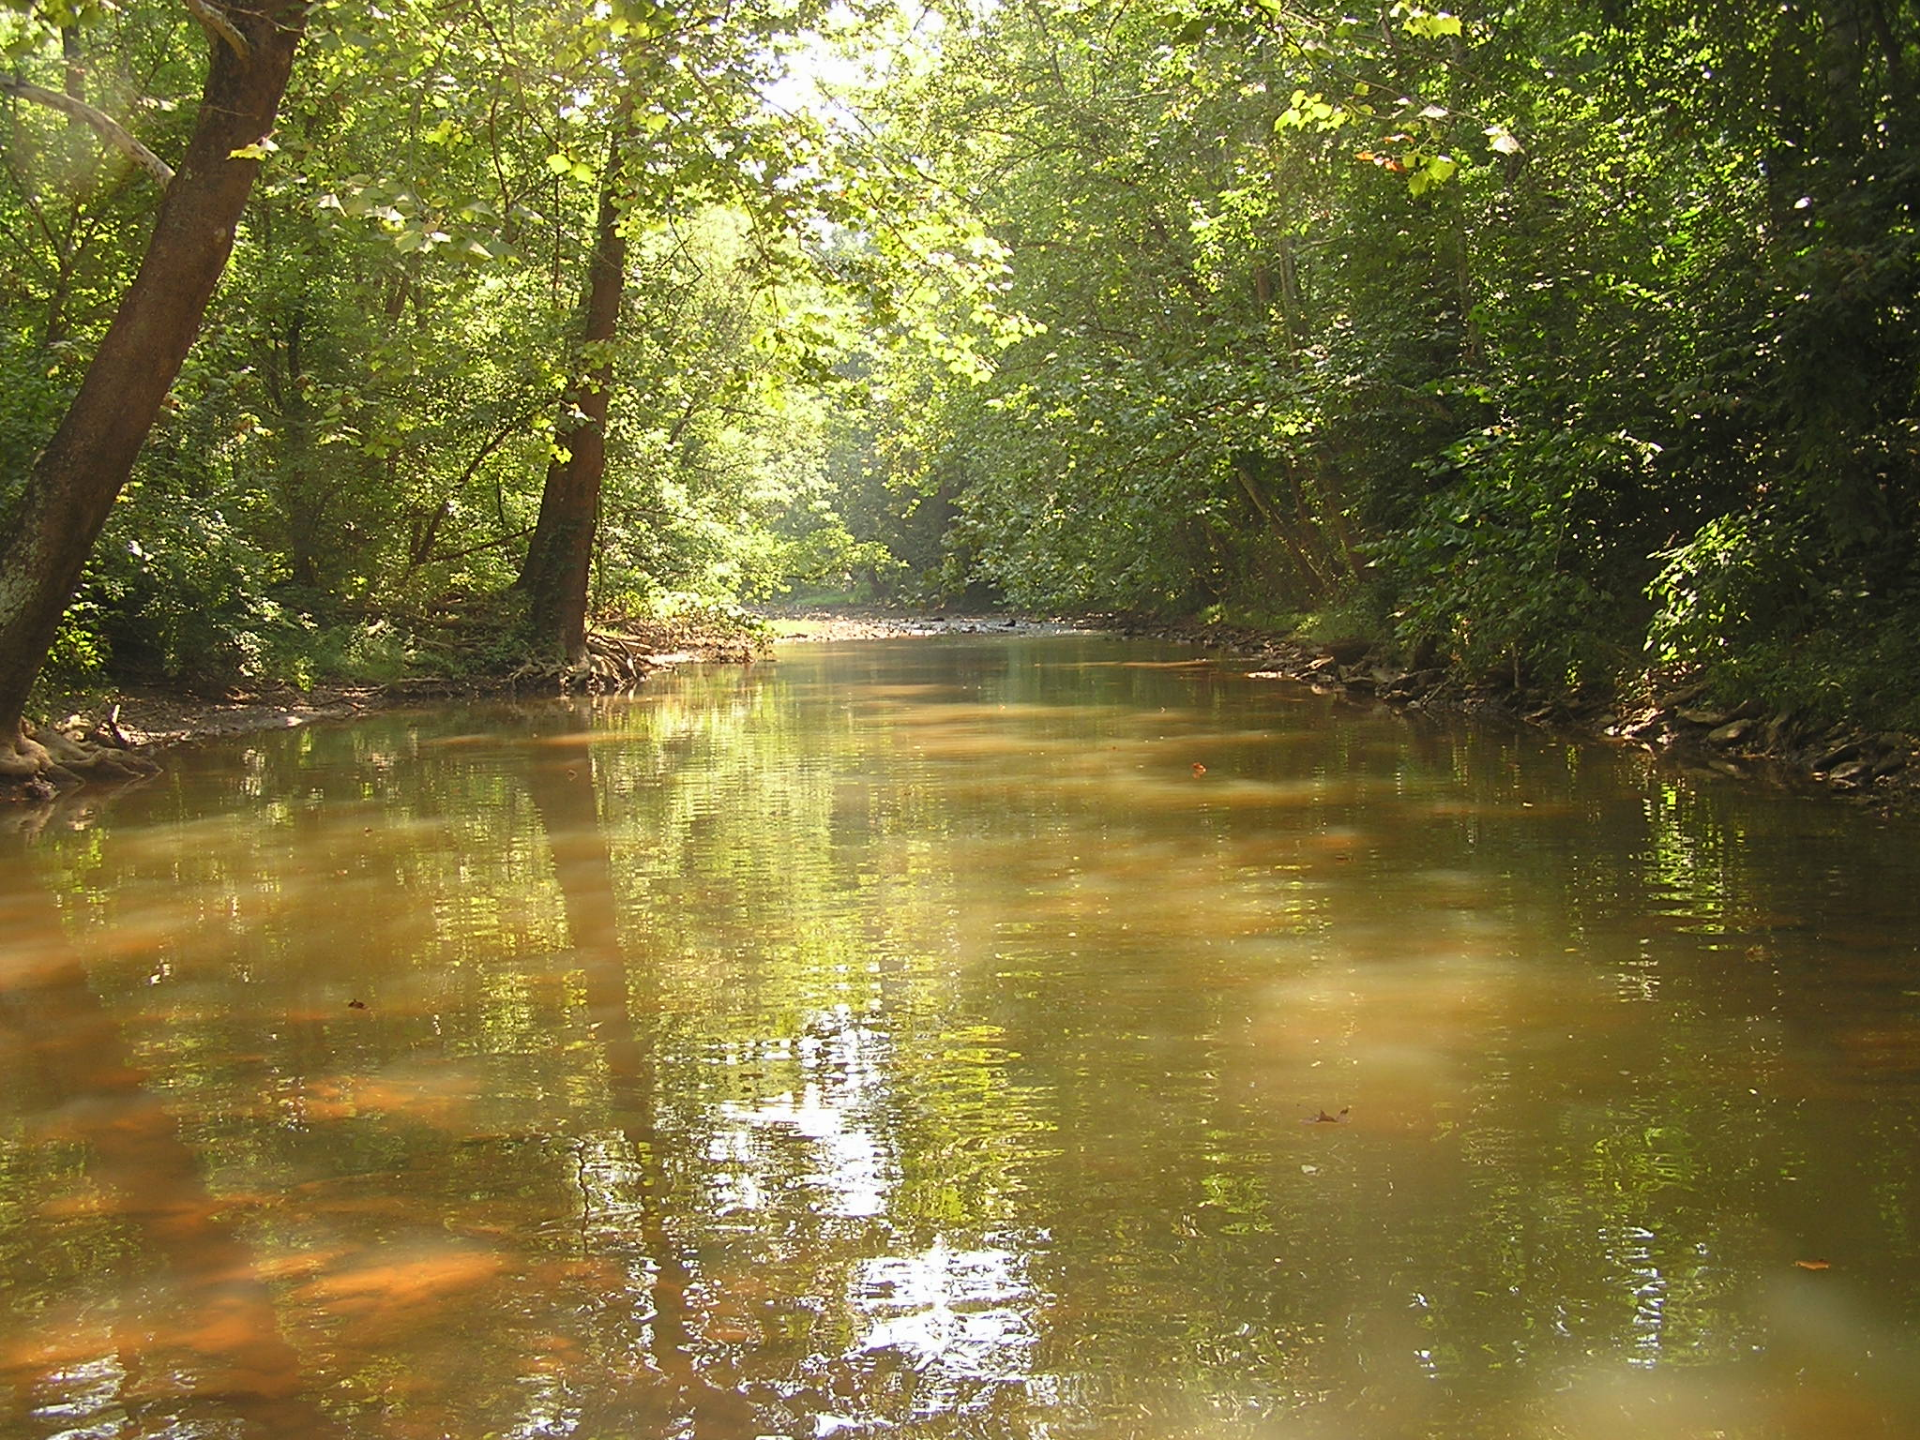
# Segment 6 & 7

Segment	Location	Setting	Condition
6	Richard mine to mouth of Aarons Creek	Swift, well defined channel	Water always turbid, often red from Richard mine Discharge
7	Aarons Creek to mouth	Swift, reinforced banks	Red streambed, but fish often present

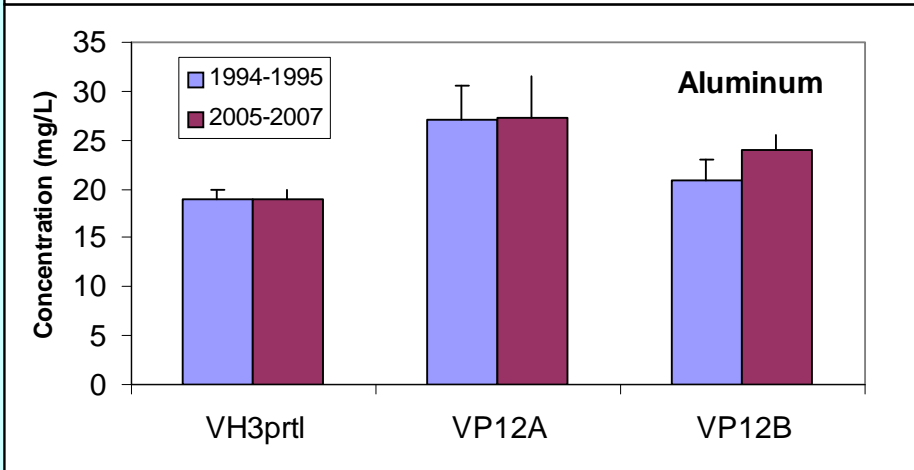
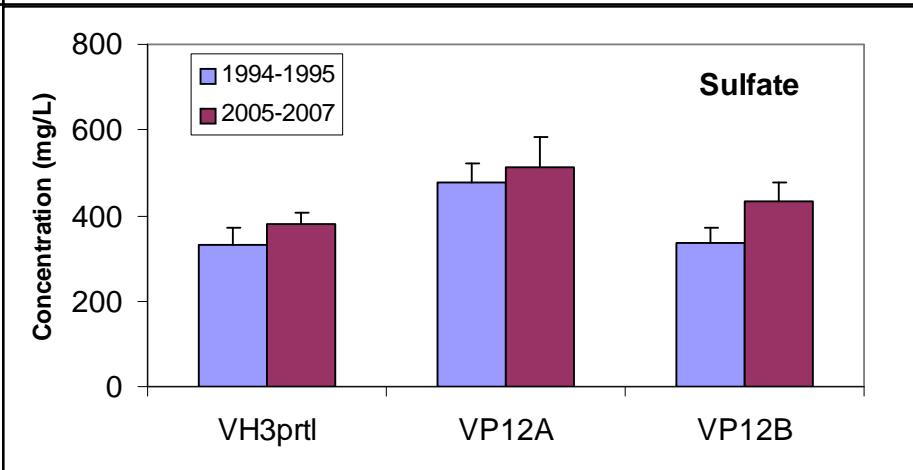
# Pyrite dissolution

- We compared water quality results at three sites where NRCS had monitored in 1994 and 1995, and where FODC monitored in 2005 to 2007.
- Sites are at the extreme eastern edge of the watershed, on the Preston anticline.
- NRCS installed wooden weirs in 1994. We monitor at the same sites: no reclamation, no wet seals.

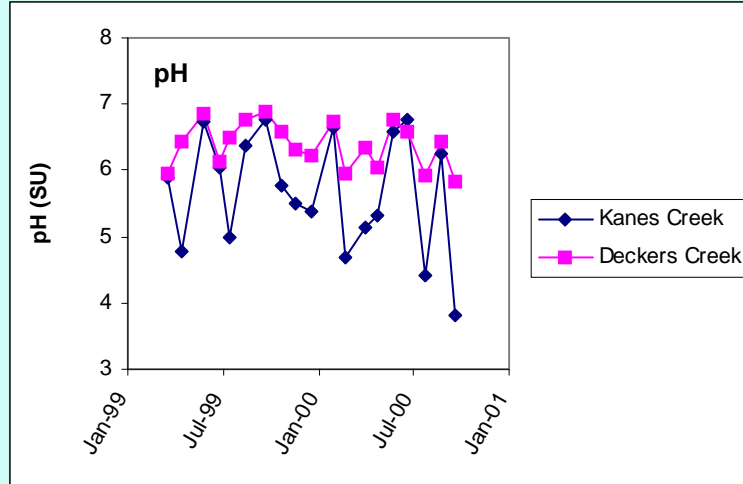
# pH in Kanes Creek and in Deckers Creek just below Kanes

- Deckers Creek pH values follow those in Kanes Creek
- “Hits” on iron in Deckers Creek occur on those days with higher iron concentrations in Kanes Creek
- Low pH values and high iron concentrations are missing after the end of 2006
- Some change in Kanes Creek is having a beneficial effect on Deckers Creek
