**Limestone Based Passive  
Treatment of an Acid Mine  
Drainage Impacted Watershed –  
Rock Creek, Kentucky**

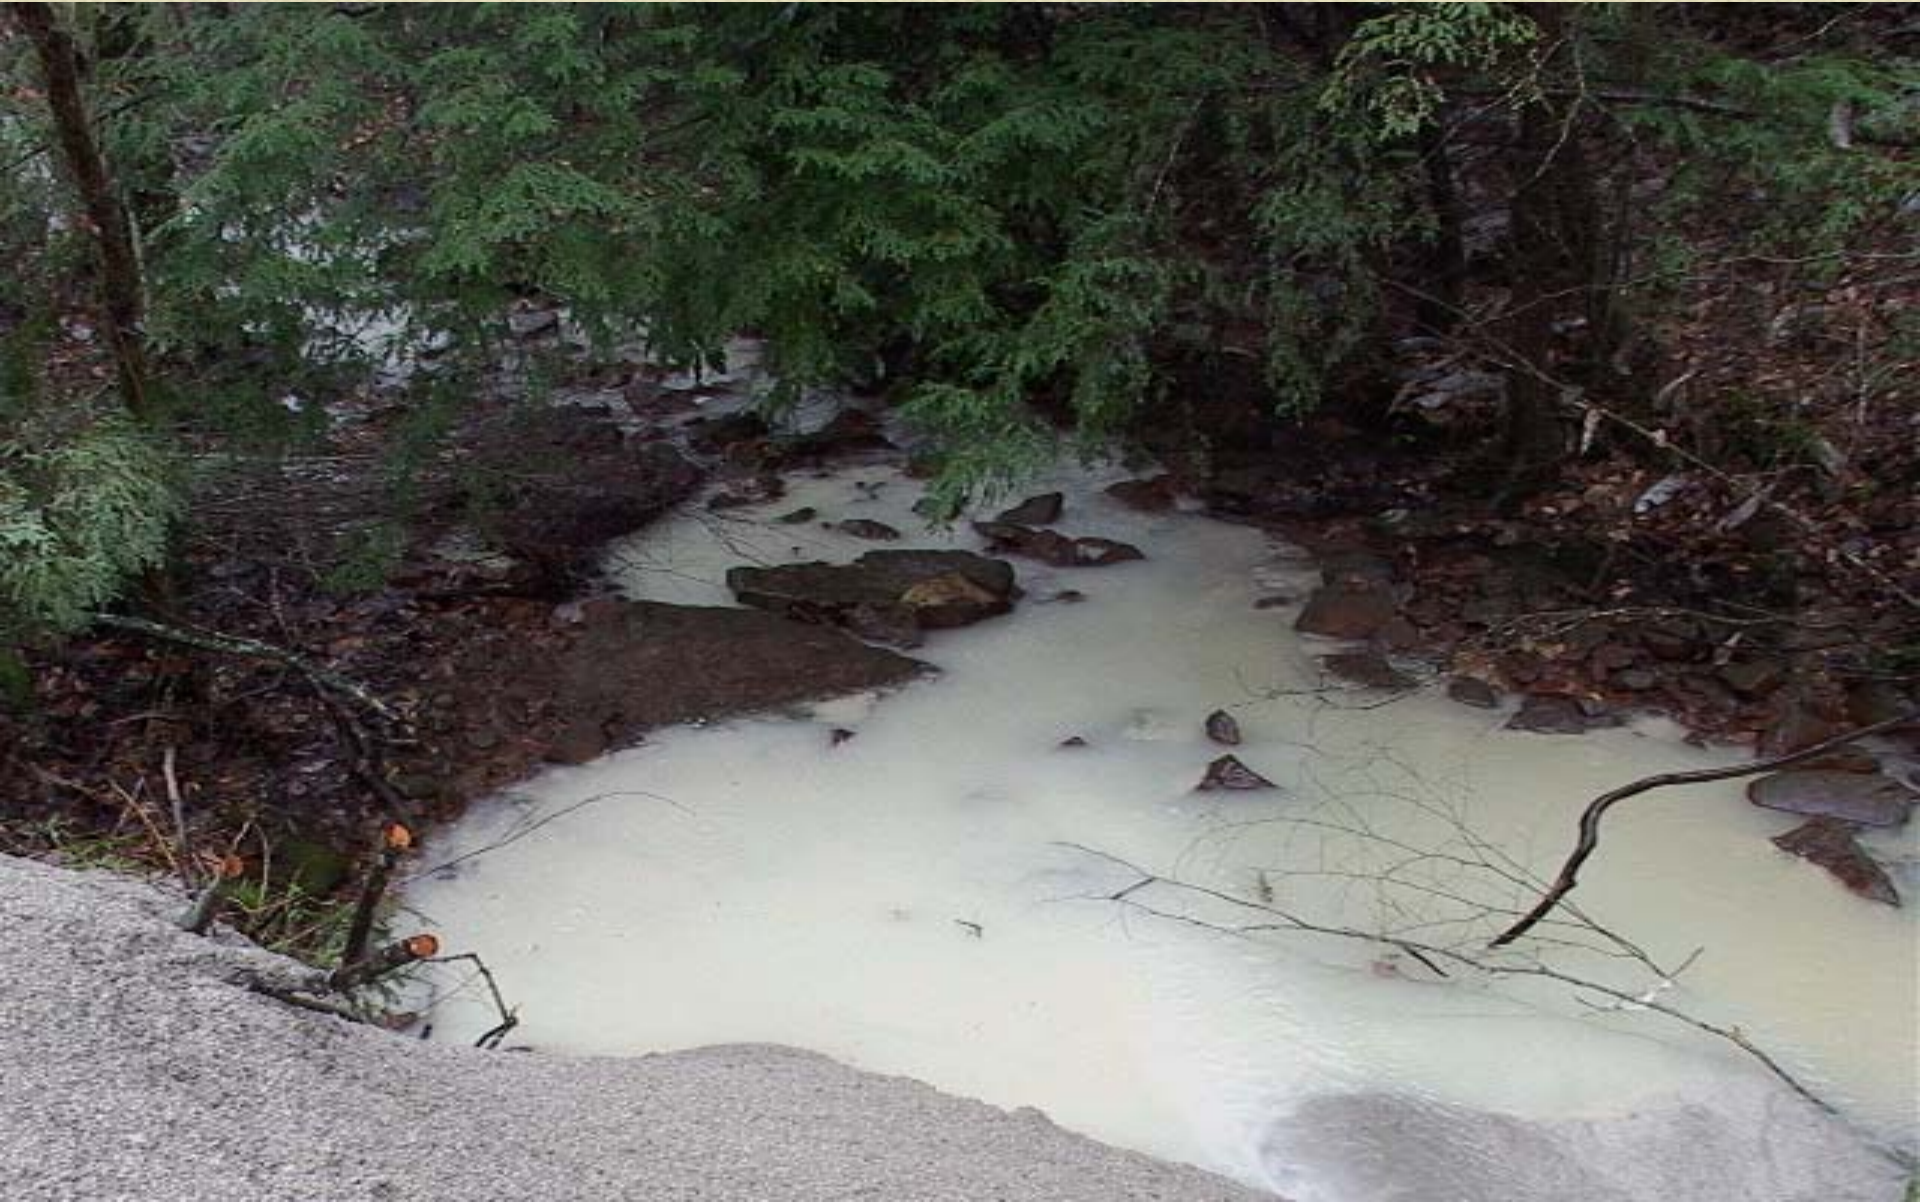
# Limestone Sand Dosing

- Limestone Dosing
- Water Monitoring Point
- ▲ Biological Monitoring Point

- ✦ Treat AMD with limestone sand at rates based on acid loading calculations
- ✦ Utilize passive treatment and mine reclamation techniques as funding allows
- ✦ Reduce limestone sand dosing as sites are reclaimed and passive treatment systems are installed

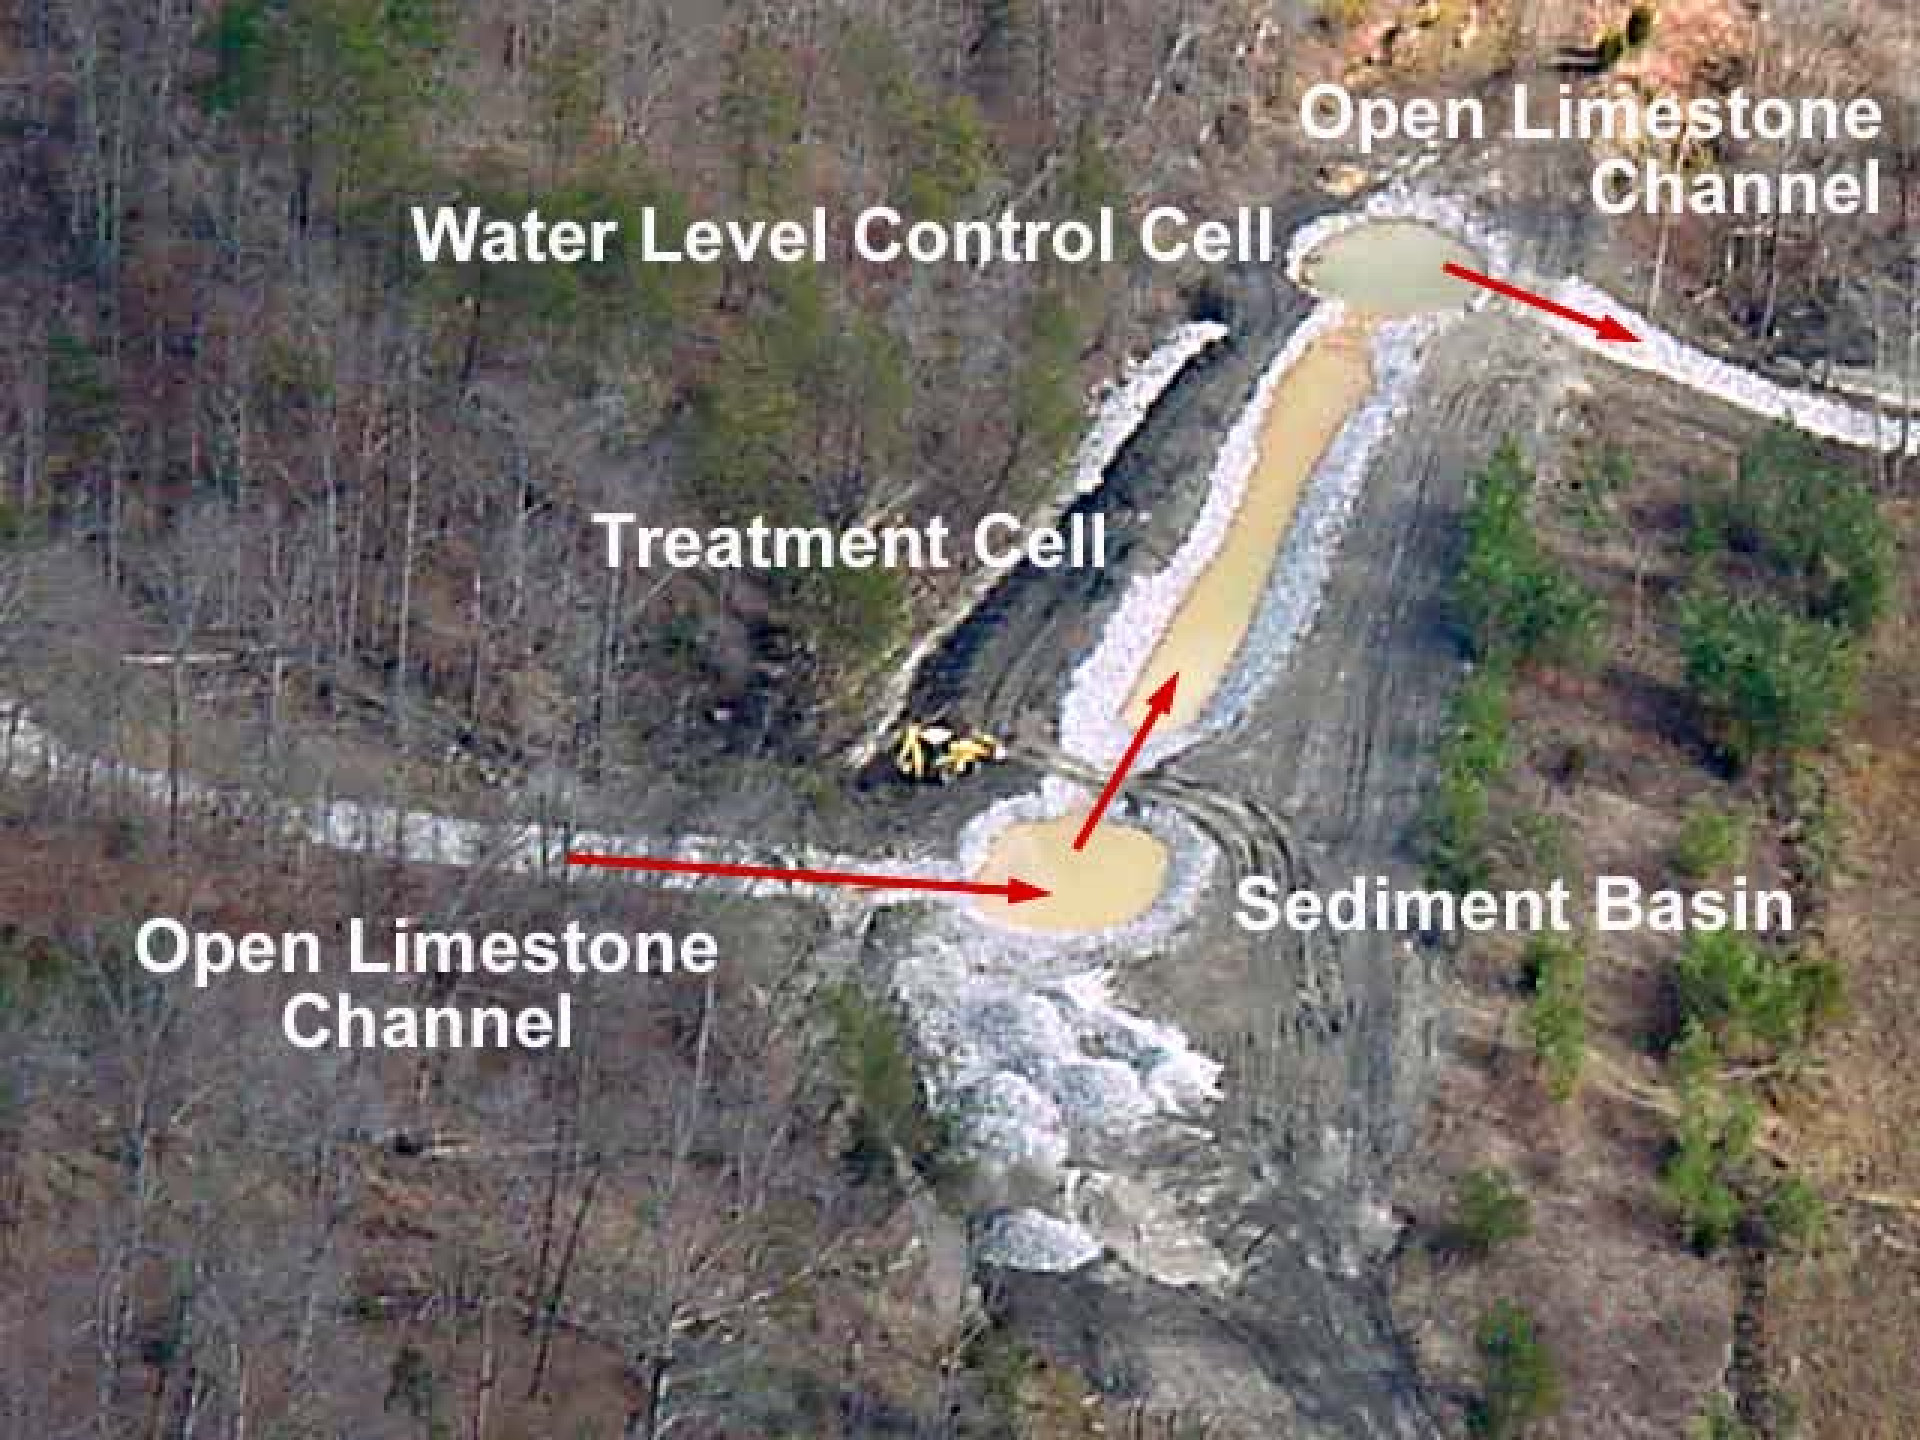
# Modified Vertical Flow System

Open Limestone  
Channel

Water Level Control Cell

Treatment Cell

Sediment Basin
