FRIENDS OF DECKERS CREEK

The Impacts of Acid Mine Drainage Remediation Projects on Water Quality, Aquatic Macroinvertebrates, and Fish Populations in the Deckers Creek Watershed

Nicholas Revetta
Project Manager

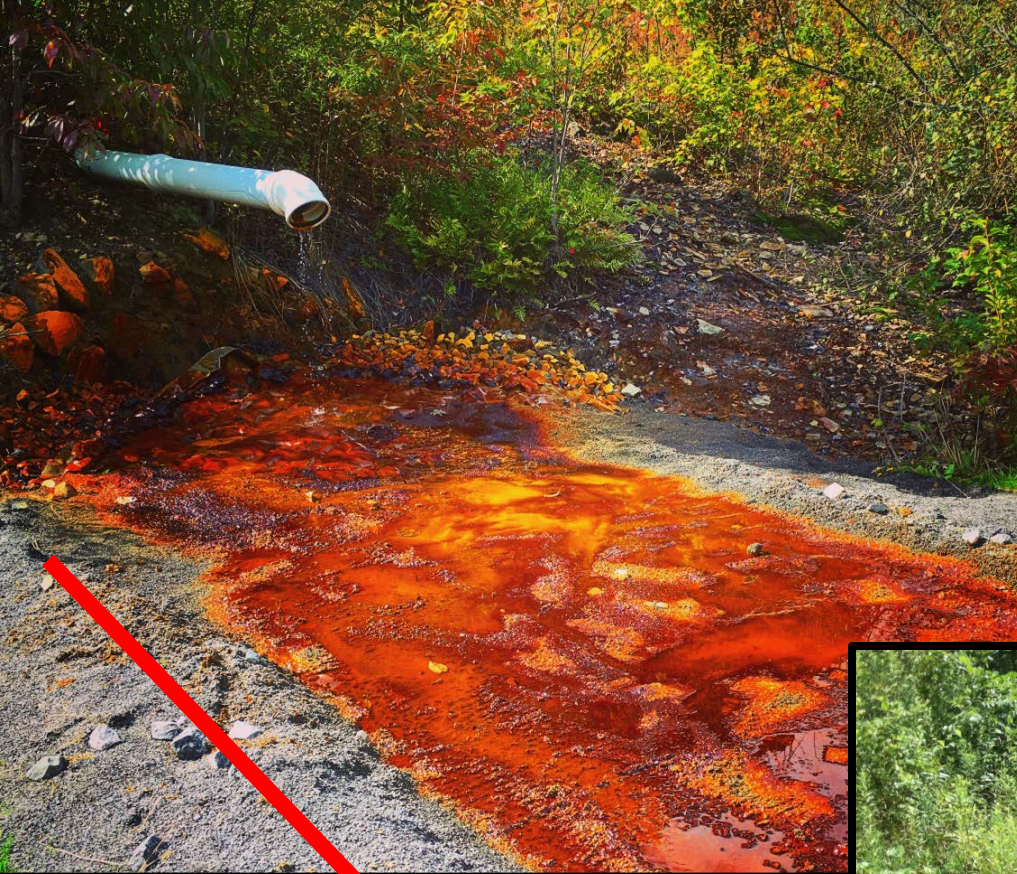
Input 2 Avg (lbs/yr)

pH – 3.5

Acidity – 20,652.55

Fe – 1,300.65

Al – 1,869.92

Input 1 Avg (lbs/yr)

pH – 3.1

Acidity – 19,889.70

Fe – 2,238.90

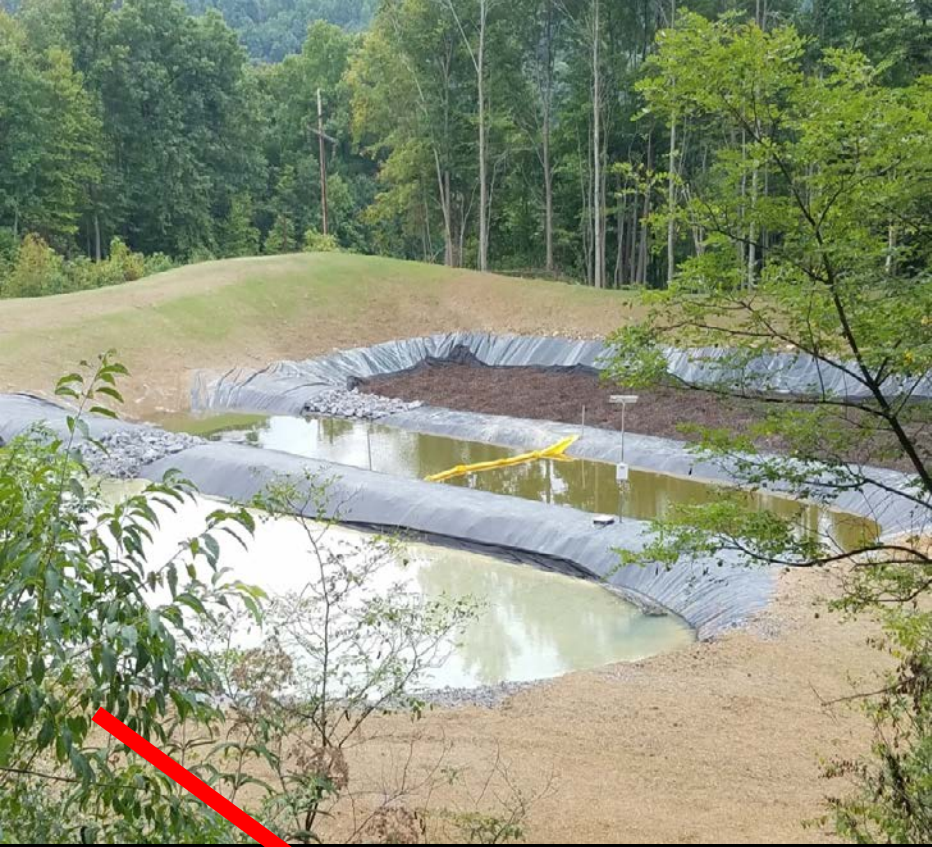
Output (lbs/yr)

pH – 8.4

Acidity – 1.63

Fe – 26.12

Al – 13.06

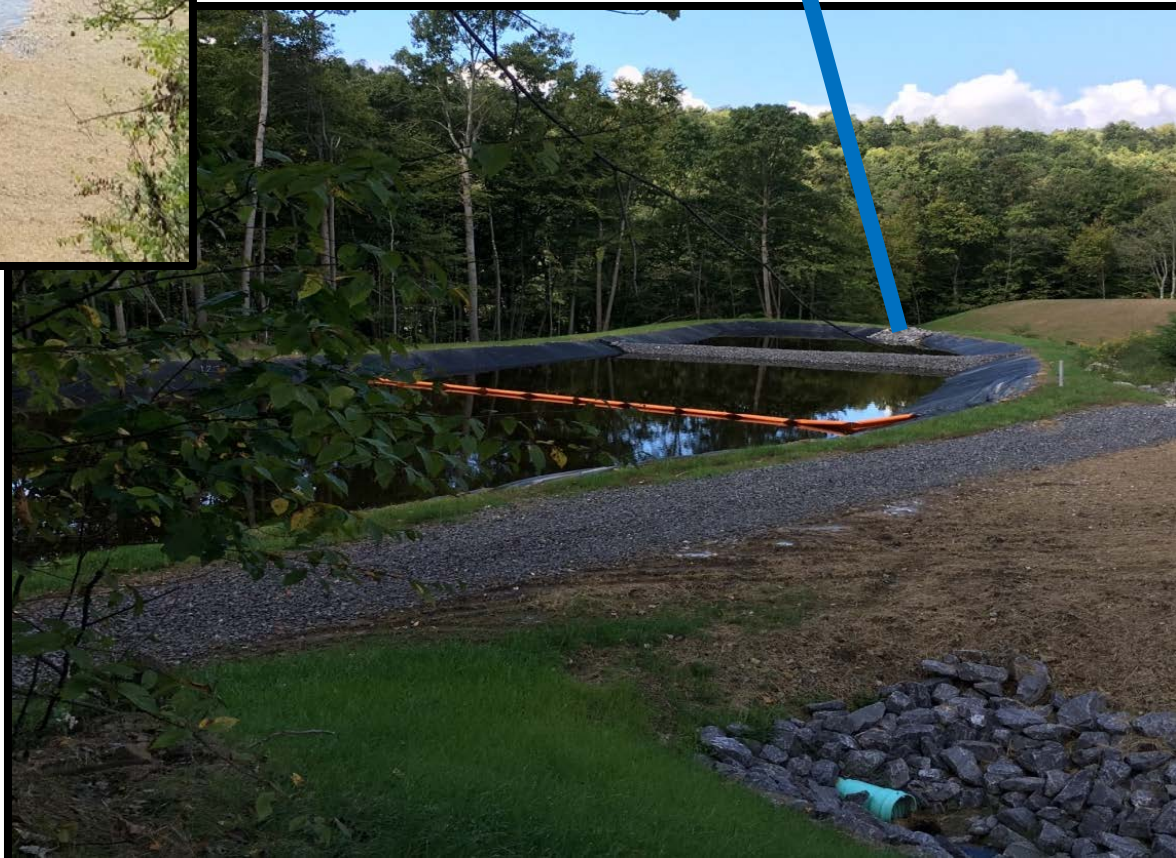
Sum of inputs (lbs/yr)

pH – 3.3

Acidity – 40,542.24

Fe – 3,359.54

Al – 3,710.08

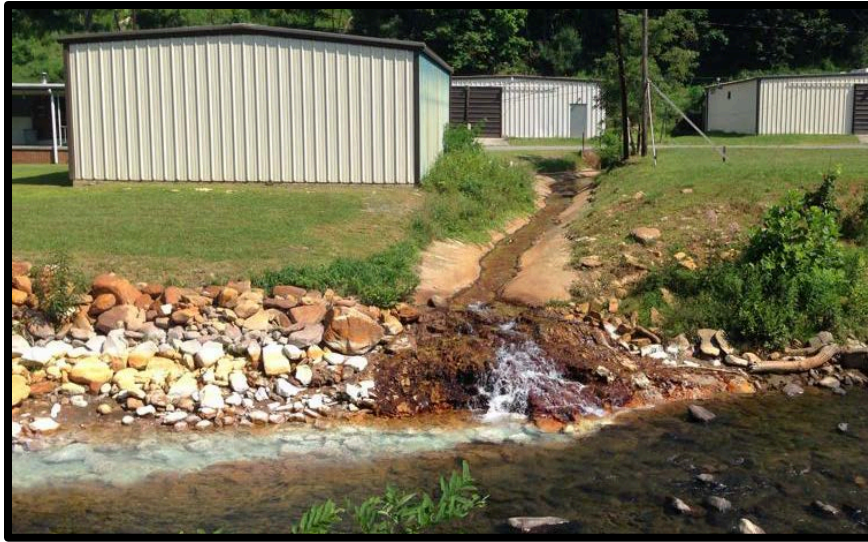
Richard Mine Pollution

Acidity – 730,500 lbs/yr

Fe – 143,000 lbs/yr

Al – 59,000 lbs/yr

Mn – 3,200 lbs/yr
