Stream Restoration Solutions for Challenging Environments

West Virginia Mine Drainage Task Force Symposium & 15th International
Mine Water Association Congress (WVTF & IMWA)

April 22, 2024: 3:00 – 4:40 PM, Stream Renewal and Treatment, Salon D
Mary Beth Berkes

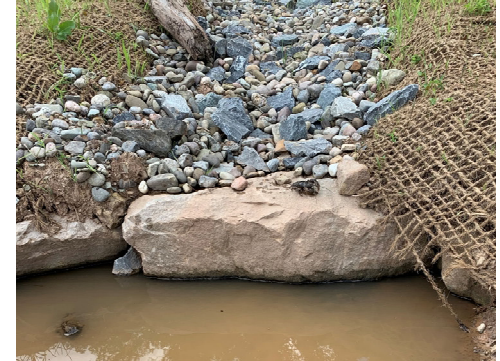
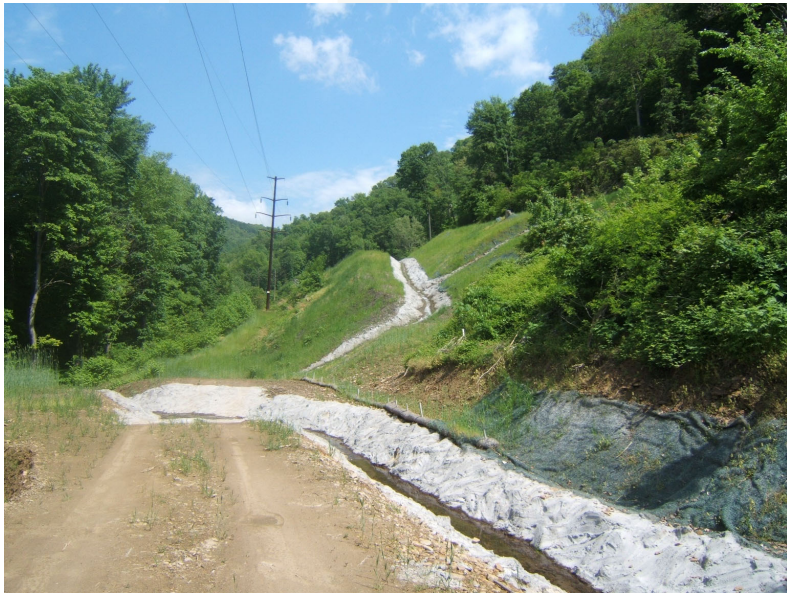
Riprap for Effective Conveyance on Steep Terrain

- ▶ **Manufactured Materials vs Native Materials**
 - ▶ Riprap Conveyance is a Common Solution
 - ▶ Natural Materials (Log and Boulders) Available at Similar Cost
 - ▶ Step Pools Equally Effective with Ecological Benefits!

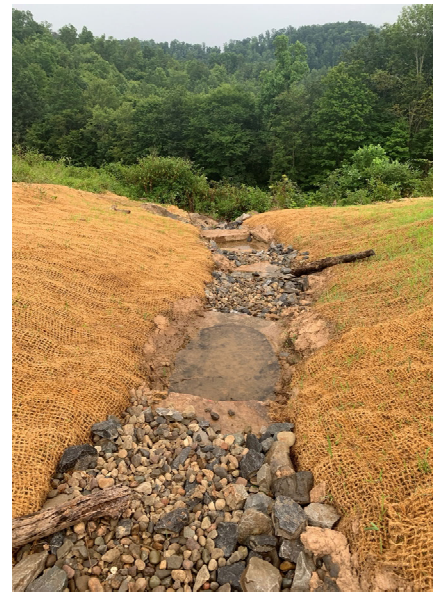
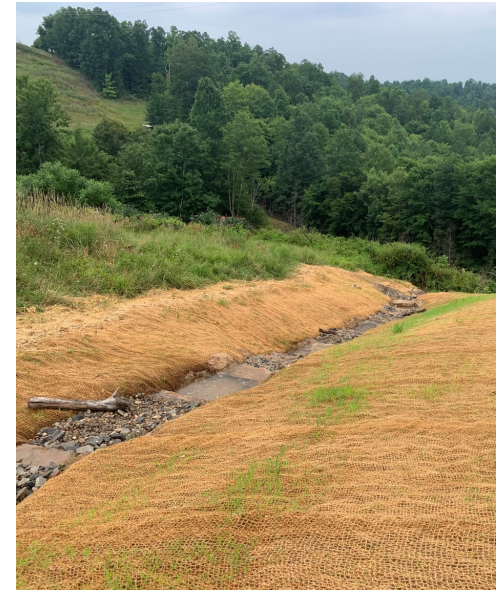
Design Reaches: Rock and Log Step Pools

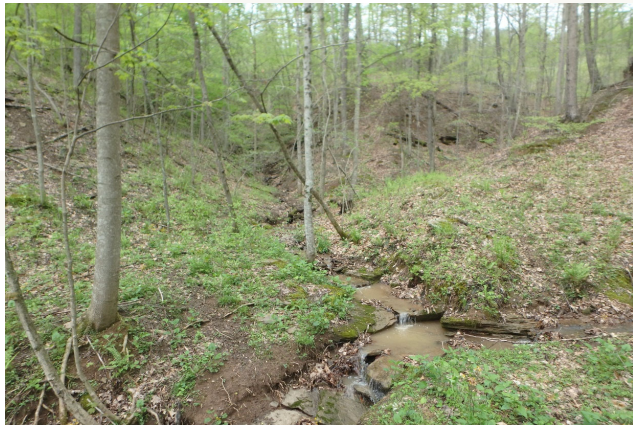
Reference Reach

- ▶ Build a System Structurally and Ecologically Comparable to a Natural Channel
- ▶ Design Based on Field Data and Comparing Dimensionless Ratios

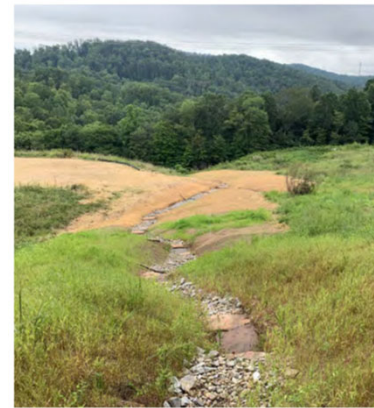
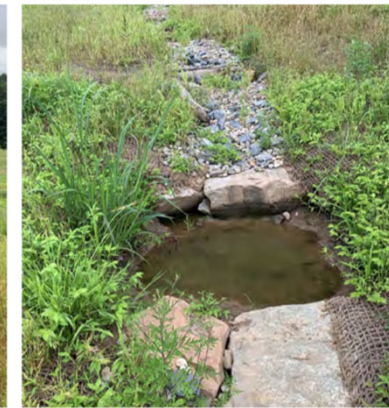
Design Reach

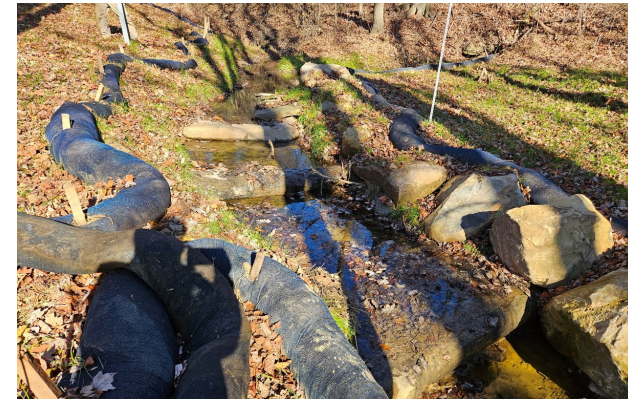
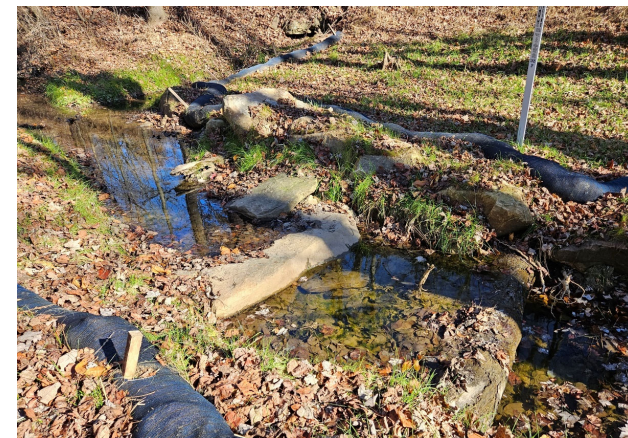
Constructed Restoration Reach

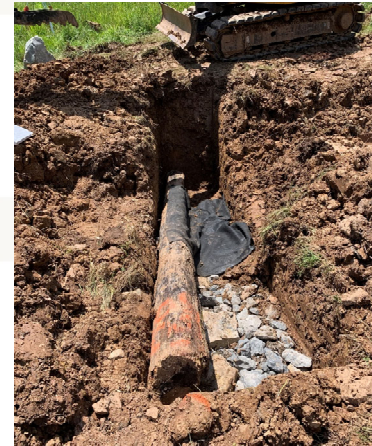
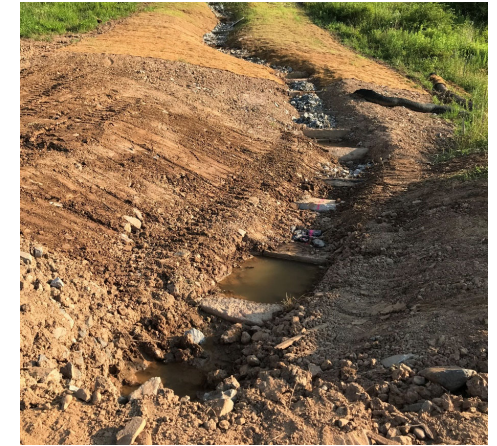
Step Pool Construction

- ▶ Increased Energy Dissipation: Flat, Deep, Pools
- ▶ Bank Erosion Less Likely
- ▶ Increased Habitat Diversity
- ▶ Native Bed Material: Promotes Balanced Sediment Transport Downstream
- ▶ Improved Water Quality

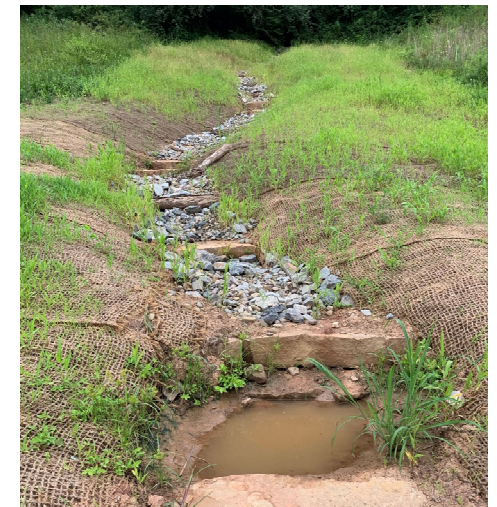
Restored Reach Post Construction

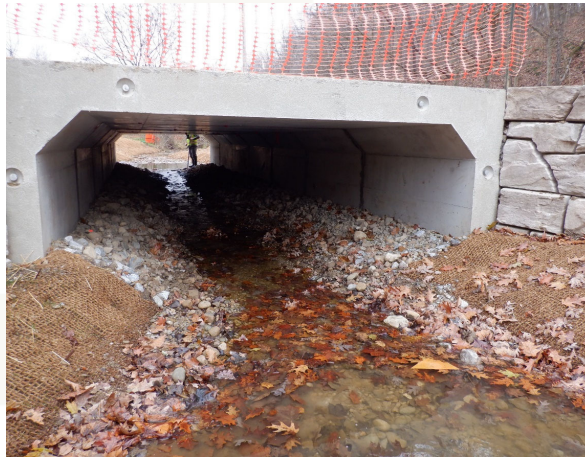
Inlet: As-Built Condition

- ▶ Maintaining Balanced Sediment Transport
- ▶ Material Loss at Inlet, Deposition in Pool at Outlet

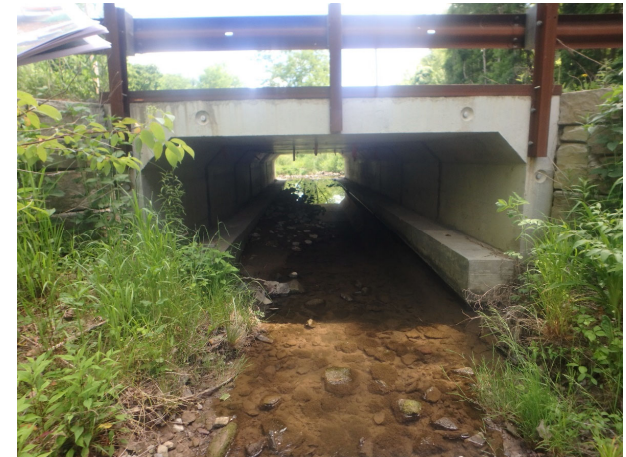
Inlet: Year 4 Monitoring

- ▶ Grade Control Through Structure and at Inlet: Fish Baffles an/or Boulders

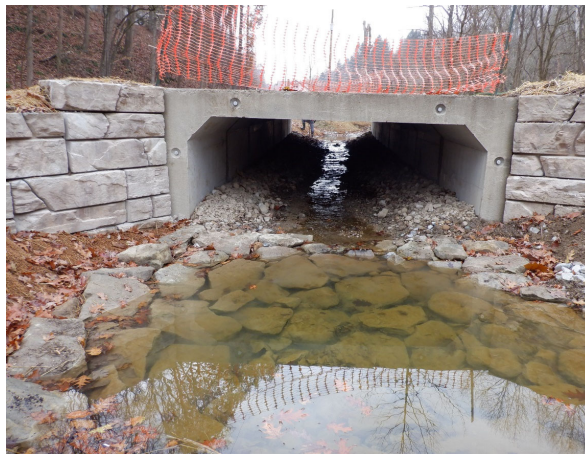
Outlet: As-Built Condition

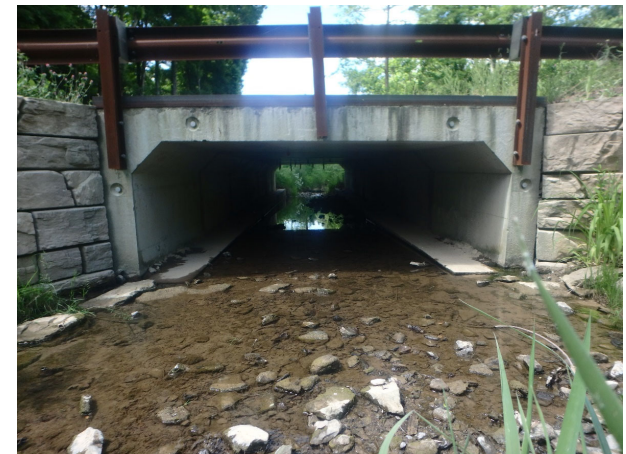
Outlet: Year 4 Monitoring

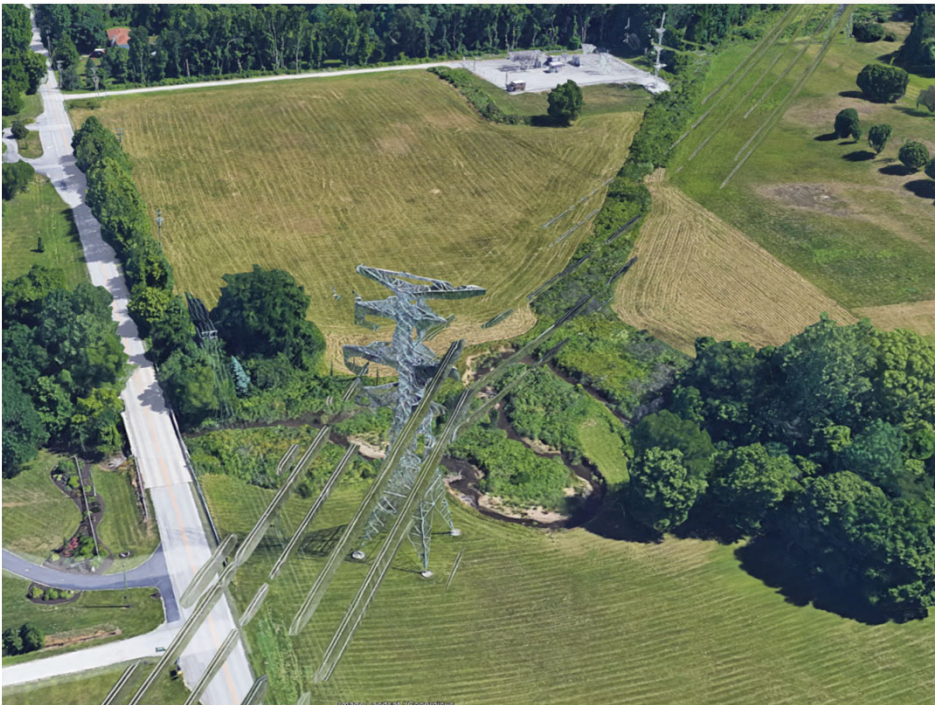
Unstable Stream

- ▶ **Challenge: Stream Prone to Movement Due to Sandy Soil, Limited Bank Vegetation**
- ▶ **Solution: Reference Reach for a Stable Dimension, Pattern, Profile – Change Alignment**
 - ▶ Reduce Bank Heights, Install Erosion Control Matting and Vegetation on Banks

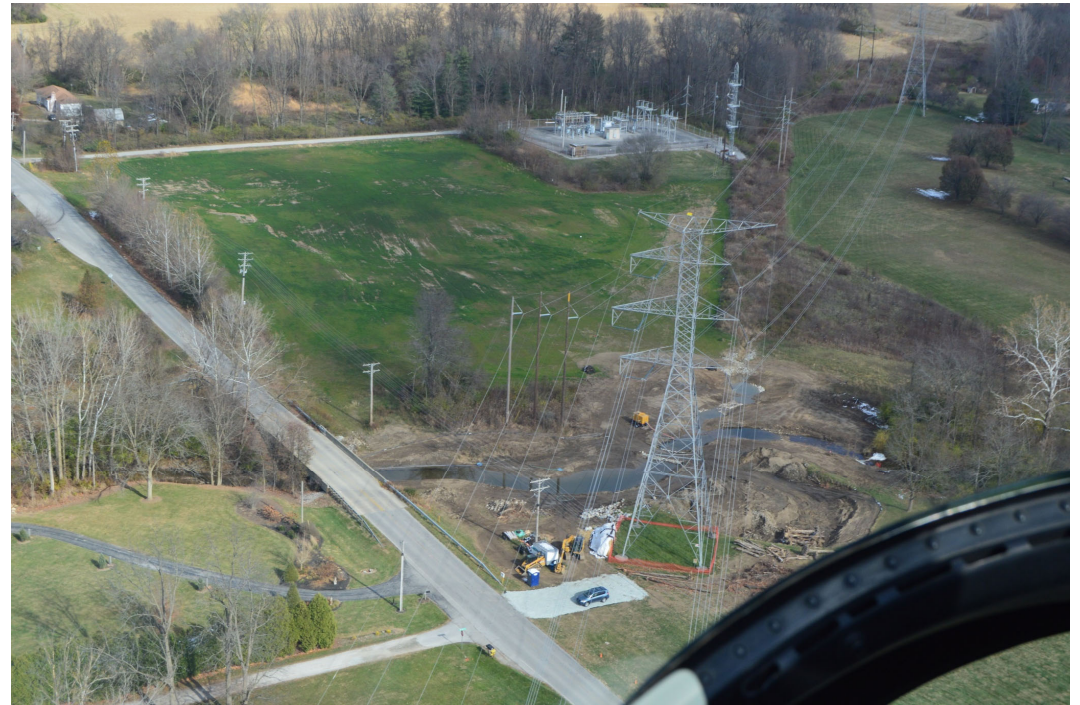
Restoration Through Realignment

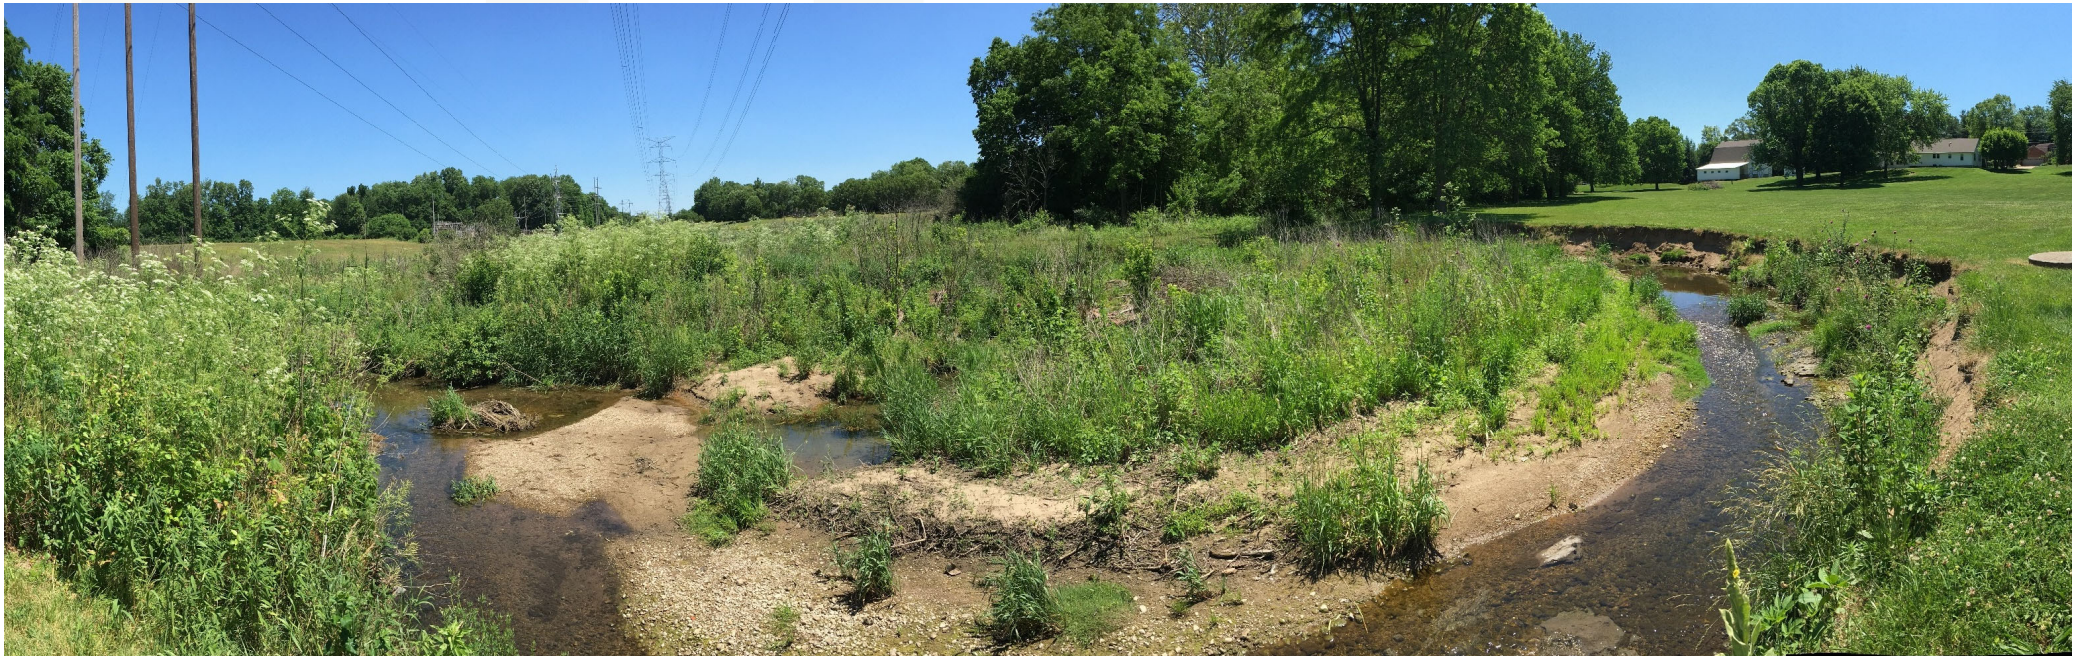
- ▶ **Solution: Focus on Stable Alignment and Banks**
 - ▶ Achieved Through Multi-stage Channel, Terracing, Designed Bankfull Area

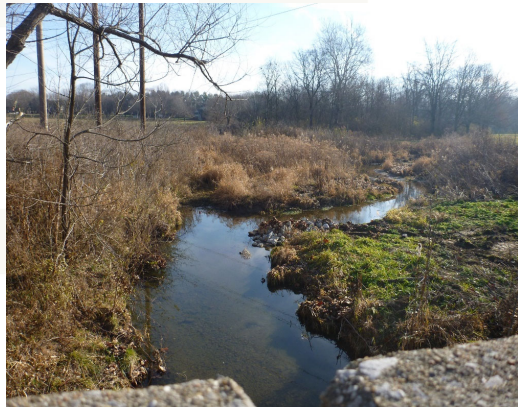
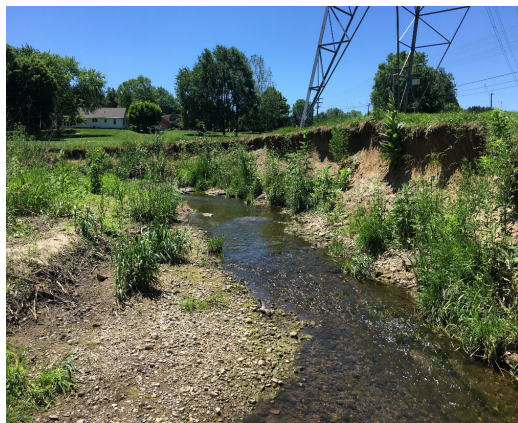
Unstable Stream

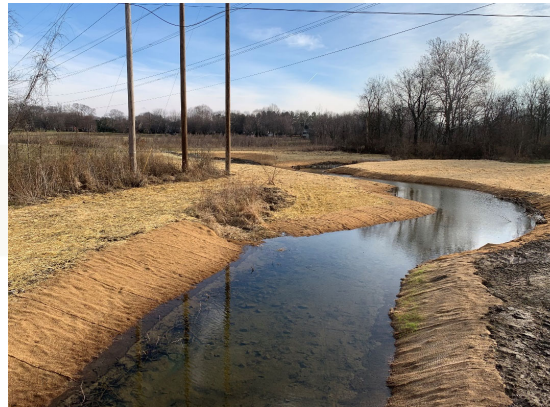
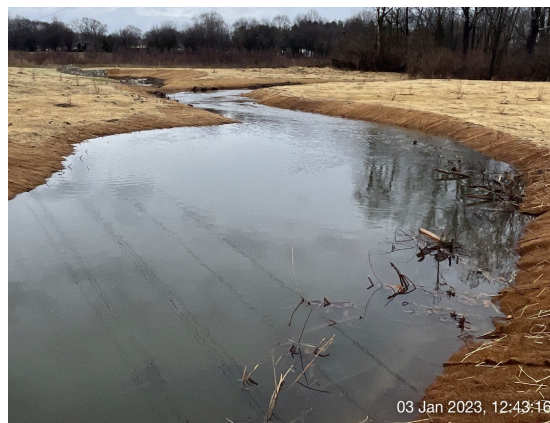
During Construction

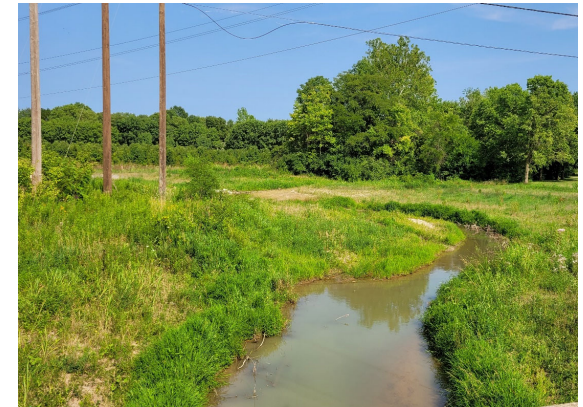
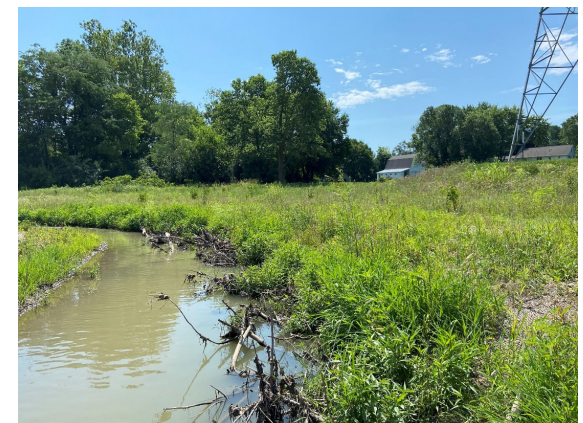
Post Construction
