Sediments in affected river systems – lessons learned from WISMUT remediation

Annia Greif & Silvia Jahn, IMWA 2024, Morgantown

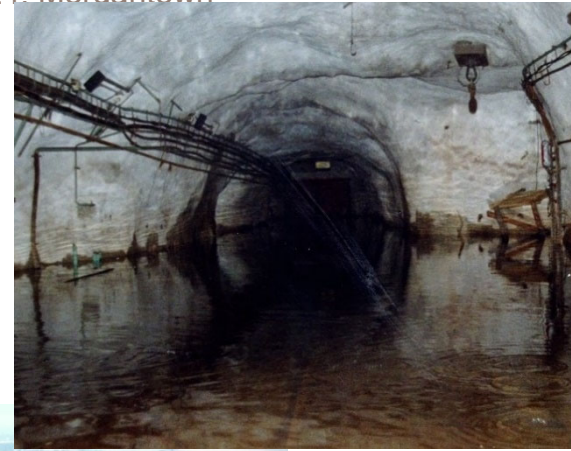
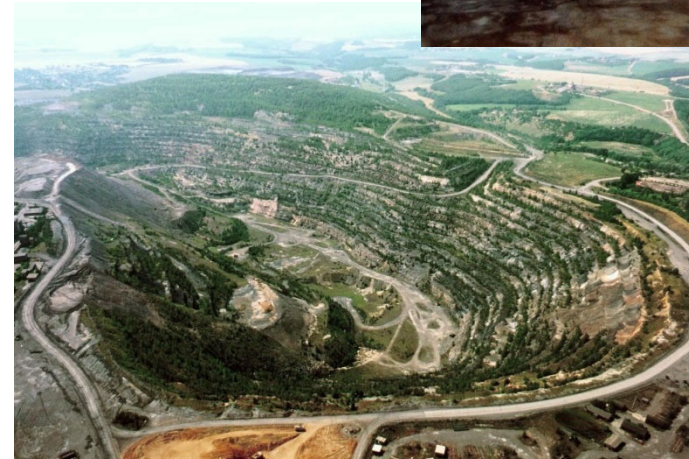
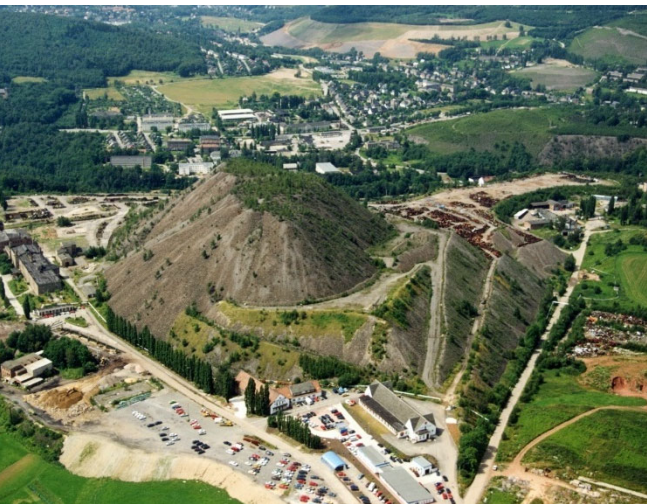
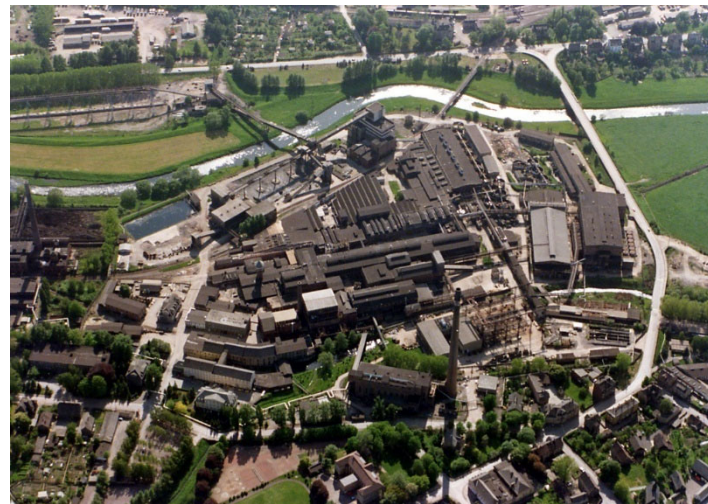
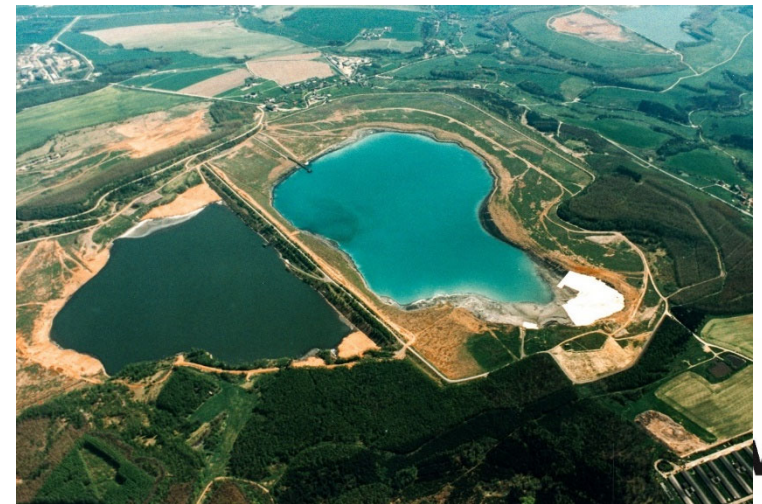
Legacies of uranium mining in eastern Germany in 1991

- › 5 underground mines
- › 1 open pit

- › 48 waste rock dumps (WRD) (310 Mm³)
- › 3 tailings management facilities (TMF) (570 ha)
- › Processing / operating areas (3,000 ha)

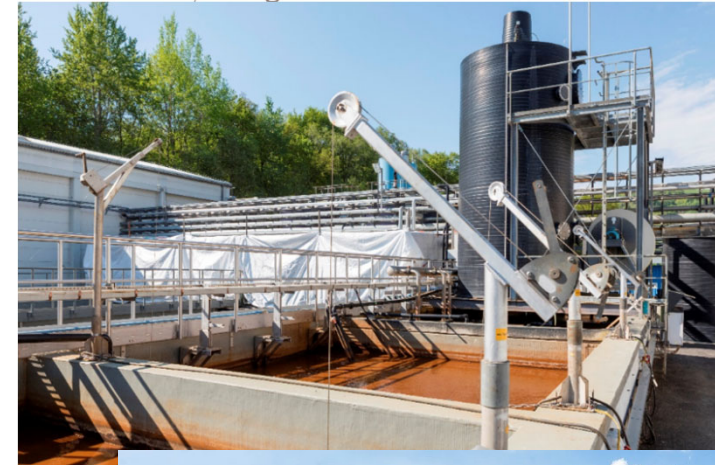
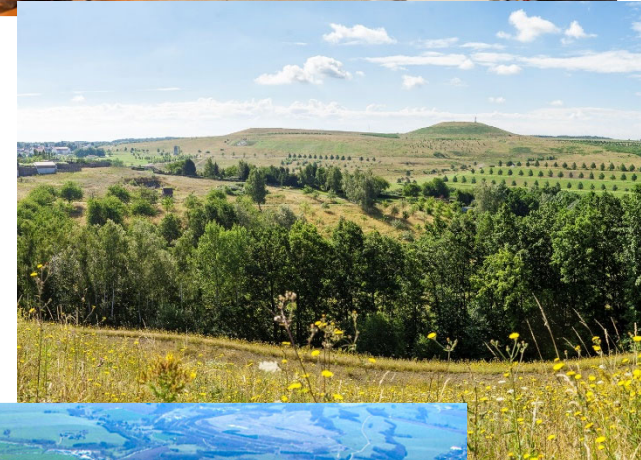
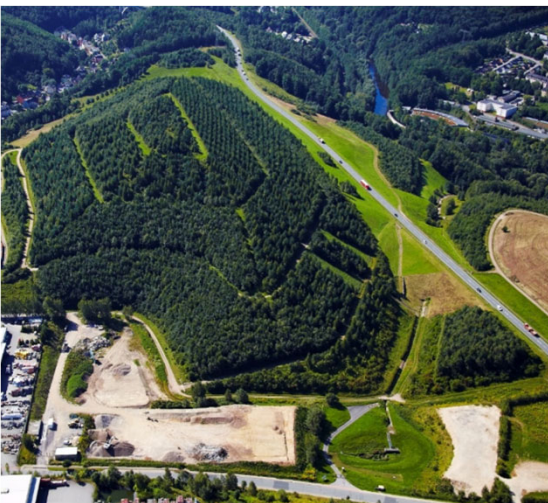
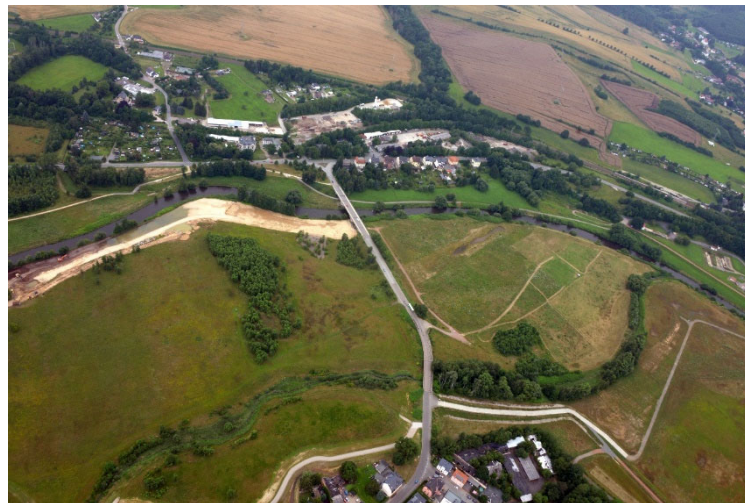
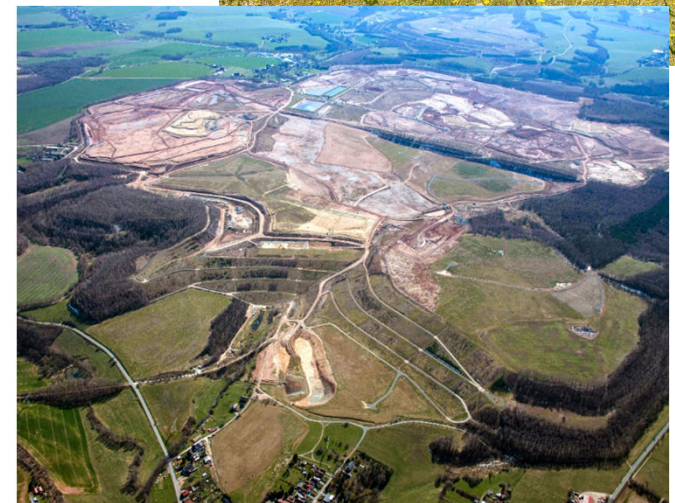
Remediation activities until 2024

- › Mine flooding (“mine water rebound”) and water treatment (in operation)
- › Backfilling of open pit (completed)
- › (In-situ-)remediation of WRD (majority completed)
- › Demolition of mills and operating areas, partial reuse for commercial or flood protection purposes (majority completed)
- › (In-situ-)remediation of TMF (not yet completed) and water treatment (in operation)

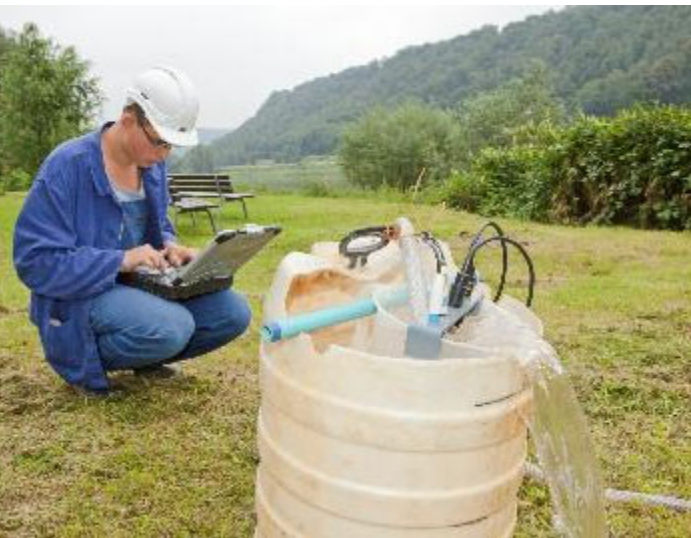
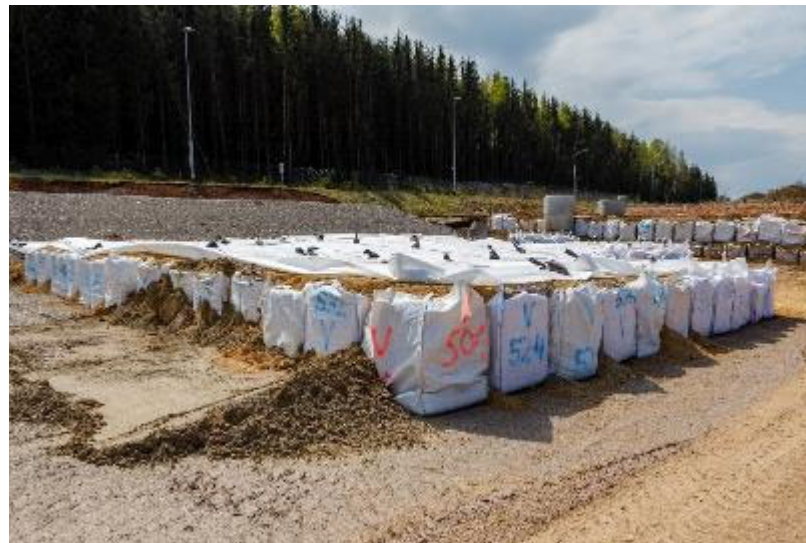
WTP Schlema-Alberoda: lime precipitation

- › 6 Water treatment plants (WTP), mostly conventionally with lime precipitation, one with ion exchange / adsorption, including the safety storage of the residues
 - Treatment of 14 M m³/a mine and seepage water (2023)
 - Main pollutants: U, Ra-226, As, Fe, Mn, Ni
- › After care measures
- › Monitoring systems (water, air and solids)

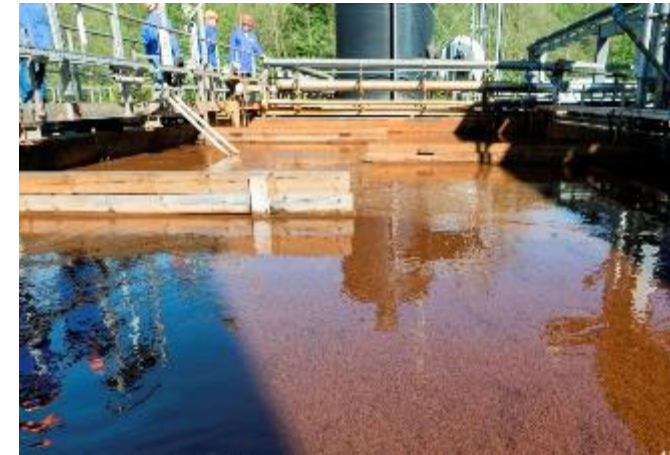
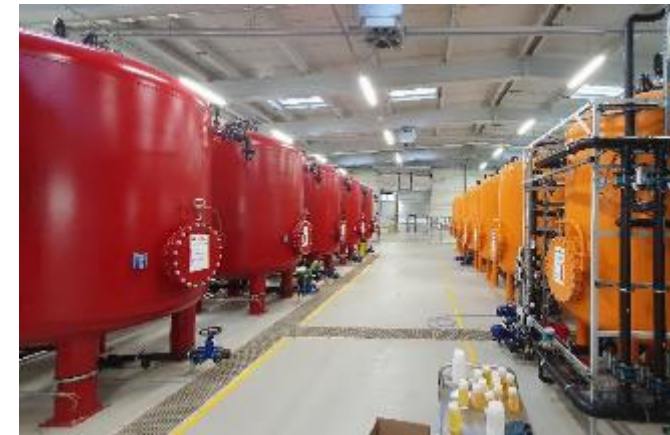
WTP Helmsdorf new: ion exchange / adsorption

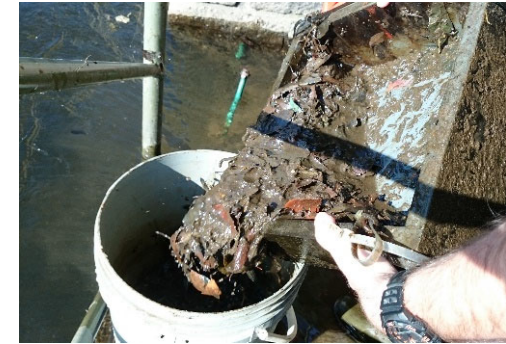
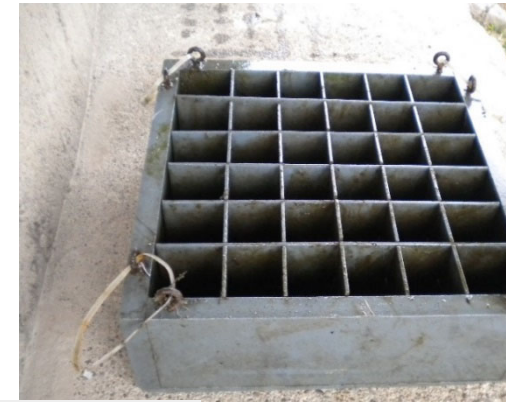
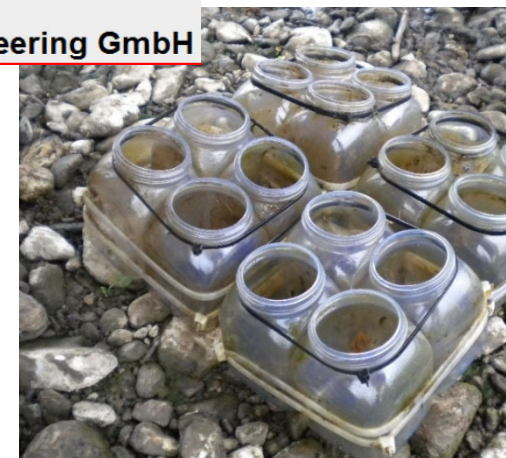
Methodology for sampling suspended particulate matter

-) Types: box trap, cup trap
-) Collection period: approximately one month (4 or 12 cycles per year)
-) Preparation: sieving to the fraction $< 63 \mu\text{m}$, drying and partitioning
 - aqua regia digestion for chemical analysis (metals)
 - Ra-226 activity by gamma spectroscopy
-) Key analytical parameters: U, Ra-226
-) + Site-specific parameters: As, Fe, Mn, Cu, Ni, Zn, total organic carbon
-) Evaluation: Comparison with the objectives (EQN: Environmental quality standards) of the EU WFD and German law
 - As (40 mg/kg), Cr (640 mg/kg), Cu (160 mg/kg), Zn (800 mg/kg) (annual mean value)

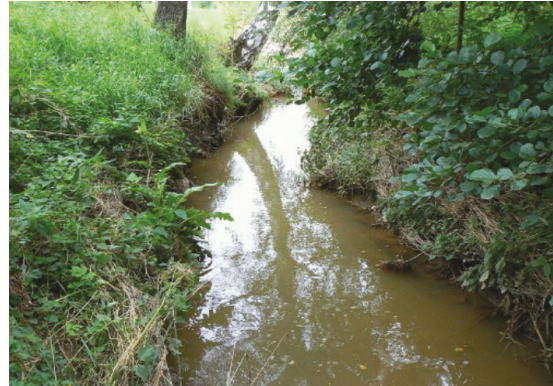
Gessenbach e-416S

- › Mine Ronneburg, cavity 17 m³
- › Flooding since 1998
- › Natural drainage in the direction of **Gessenbach**
- › Removal of the contaminated water via a drainage system in the morphologically deeper area of the Gessental valley

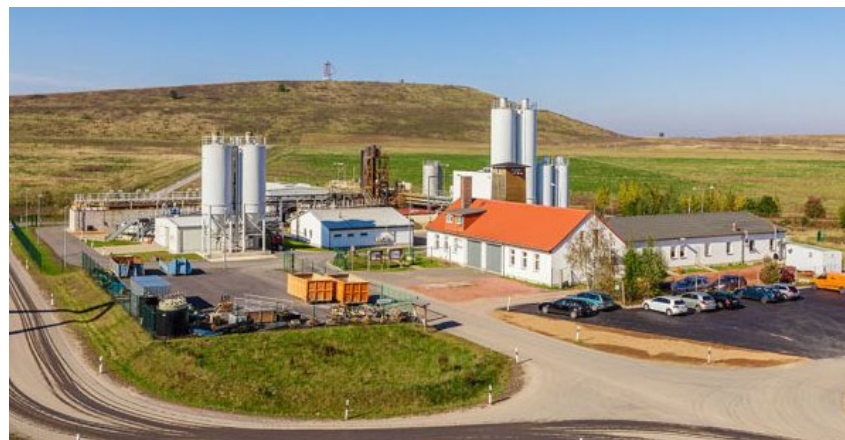
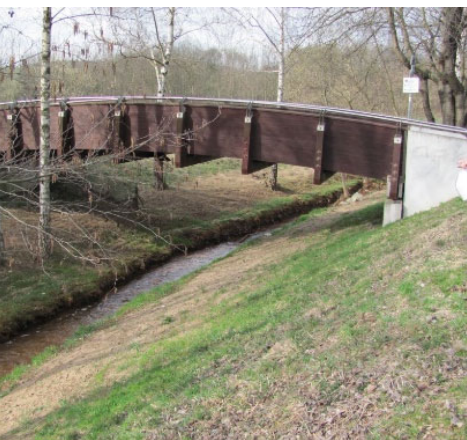
WTP Ronneburg

-
- › Water treatment plant (WTP) since 2002 capacity 550 m³/a since 2011 capacity 850 m³/a treated volume 5 M m³/a (2023),
 - › Discharge in **Wipse** (stream)
 - › 2 small influenced water bodies 5 traps

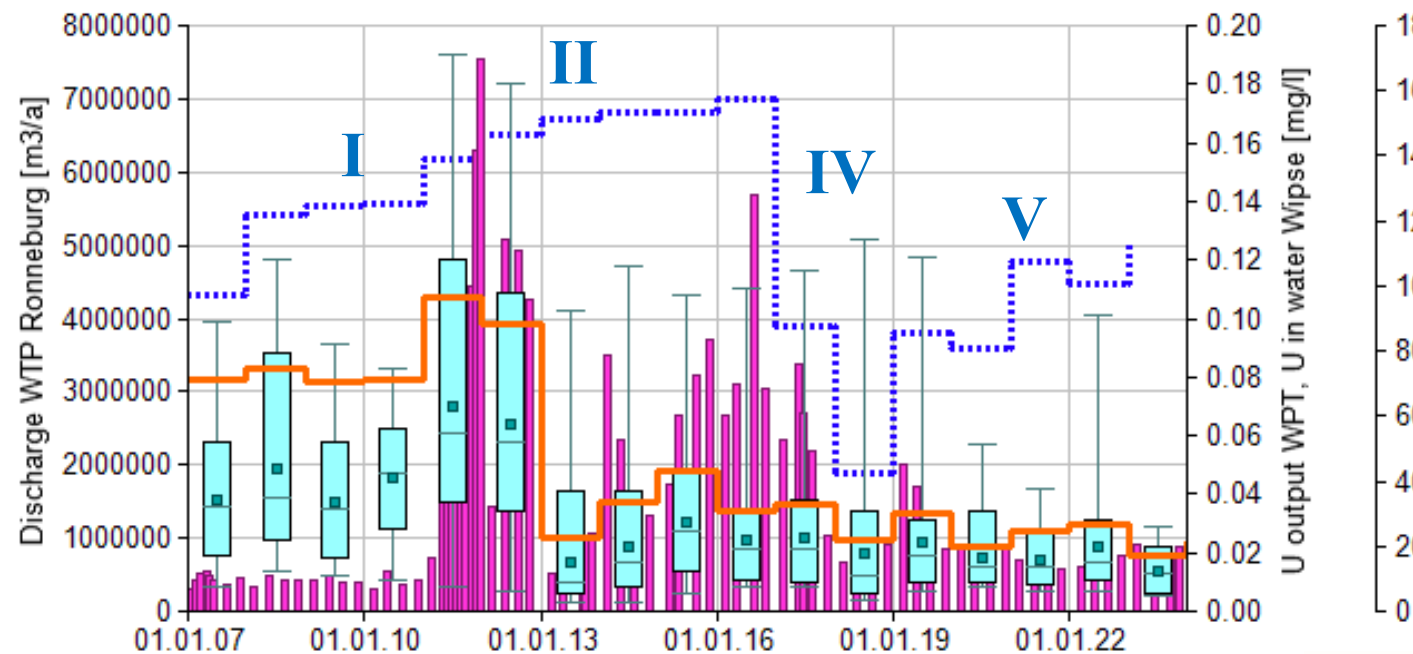
Case study: Ronneburg site - Wipse

I Water treatment since 2002

Upgrading the WTP capacity from 550 to 850 m³/h

II Large quantity to be treated

due to the drawdown of mine water level 2011-2017

IV Minimal treated volume

due to recovery since 2018

V Regular operation

Maintaining mine water level at 247 m above sea level

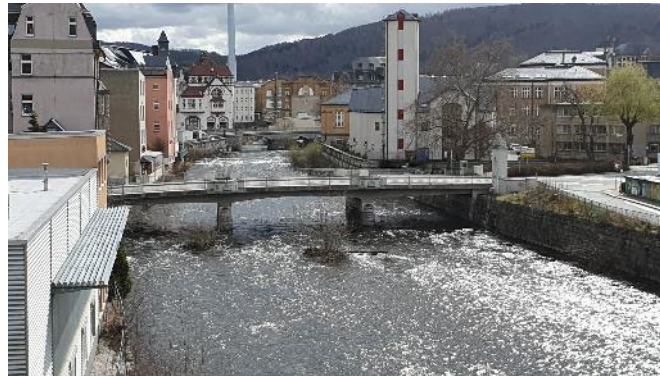
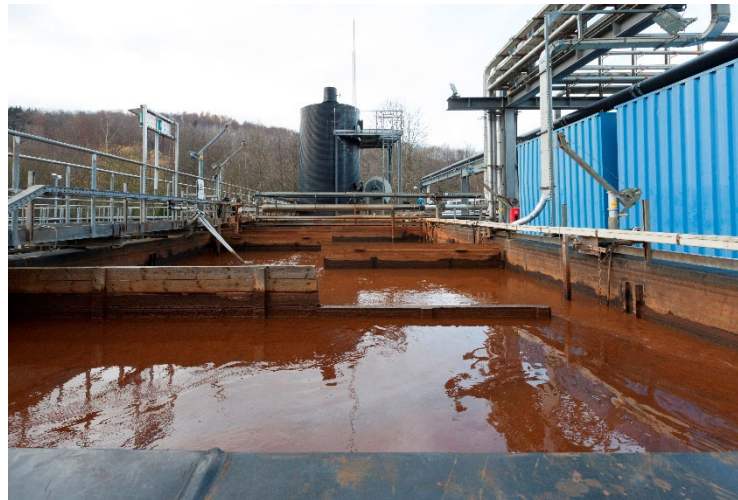
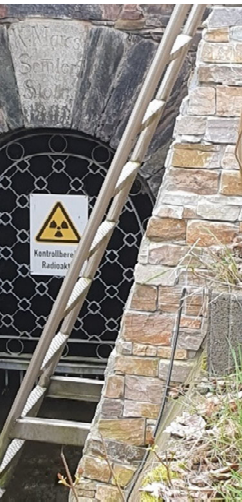
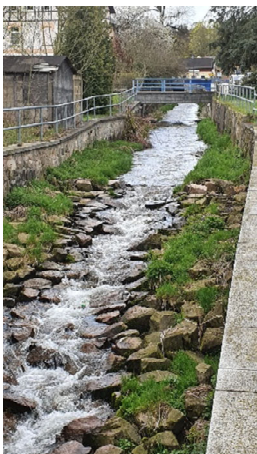
Zwickauer Mulde SF1A

Mine → WTP Schlema-Alberoda

Schneeberg →
Semmler Adit

- › Mine Schlema (Wismut) cavity 35 M m³, flooding starts 1991
- › WTP since 1999, capacity 1150 m³/h since 2001, treated volume: 5 M m³/ (2023)
- › WRD landscape
- › Discharge in **Zwickauer Mulde** (river)
- › high pre-load of metals from upper catchments

-
- › Mine Schneeberg (historical) 5 M m³/a (2023), water not treated, discharge via **Schlemabach** (stream)
 - › 2 influenced water bodies, 4 traps

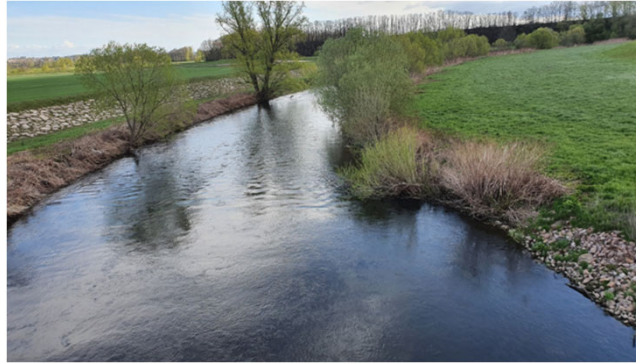
Case study: Crossen site – Zwickauer Mulde, 150 km downstream

- Construction of the Schlema-Alberoda WTP was of trans-regional importance for the Zwickauer Mulde river.
- The decline in concentration since 1998 can also be observed at the Crossen site.
- Concentrations fluctuate less than at Schlema site.
- At the Crossen site between upstream and downstream only slight differences.
- The sediment pollution is similar.

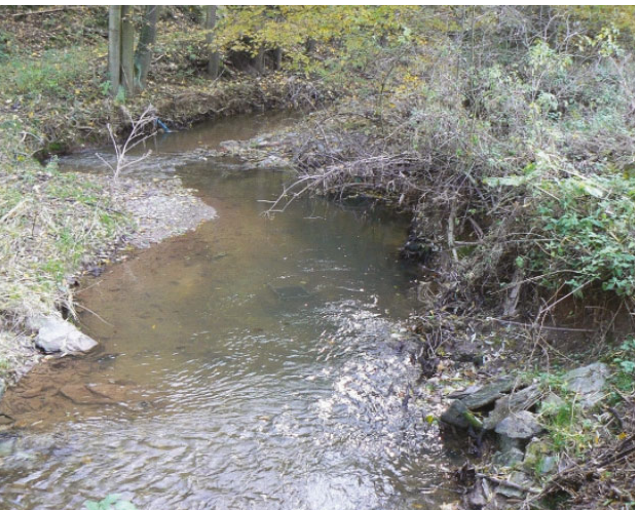
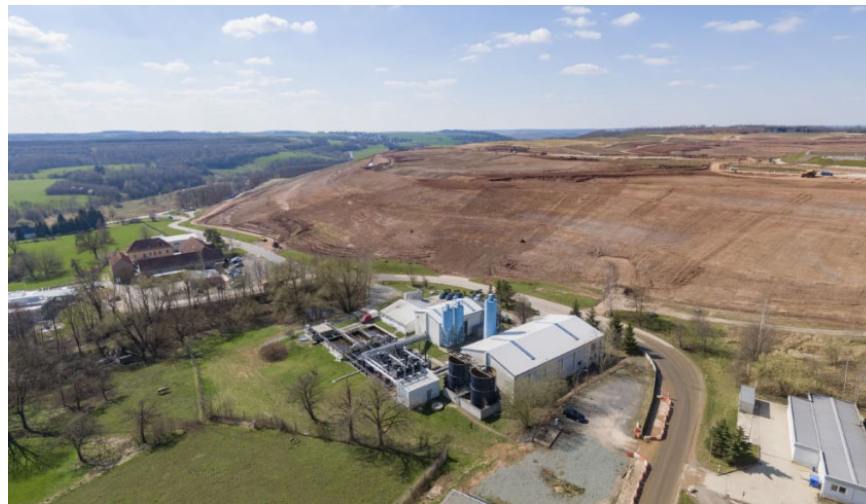
Tailing pond Culmitzsch and WTP Seelingstädt

- › Processing site Seelings
- › TMF Trünzig (Pond A+B)
- › TMF Culmitzsch (Pond A+B)
- › WTP Seelingstädt since 2002, capacity 330 m³/h, treated volume 1.7 M m³ (2023), treated parameters U, Ra-226 (As)
- › Discharge in **Culmitzsch** (stream)
- › 1 small influenced water body, 1 trap

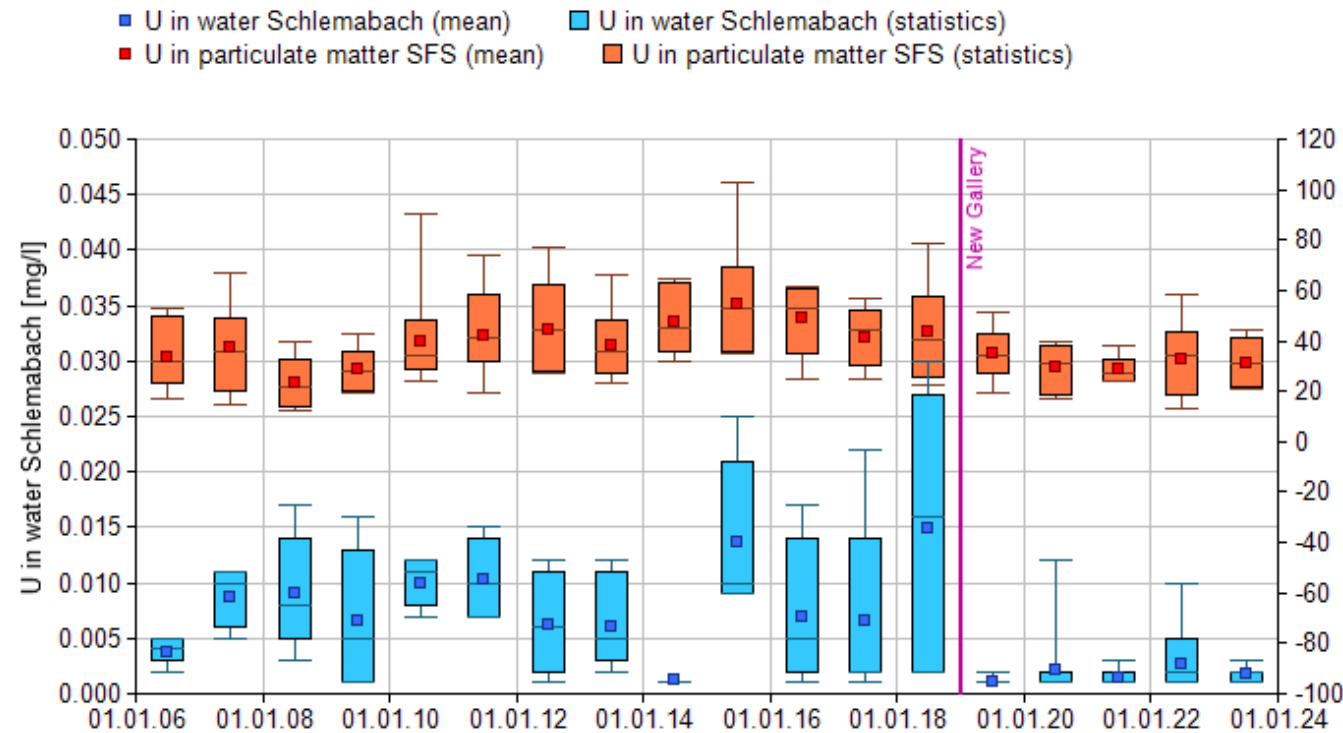
Case study: Schlema-Alberoda site – Schlemabach

Historical Mine Schneeberg:

- › Until 2018 cross-section of the Markus-Semmler gallery too small for the mine water volume, partial discharge into the stream Schlemabach
- › Construction of a new gallery section
- › Since 2018 water quality in the Schlemabach improved
- › Influences from the upper catchment area remain in the sediment signature
