# Water Management and Treatment in the Closure Phase: Case Studies and the Associated Challenges

A.A. van Coller, V.A. Shaw, G.E. Trusler

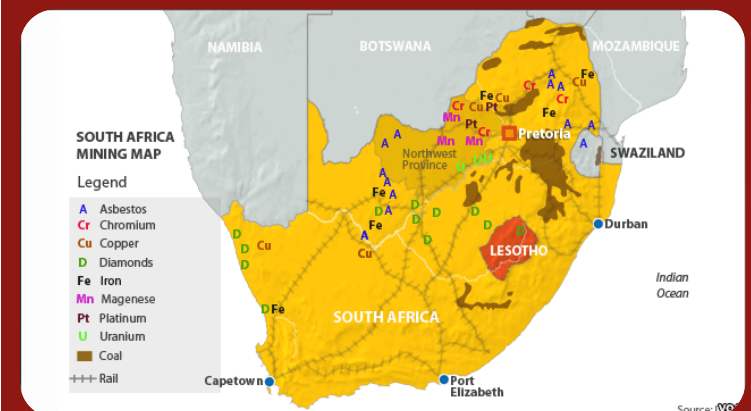
## Concentrated Mining Areas

- South Africa has extensive mineral resources which are generally concentrated in various regions, as a result of the geological formations and their setting in the country.
- Platinum Group Elements (PGEs) and Copper mines are generally concentrated along the northern part of the country,
- large coal mines in the Mpumalanga coalfields, and
- gold mines in and around the Witwatersrand, where the well-known south African goldfields are located across a vast area.
- Although the above-mentioned extend over vast areas, there are many mines that are in relatively proximity to one another, and hydraulically interlinked,
- And experience similar mine water related issues.
