“Abandoned Coal Mine Mitigation in High Pressure Artesian Conditions”

Presentation By:

Joshua Zimmermann, PE
(jzimmermann@brierleyassociates.com)

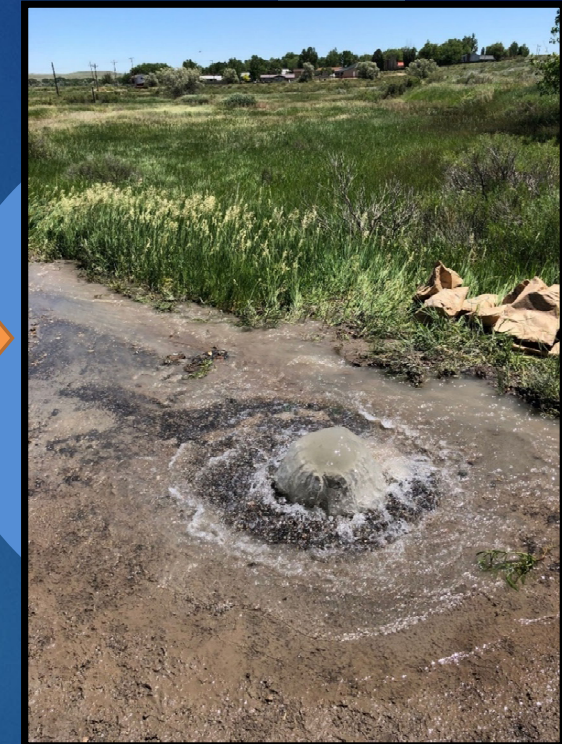
Artesian Conditions; Mined interval

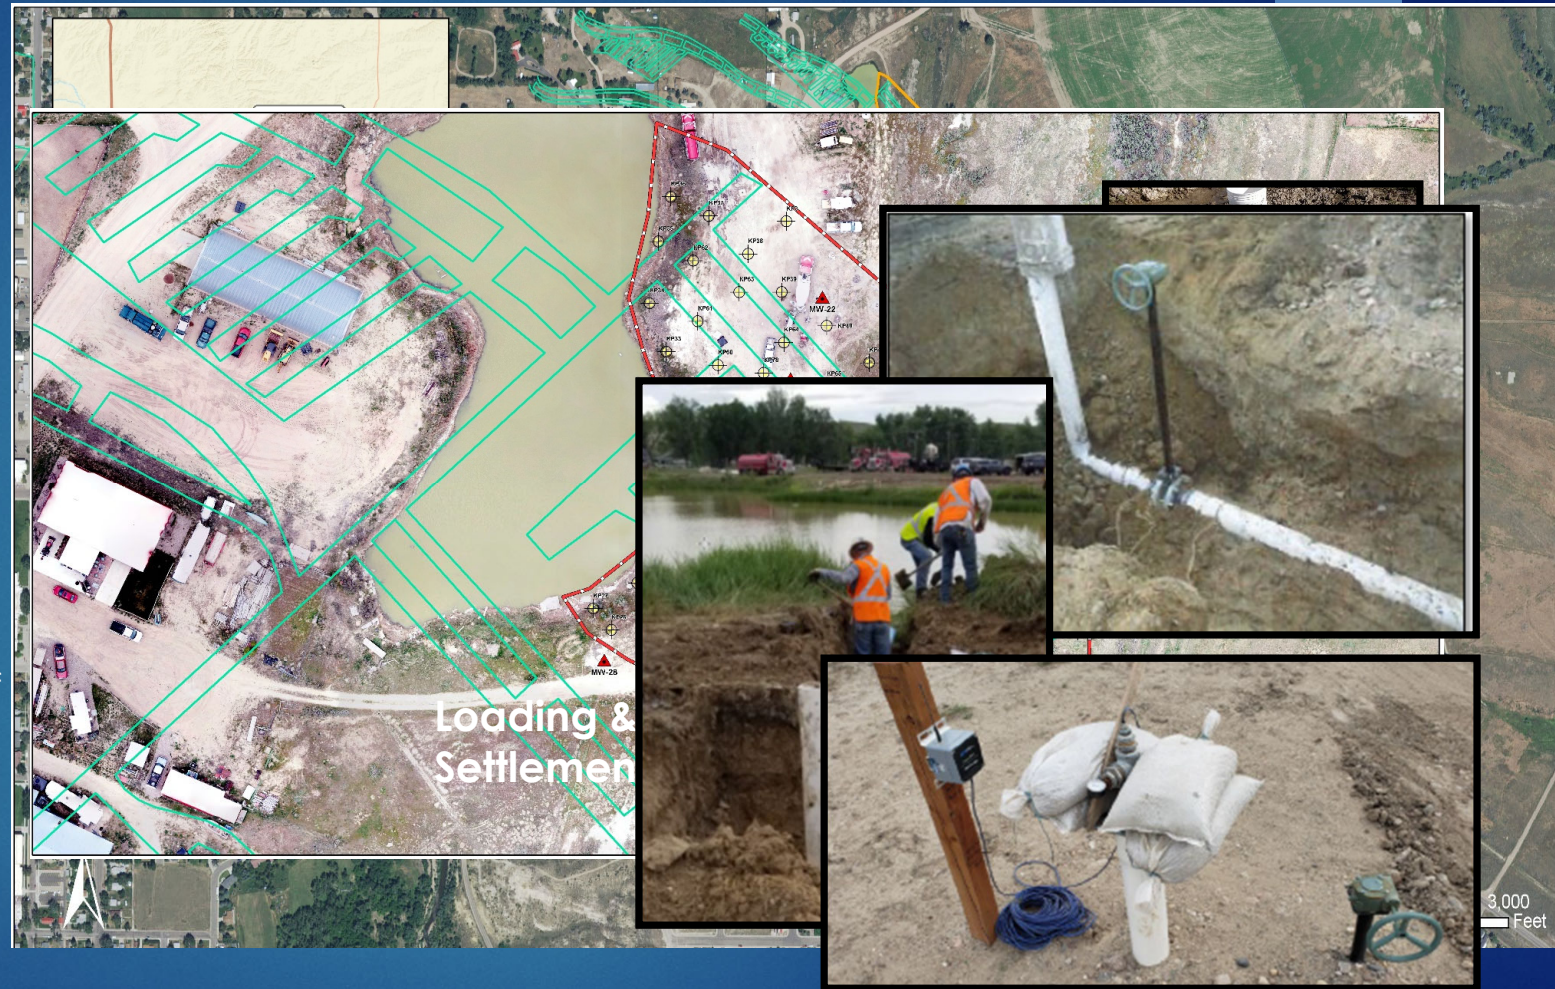
- Purpose: To test the feasibility of mitigation under artesian conditions within a heavily developed suburb
- 7 monitoring wells in Pilot area (shallow/deep).
- Approximately 100 proposed injection borings for grouting.
- Grout barrier towards sub-development to prohibit groundwater flow.
- Surcharge load cells to simulate footing weights and measurement of differential Settlement
- One discharge well equipped with ball valve to relief pressure if above 'baseline' pressure readings
- Total Grout Injected: 3,800 m³ (4,975CY) over .01 sq km (2 acres)

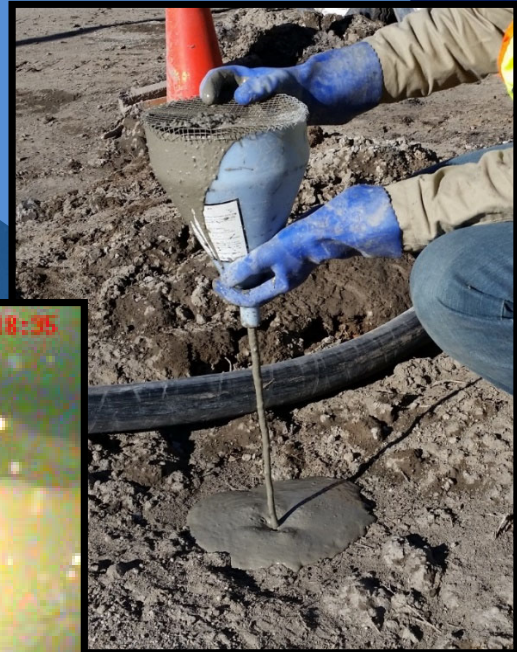
Modern Approach

- Focus on filling voids, not on strength of grout (confinement)
- Compression Strength 200 psi (1.4 MPa) (sample coring showed 1,200 to 8,000 psi in-situ) (8 to 55 Mpa)
- Heavier than water, consolidates and cures within mine
- Fills mine voids, joints and fractures in rock overburden and rubbleized material with pressure

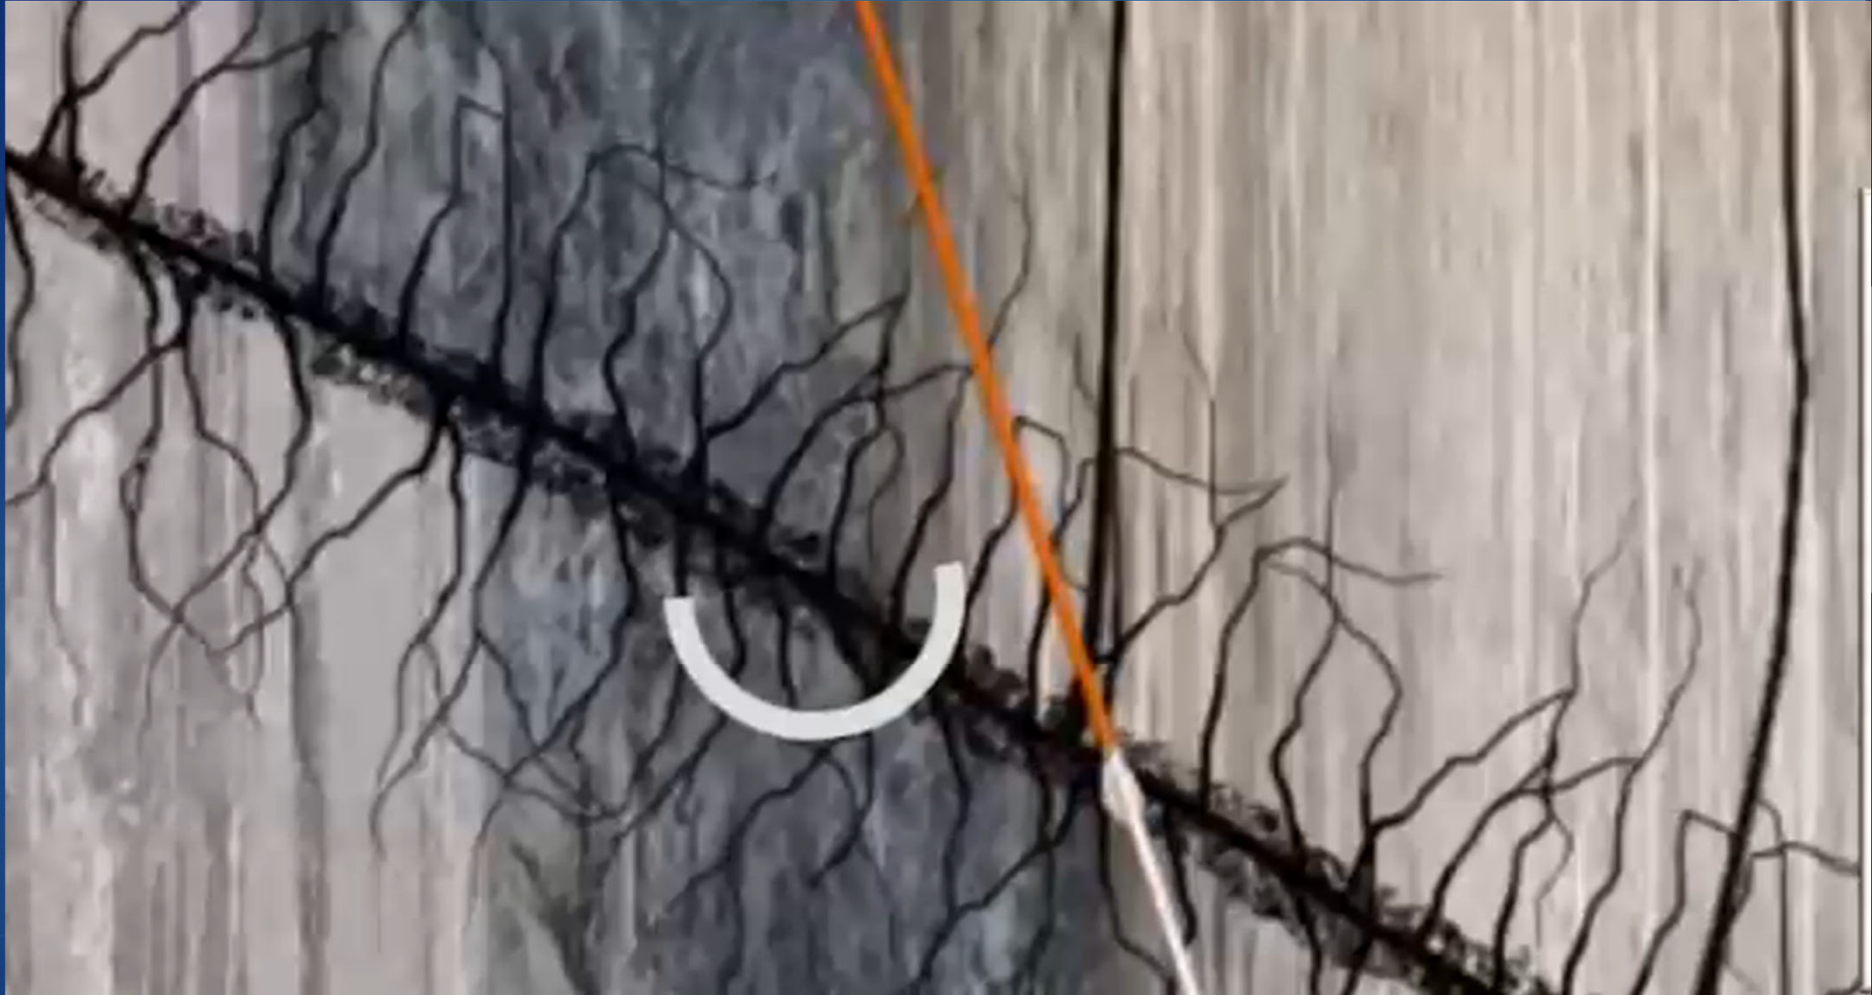
Slide 11

Alternative Grouting Approach – Cont.

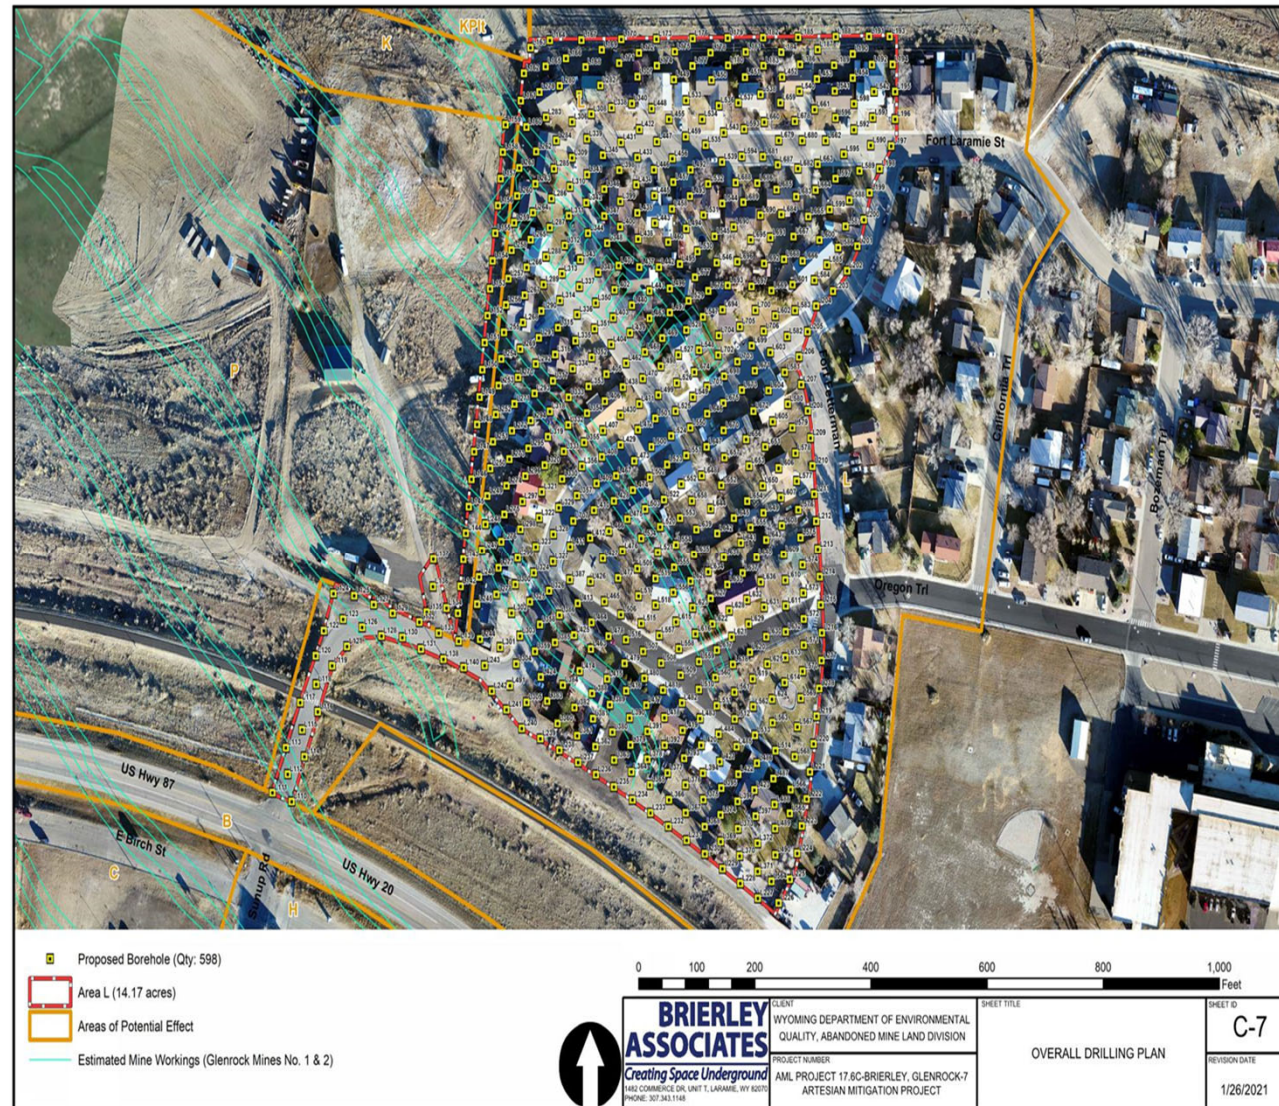
Appendix C to Contract between AMI, and Contractor, AMI, Project 17.6C-Brierley, Glenrock-7 Artesian Mitigation Project, Page Appendix C-7 of C-13

- 598 boreholes
 - Average Depth ~150 ft BGS
 - Range from 130-200 ft BGS
 - Grout Injected, 25,256 CY
- Water discharged from 6 permitted wells on the NW corner of sub-development
 - Set in voids/rubble in mine interval
- Baseline surveys were conducted prior to project start. Including; thermal, orthomosaic mapping, LiDAR scans, and placement of cloud-based piezometers for groundwater monitoring

*Orthomosaic produced from drone imagery collection on December 8, 2020 by Brierley Associates

- Manifold
 - ▽ Shallow Monitoring Well
 - Area L Discharge Well (Installed 2020)
 - Area L Proposed Shallow Wells
 - ▲ Active Monitoring Well
 - ★ Historic Subsidence Event
 - Area L Trenching (12" PVC)
 - Area L Trenching (24" Corrugated HDPE)
 - Area L (14.17 acres)
 - Converse County Parcel Boundary
 - ▨ Area L (Mitigation Not Needed)
 - Estimated Mine Workings (Glenrock No. 1 and 2 Mines)
- GROUT SOURCE**
- CTL
 - Brierley Associates
 - D'appolonia
 - D'appolonia Sand Slurry

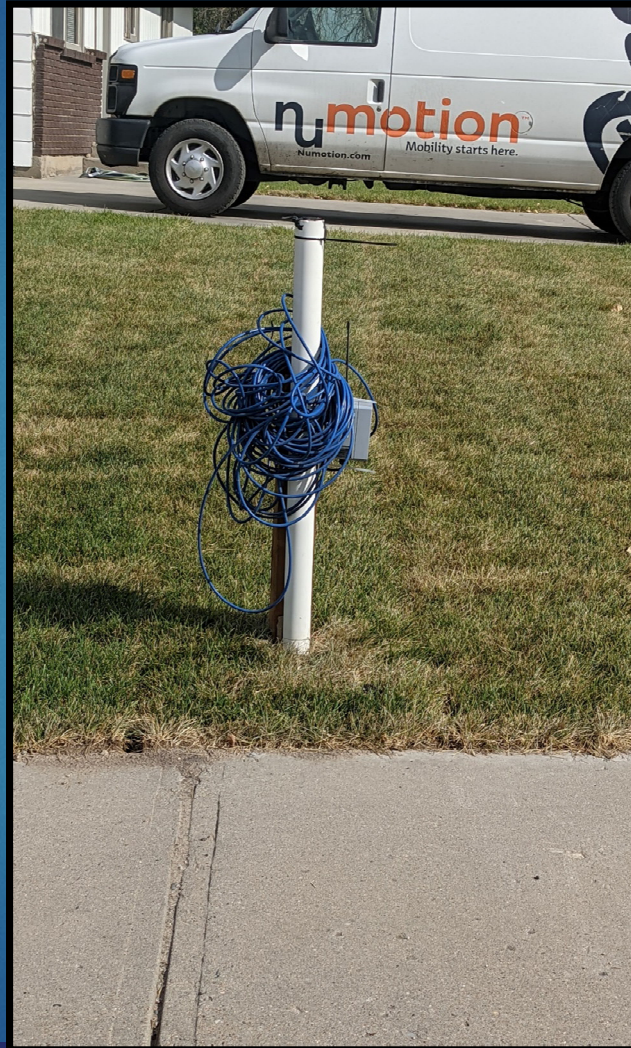
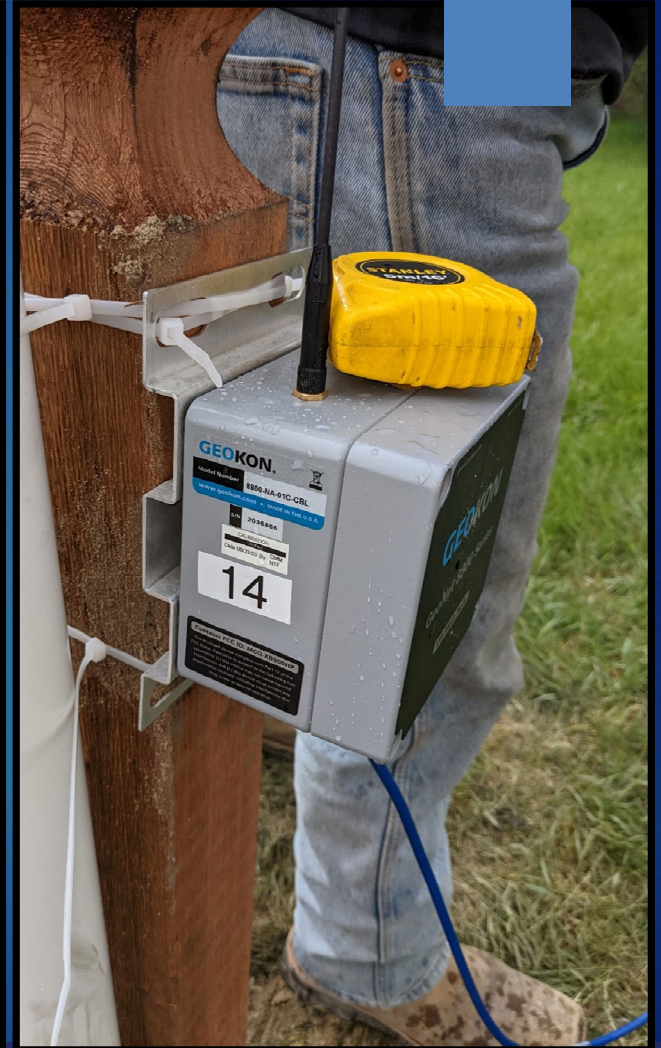
- ▶ Installed across the APE to monitor shallow groundwater response to construction operations
- ▶ 20 total monitoring wells: 16 shallow wells (20 feet or 6 meters in depth or less) and 4 deep wells set in the mine interval
- ▶ Each set with a vibrating wire piezometer and wireless node for remote data monitoring on regular intervals
- ▶ Wells installed in multiple stages before project

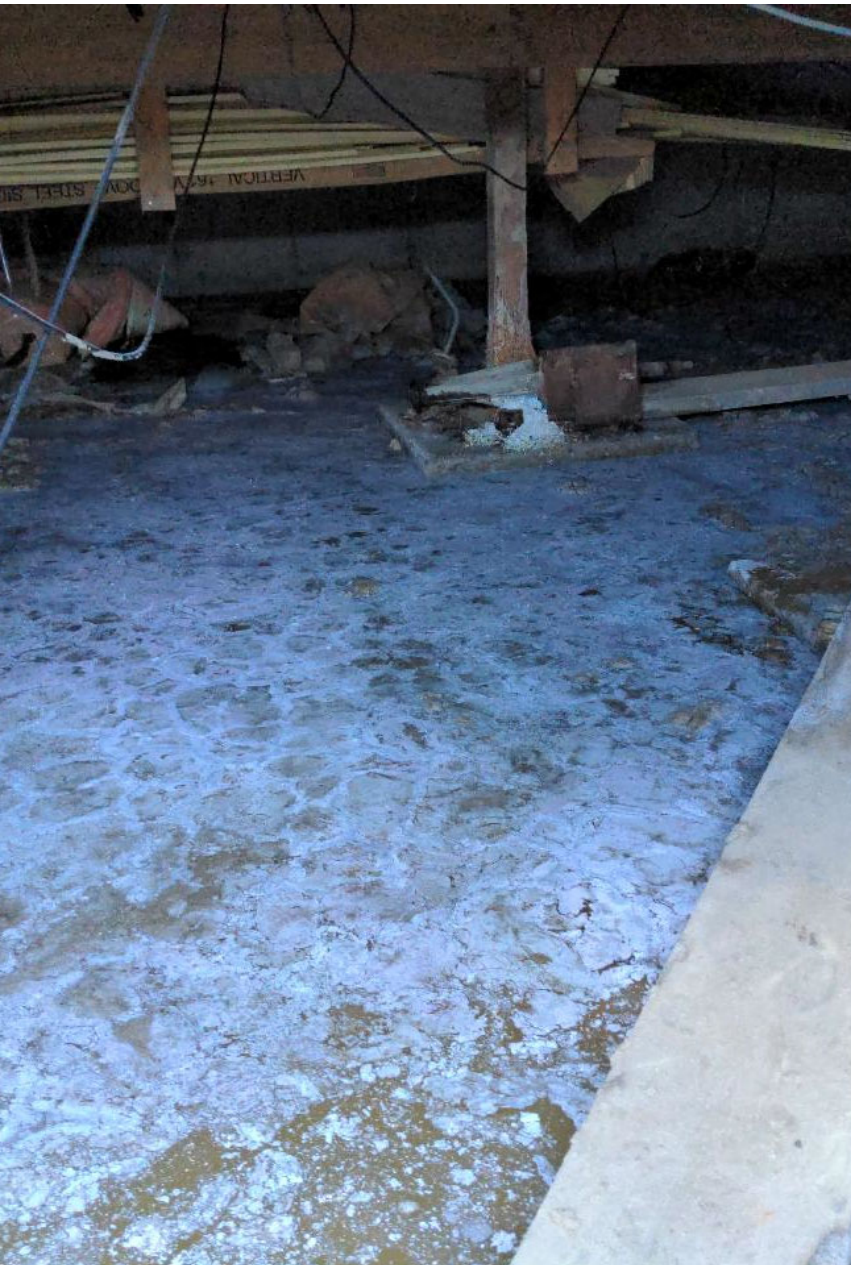
110 South Pass

- ▶ Crawlspace always flooded with at least 6 inches (15 cm) of water (42 years).
- ▶ Water level directly responds to the opening of discharge wells.
- ▶ Property is confirmed to be undermined by 2018 exploratory borings.

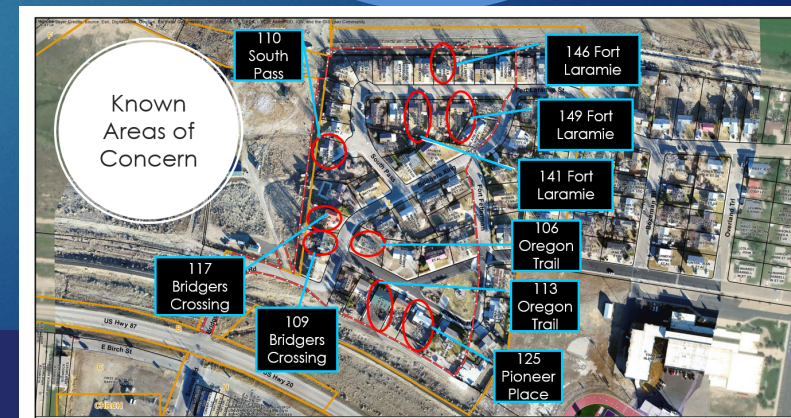
- ▶ Upon completion in November 2021, ~24,538 cubic yards (19,000 cubic meters) of grout has been injected into the Area. This equates to ~4,956,038 gallons of water (18.7 million liters).
 - ▶ Orange = Coal
 - ▶ Purple = Rubble
 - ▶ Green = Void
 - ▶ Blue = Grout
 - ▶ Yellow Circles = Representative volumes of grout injected at location
- ▶ ~5,650,922 gallons (21.3 million liters) of water has been discharged through the well system.
 - ▶ Approx. 8 Olympic Sized Swimming Pools

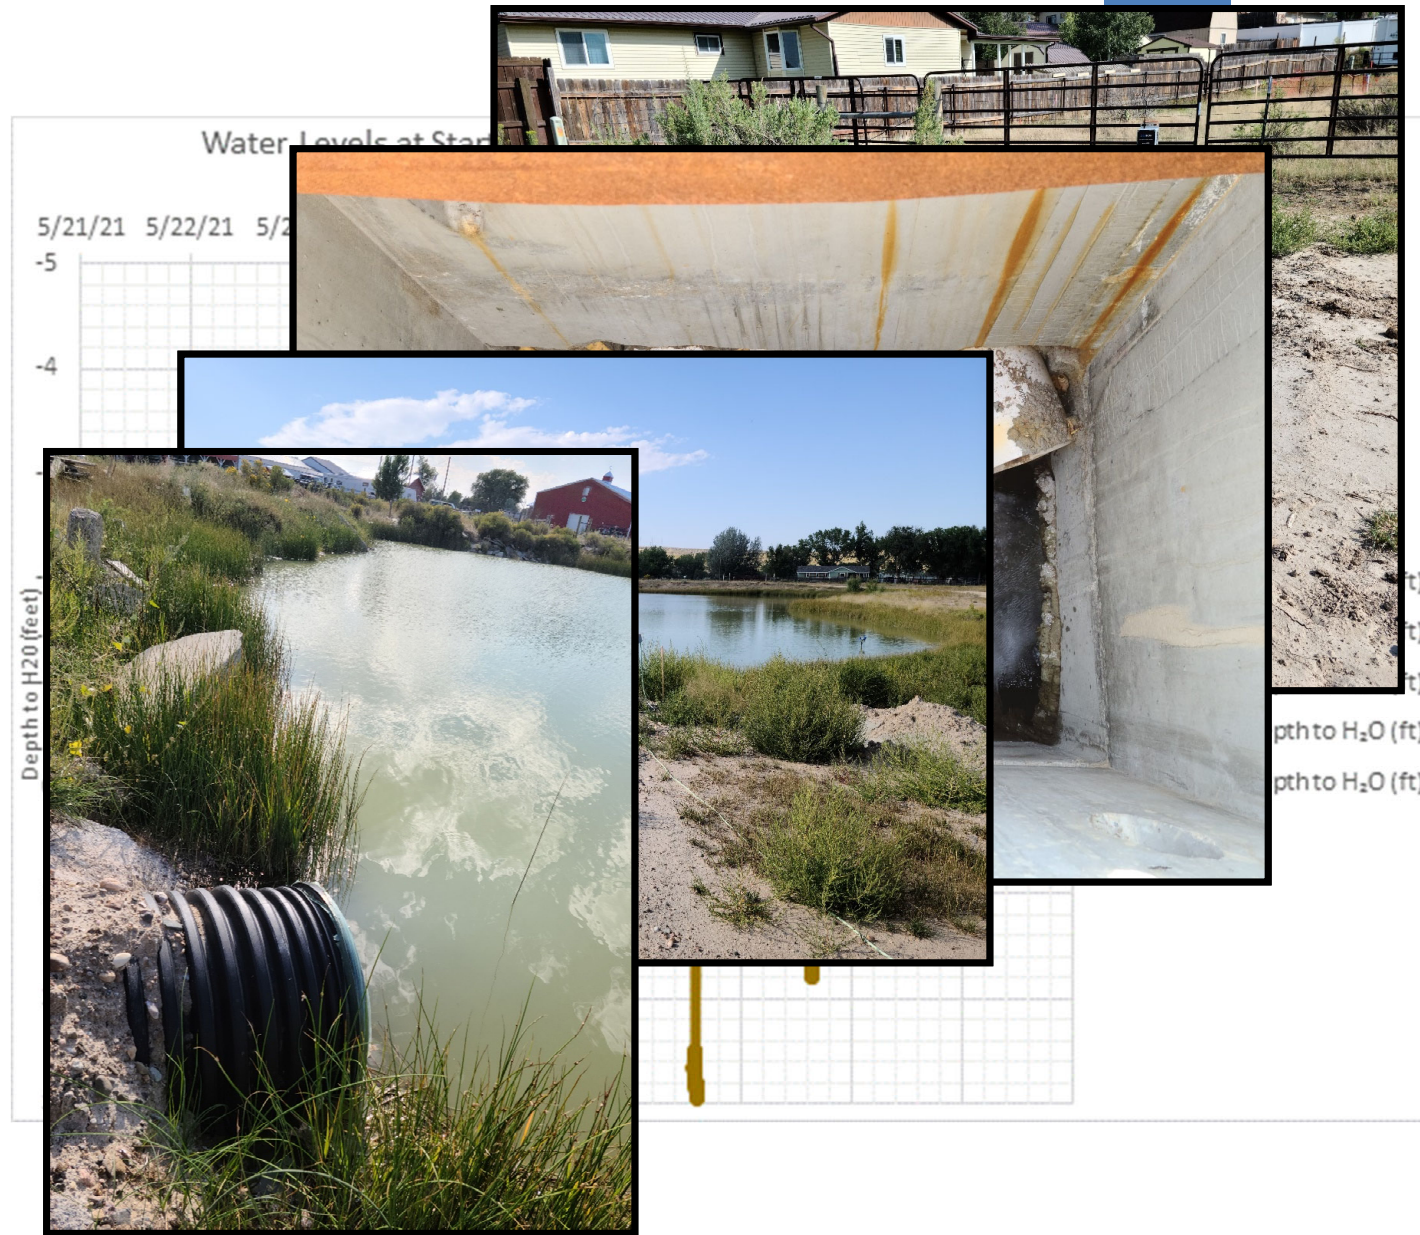
Groundwater Response

- ▶ Mitigation began in late-May 2021
 - ▶ Work began at the southern end of the APE to push water to discharge wells located to the North
 - ▶ Immediate response notated in discharge and monitoring wells across the site.
 - ▶ Distance from grouting to discharge well ~ 700+ feet (200 meters)

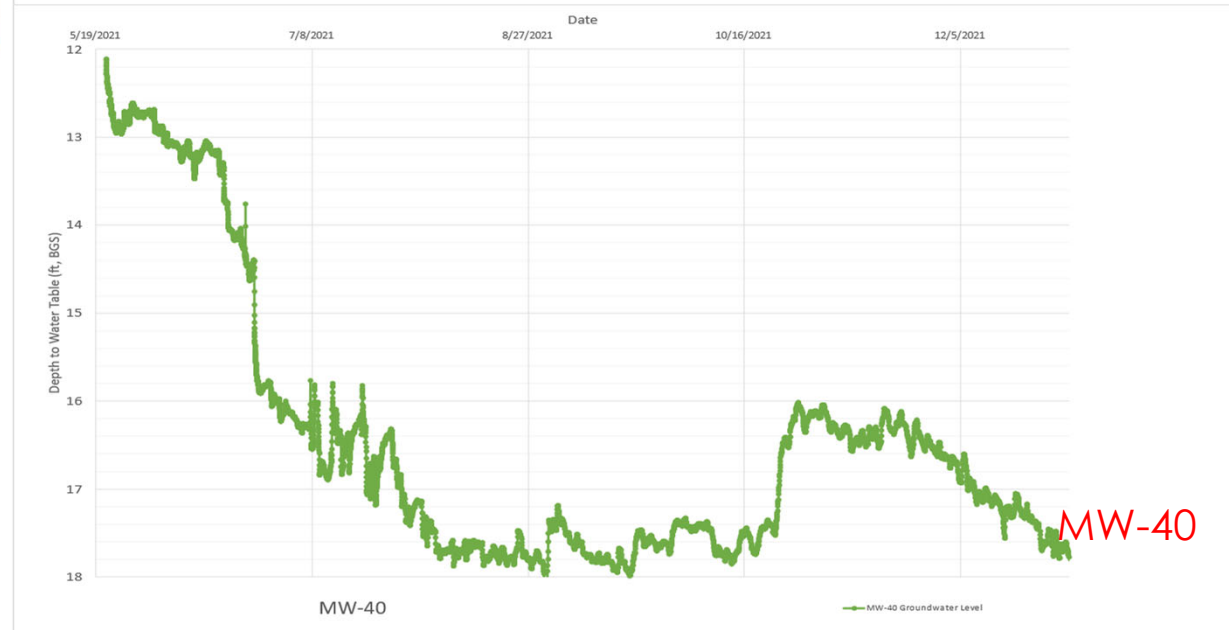
Shallow Groundwater Response

- ▶ Large decrease in groundwater level in shallow wells across job site
 - ▶ MW-38: GW decreased a net ~8 feet from the baseline at the beginning of the project (from ~6 feet BGS to ~14 feet BGS) (2.4 meter drop)
 - ▶ MW-40: GW decreased a net ~6 feet from the baseline at the beginning of the project (from ~12 feet BGS to 18 feet BGS) (3.6 meter drop)
- ▶ Decrease in GW level has been consistent and maintained at these decreased levels
