Iberian Pyrite Belt

Trimpancho Mining Complex

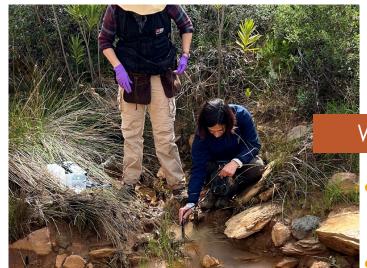
Methodology

- pH, EC, and Eh in situ
- Filtered samples (<0.45µm) for metalsICP-OES
- Acidity and sulfate
 volumetric titration
- turbidimetry

- Air temperature and humidity measured in situ
- XRD, FTIR, and SEM-EDS for mineralogical and chemical characterization

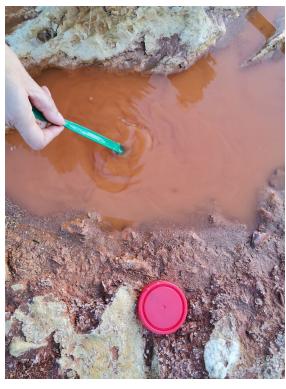
Mineral	Formula
Melanterite	FeSO ₄ ·7H ₂ O
Rozenite	FeSO ₄ ·4H ₂ O
Copiapite	Fe ²⁺ Fe ³⁺ ₄ (SO ₄) ₆ (OH) ₂ 20H ₂ O
Magnesiocopiapite	MgFe ³⁺ ₄ (SO ₄) ₆ (OH) ₂ ·20H ₂ O
Aluminocopiapite	Al _{2/3} Fe ³⁺ ₄ (SO ₄) ₆ (OH) ₂ 20H ₂ O
Epsomite	MgSO ₄ ·7H ₂ O
Hexahydrite	MgSO ₄ 6H ₂ O
Halotrichite	$Fe^{2+}Al_2(SO_4)_4 \cdot 22H_2O$
Coquimbite	$AIFe_3(SO_4)_6(H_2O)_{12} \cdot 6H_2O$
Jarosite	$KFe^{3+}_3(SO_4)_2(OH)_6$

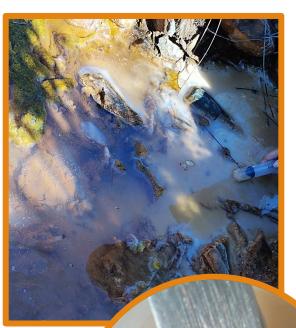
Aluminum hidroxysulfate mineral

- Mineral phase: Basaluminite (?)
- Morphology: tiny irregular particles
- Chemical composition: O (51 at.%), Al (29 at.%), S (12 at.%) and Fe (8 at.%)
