# Upper He Creek hydraulic and hydrogeologic control solutions in east central Tennessee

Terry W. Schmidt

*Presented at WVTF & IMWC April 22, 2024*

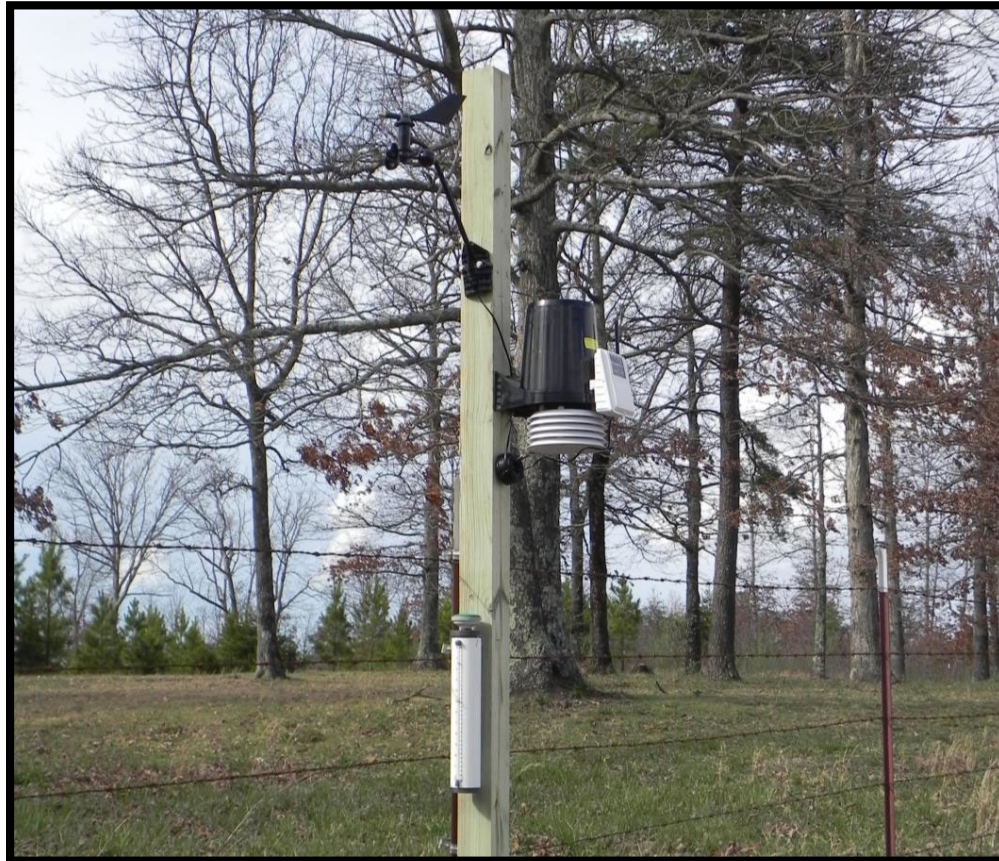
# Weather Station

- **1 Weather Station (Precipitation)**
- **7 Surface Water Flow Stations**
  - **3 stream flow stations**
  - **3 pump flow stations**
  - **1 gravity flow discharge station**
- **5 Groundwater Level Stations**
- **1 Evapotranspiration Lysimeter**
- **Monitored 3/15/12 – 10/11/12 (10 min intervals)**

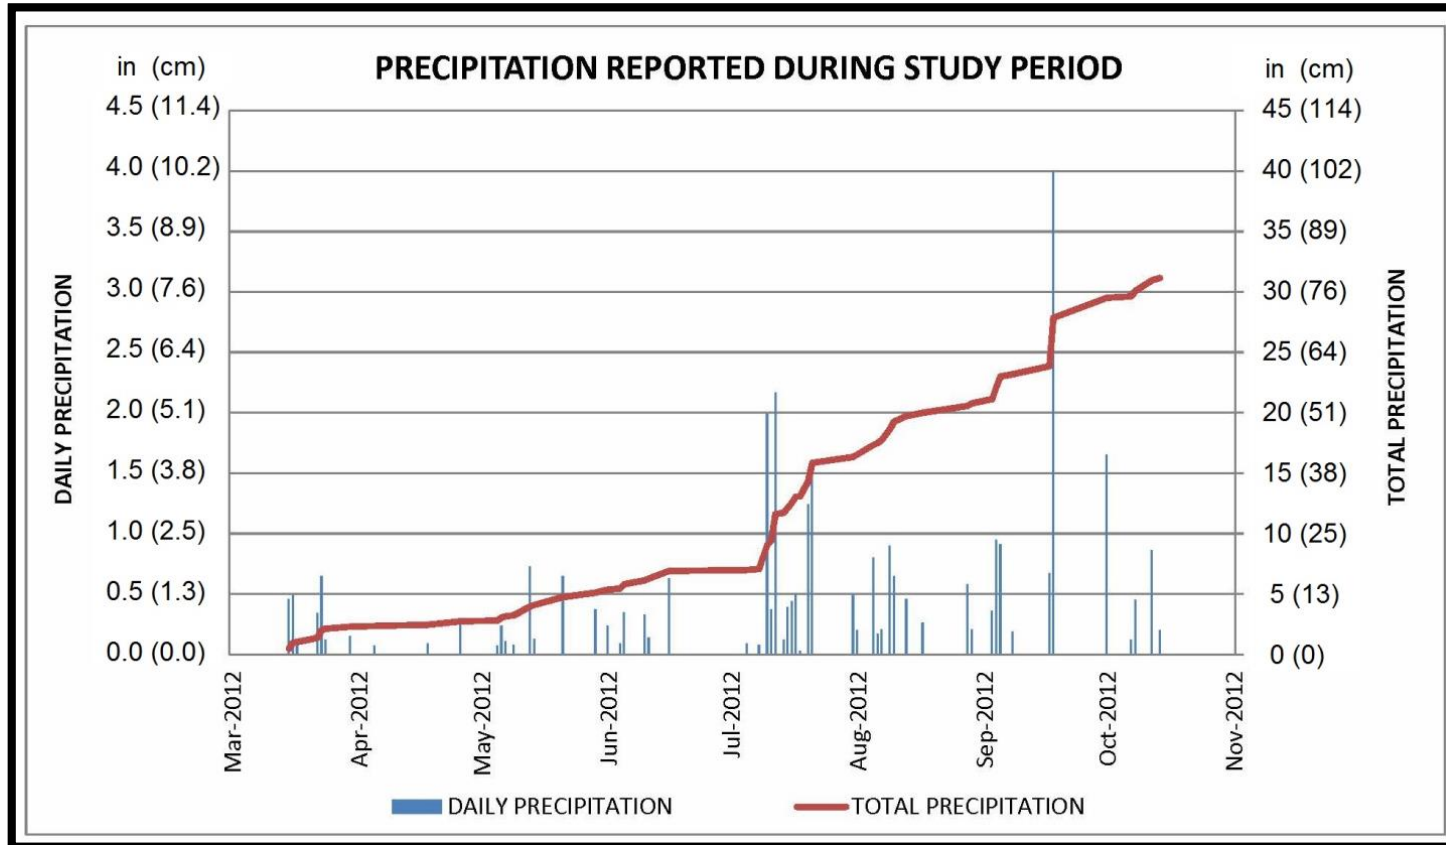
# Precipitation Summary From Weather Station

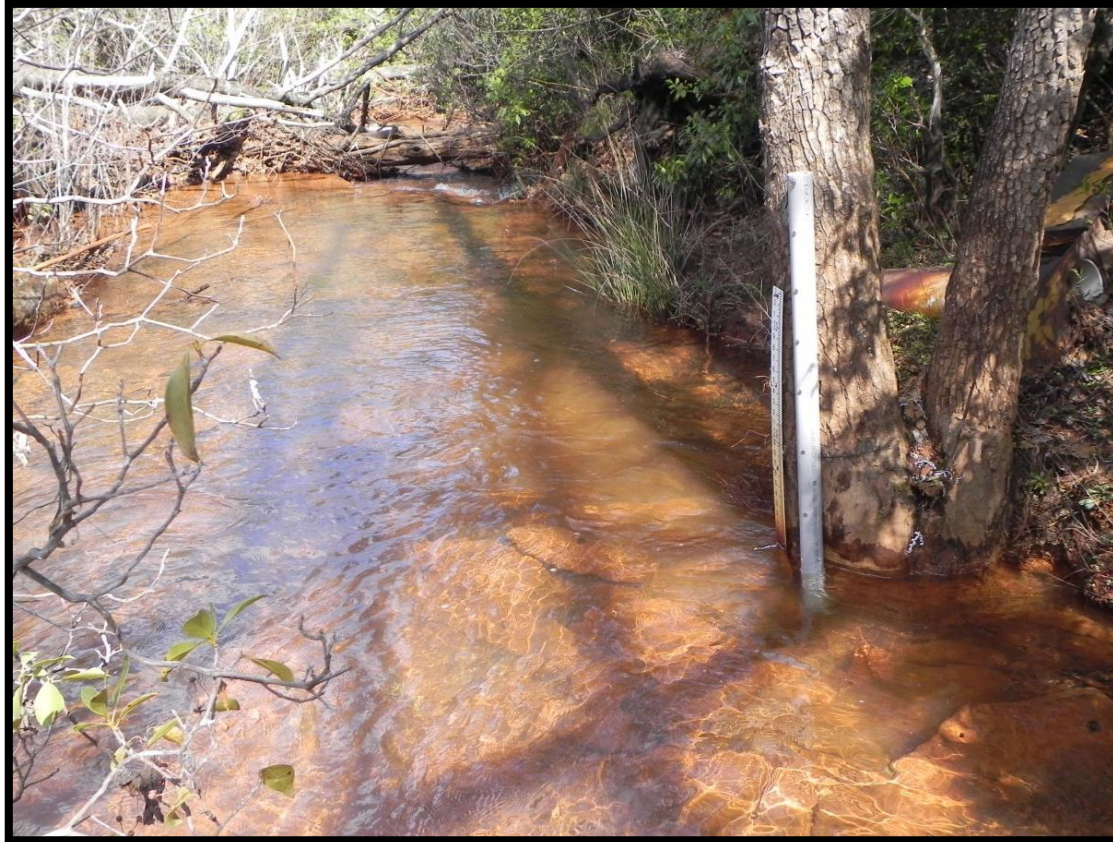
## Example - Big He Creek Monitoring Station

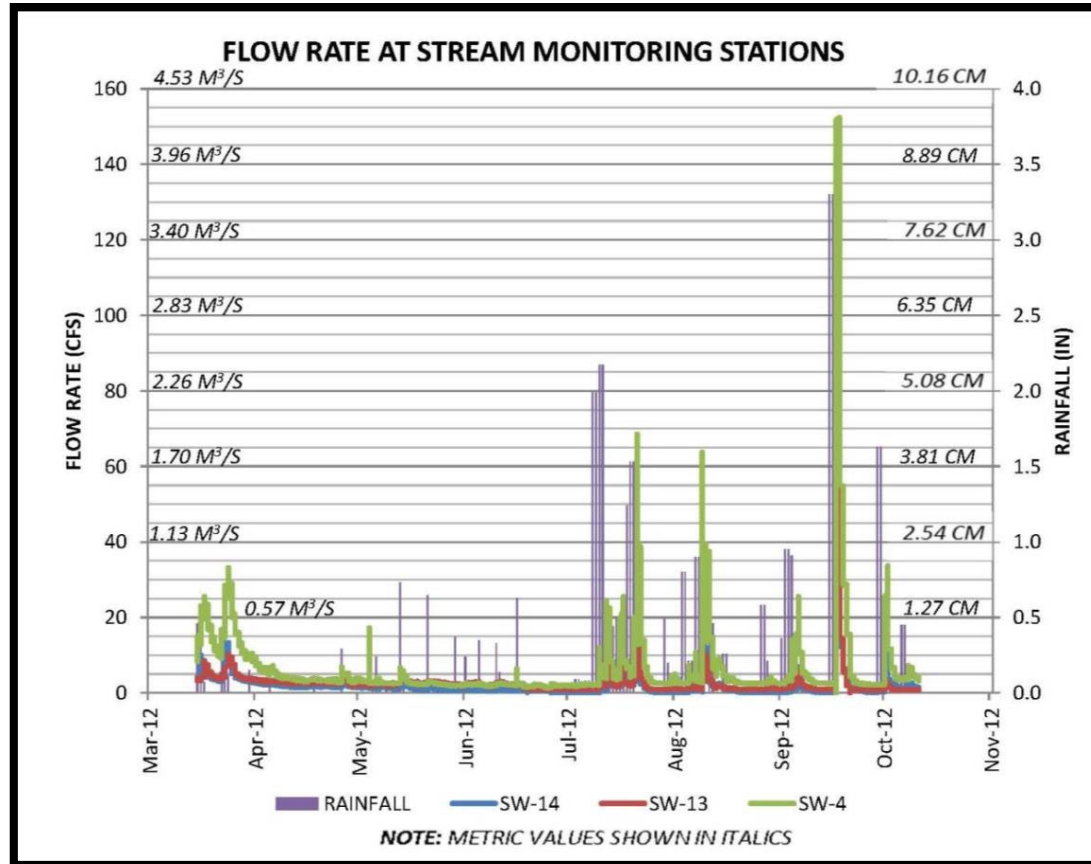
# Stream Flow Gauge Rates Summary

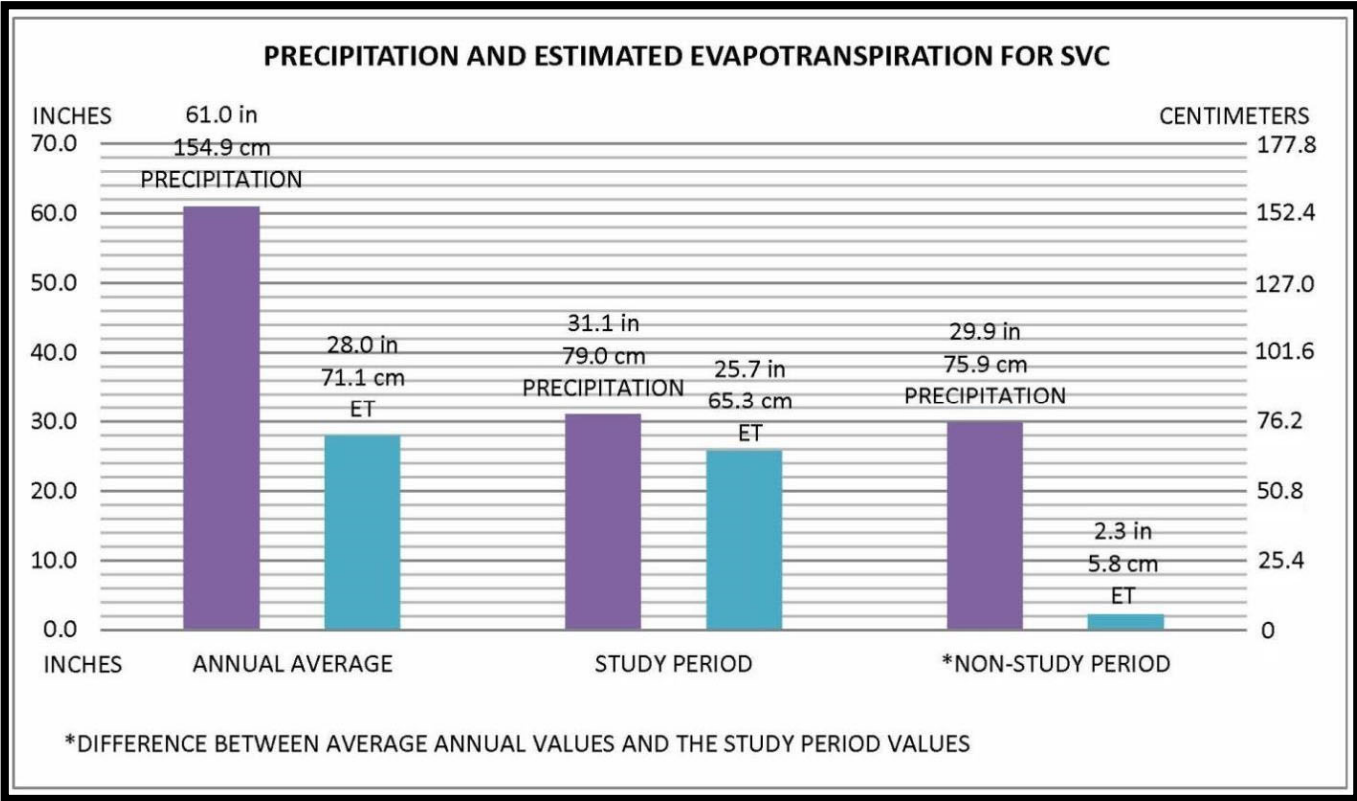
# PRECIPITATION AND ET

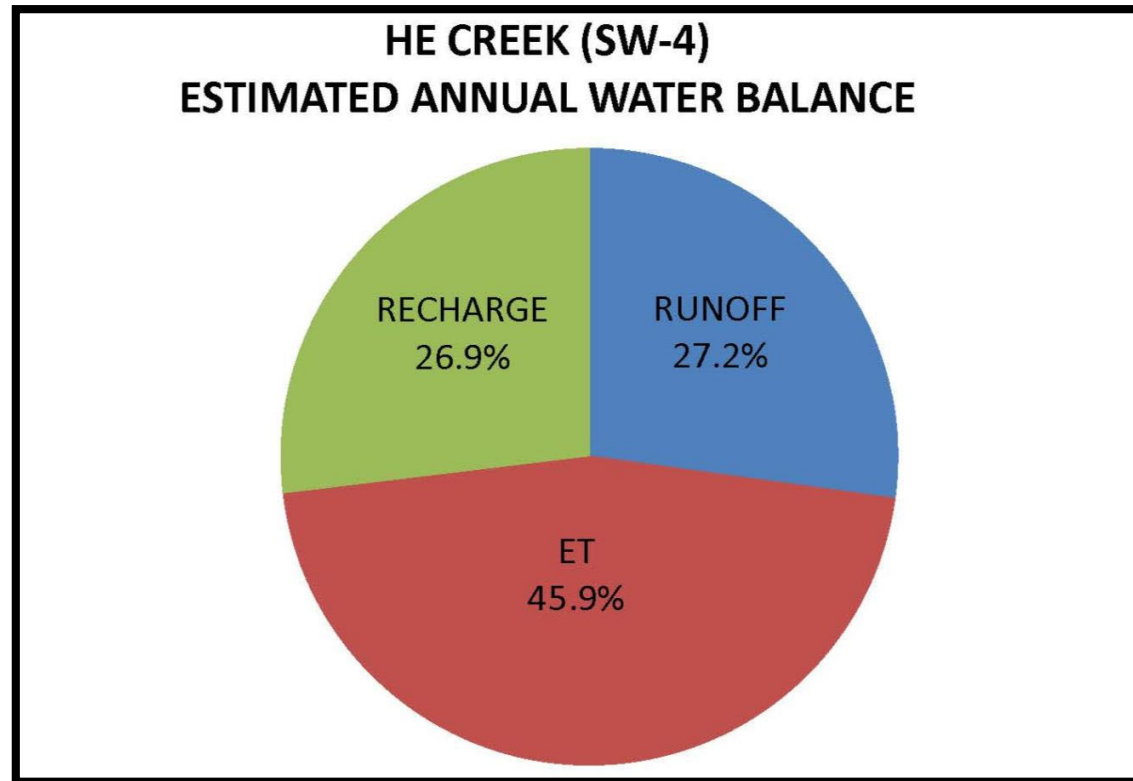
# WATER BALANCE

PRECIPITATION	RUNOFF	ET	INFILTRATION
	GPM (M <sup>3</sup> /min)	GPM (M <sup>3</sup> /min)	GPM (M <sup>3</sup> /min)	GPM (M <sup>3</sup> /min)
BIG HE CREEK	4,128 (15,624)	860 (3.26)	1,895 (7.17)	1,373 (5.20)
LITTLE HE CREEK	3,309 (12,525)	880 (3.33)	1,519 (5.75)	910 (3.45)
HE CREEK	<b>8,667 (32,805)</b>	<b>2,356 (8.92)</b>	<b>3,978 (15.06)</b>	<b>2,332 (8.83)</b>
	IN (CM)	IN (CM)	IN (CM)	IN (CM)
BIG HE CREEK	61.0 (154.9)	12.7 (32.3)	28.0 (71.1)	20.3 (51.5)
LITTLE HE CREEK	61.0 (154.9)	16.2 (41.2)	28.0 (71.1)	16.8 (42.6)
HE CREEK	<b>61.0 (154.9)</b>	<b>16.6 (42.1)</b>	<b>28.0 (71.1)</b>	<b>16.4 (41.7)</b>

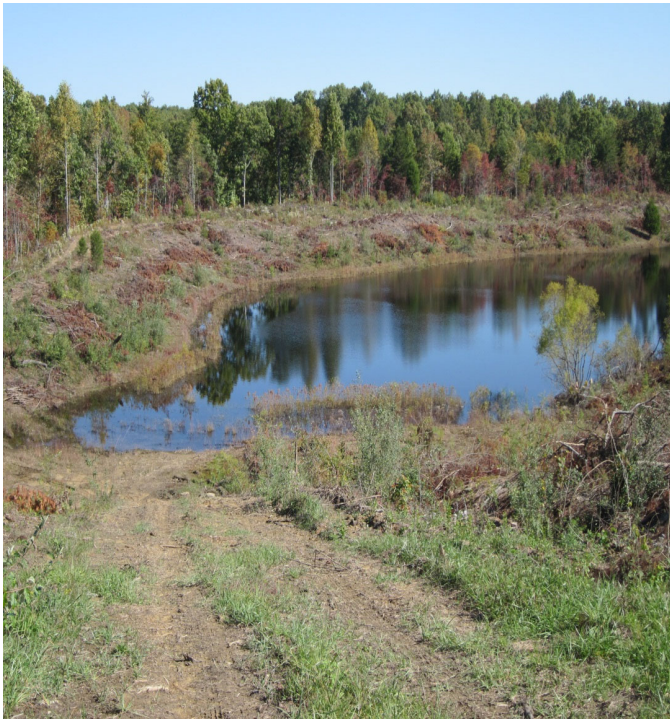
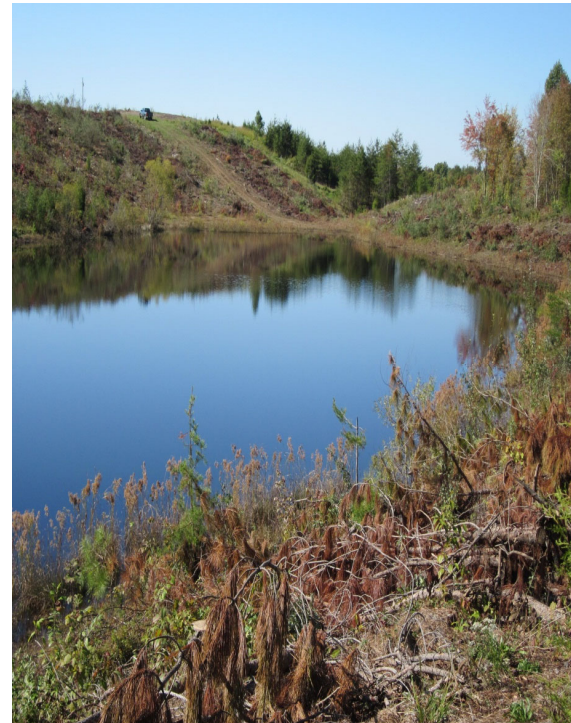
# Basin 2-2-006 Removal Example

## 129-acre drainage area

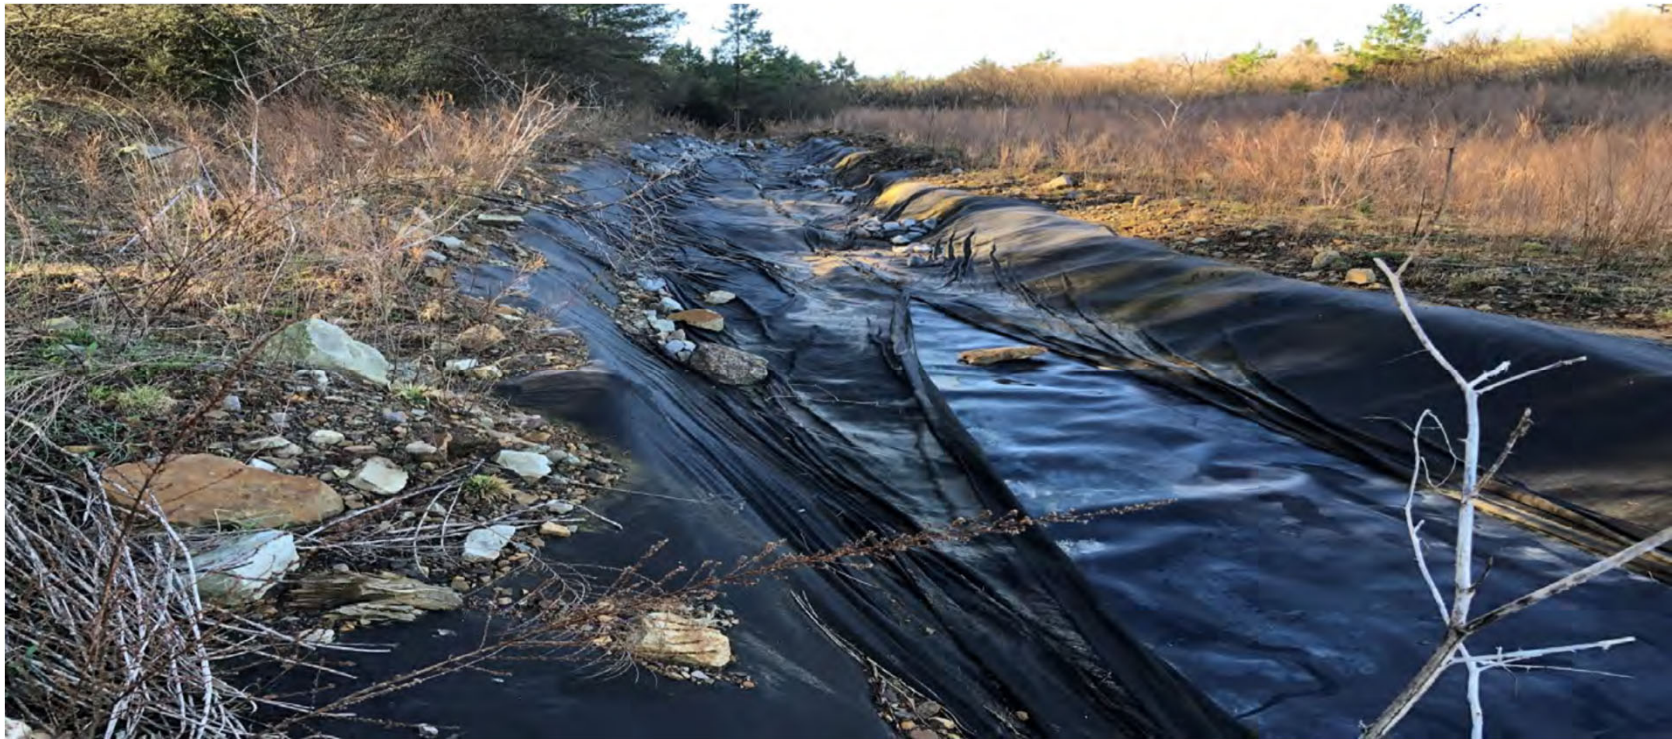
# Basin 2-2-006 Channel Failure & Repairs

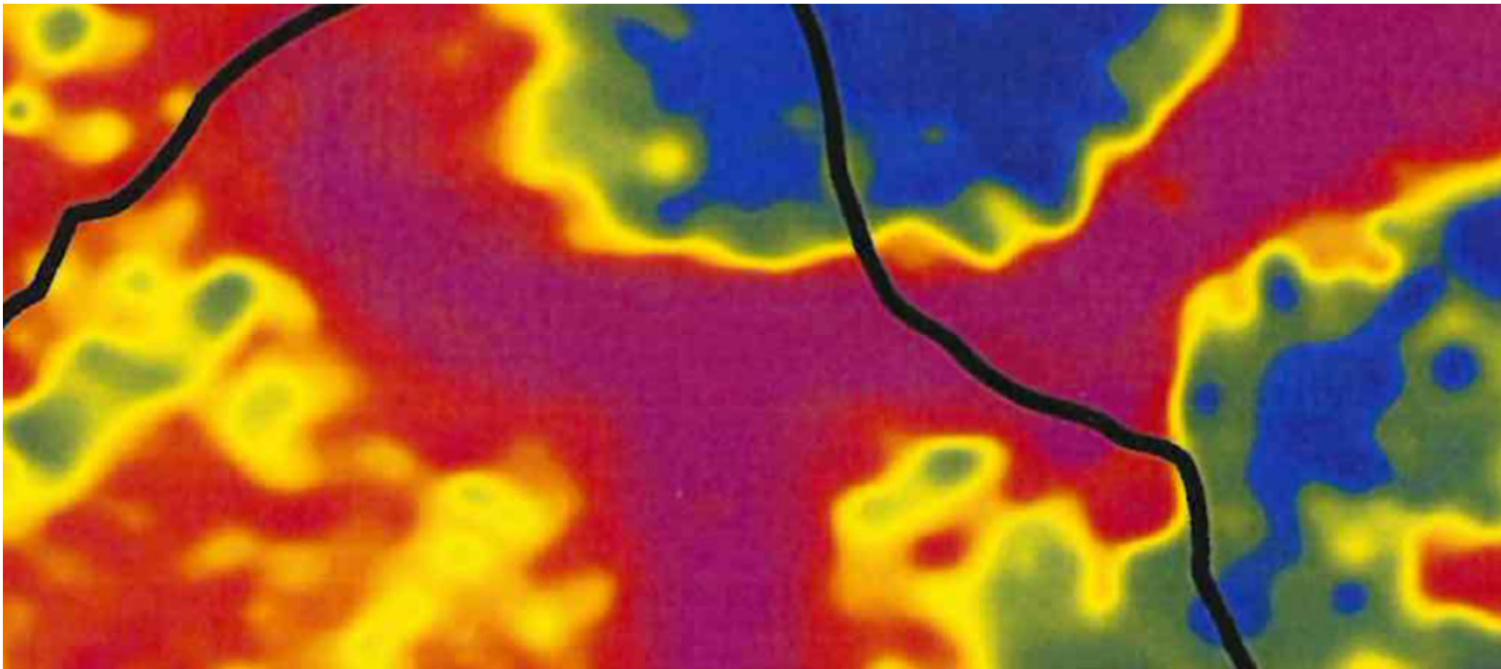
# 2004 Airborne Geophysical Survey - RESOLVE

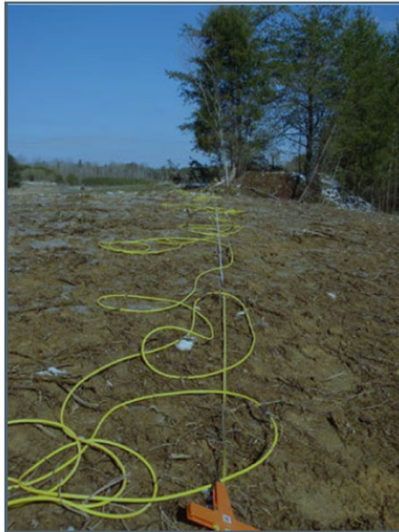
Figure 2. ERT setup on Line 3 SVC Site, Dunlap, TN

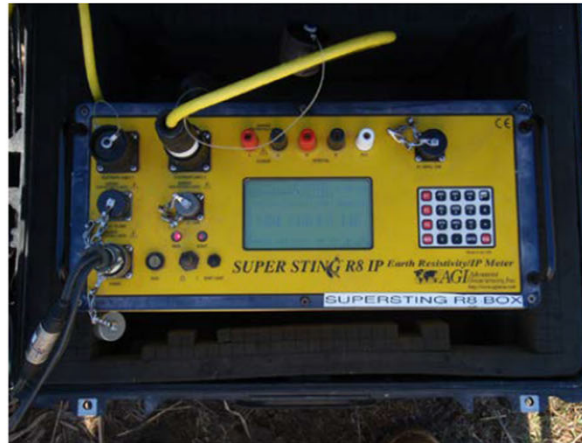
Figure 3. AGI Supersting RES/IP Meter

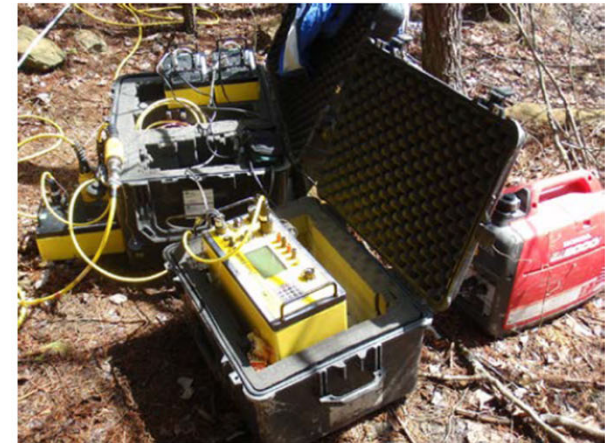
Figure 4. Complete equipment collecting data on Line 4, SVC Site Dunlap, TN

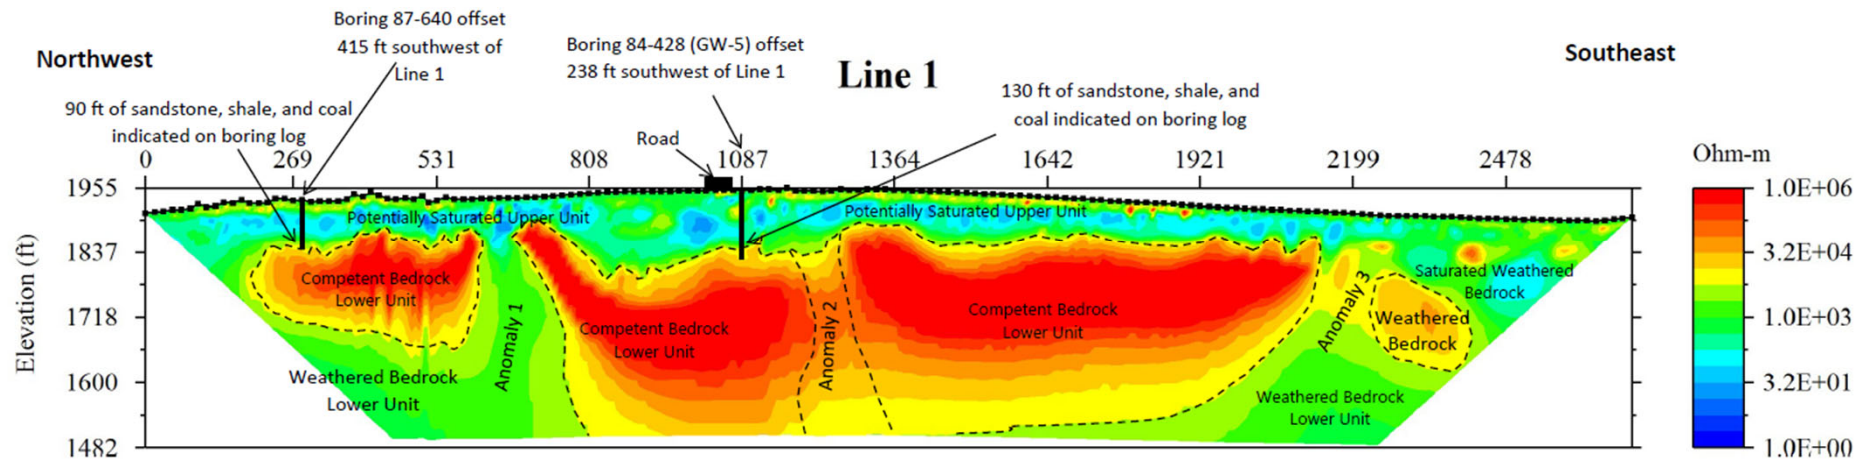
# Electrical Resistivity Cross-Section

However, test drilling postponed – property control change

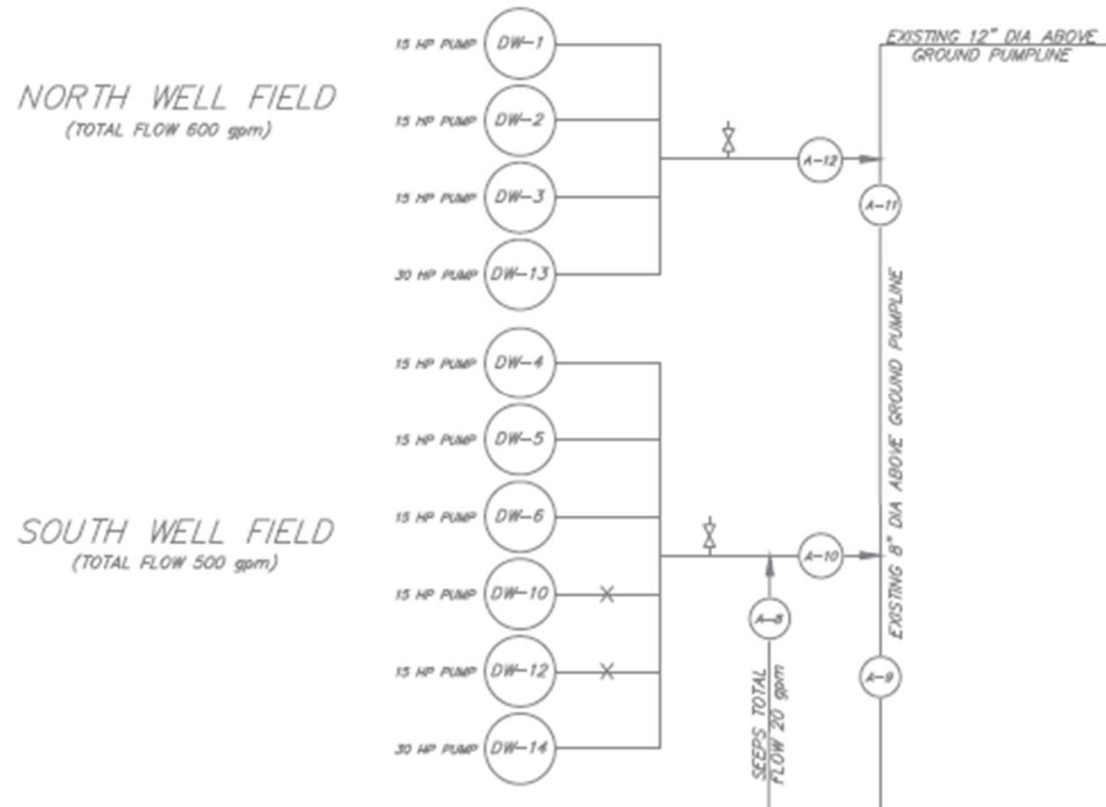
# Northern and Southern Pumping Fields

- **Backfill water levels tracked for decades**
- **Seasonal variances could exceed 30 feet (10 meters)**
- **Pumping system rates at both field < peak infiltration**
- **Addition pumping capacity recommended at both fields**
- **NTEC agreed and pursued additional pumping capacity**

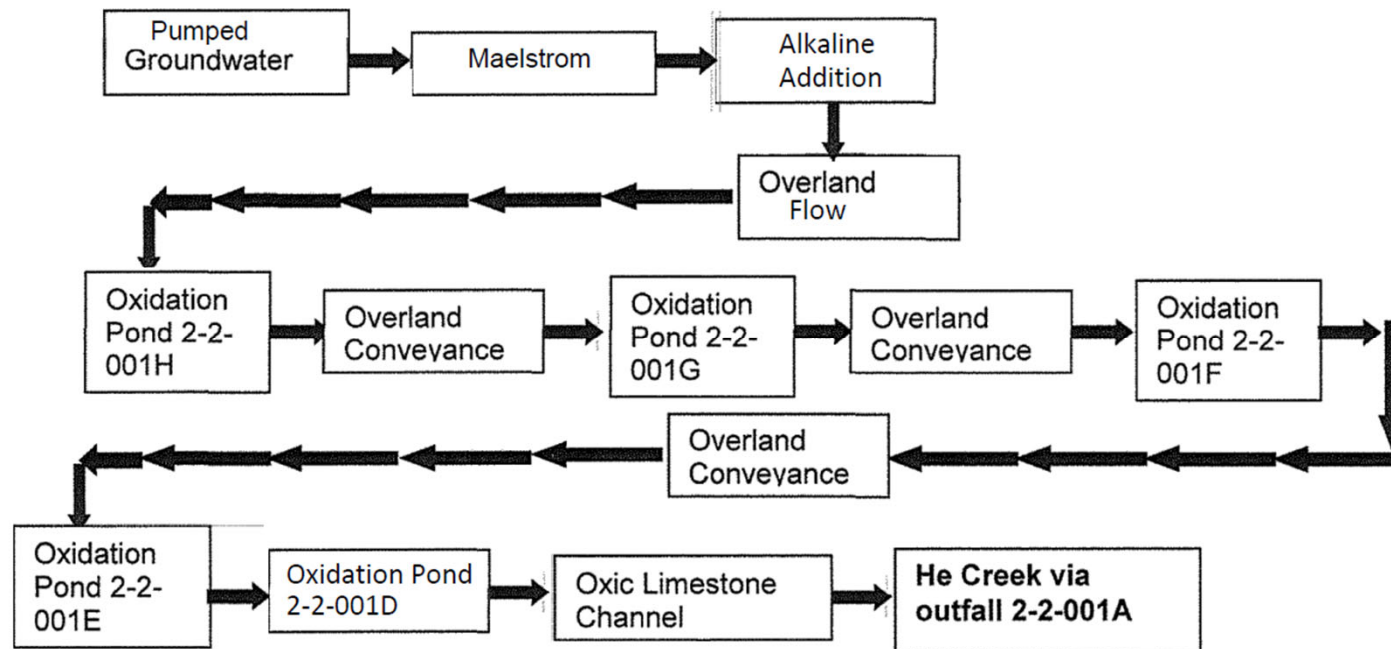
# Pumped Water Treatment Flow Diagram

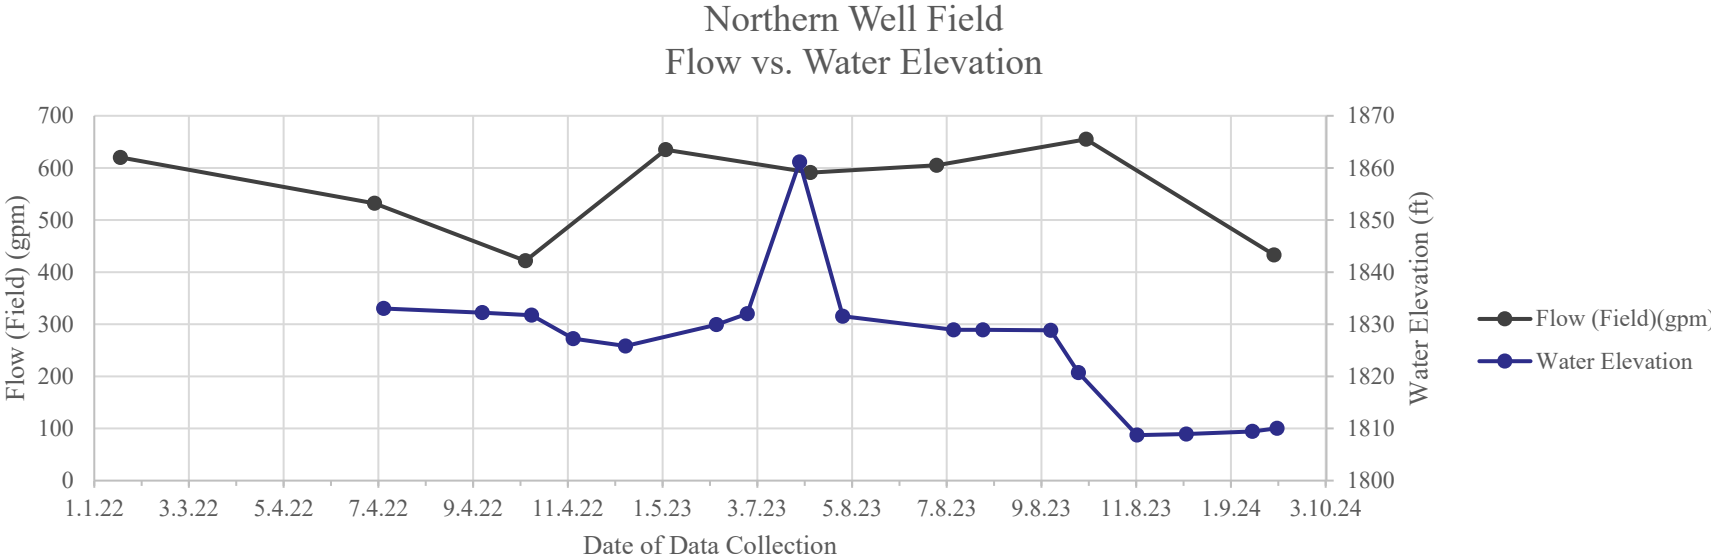
# Northern Well Field Elevations and Flows

- **Drawdown aided by near draught conditions late 2023 through early 2024**
- **Pumping capacity increased by 200 GPM+/- at each field**
- **Backfill groundwater elevation reached 30-year low**

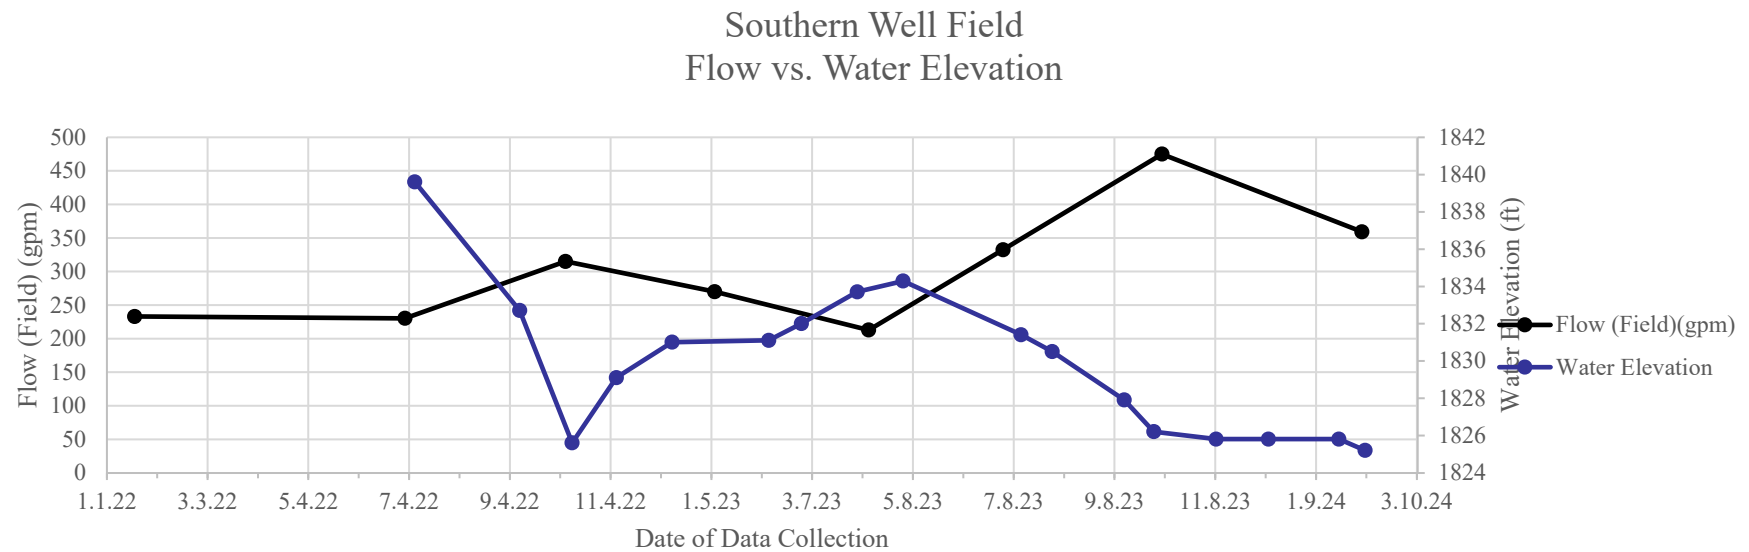
# Southern Well Field Elevations and Flows
