## Sandy Creek restoration – the tale of two acid mine drainage treatment systems

BENJAMIN FANCHER – WVDEP OFFICE OF SPECIAL RECLAMATION  
MONDAY APRIL 22, 2024

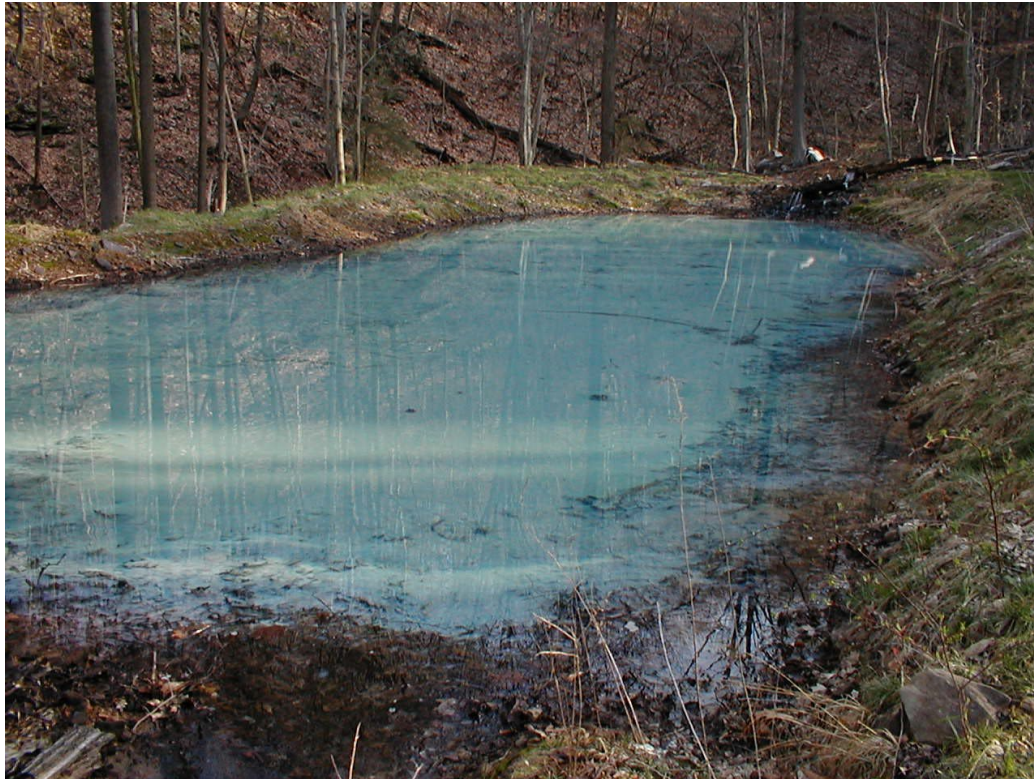
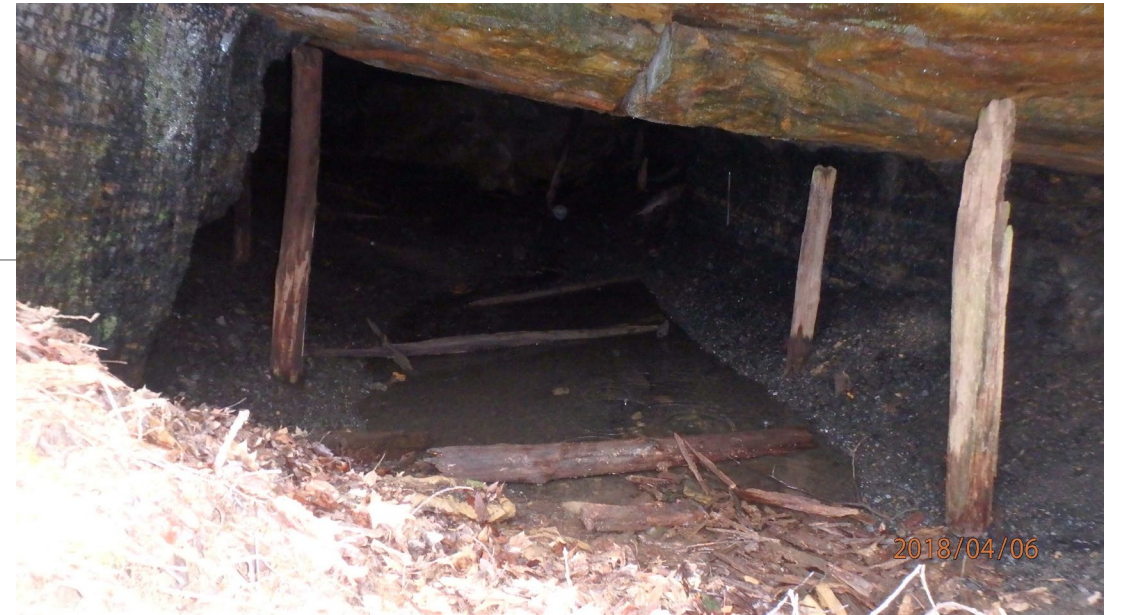
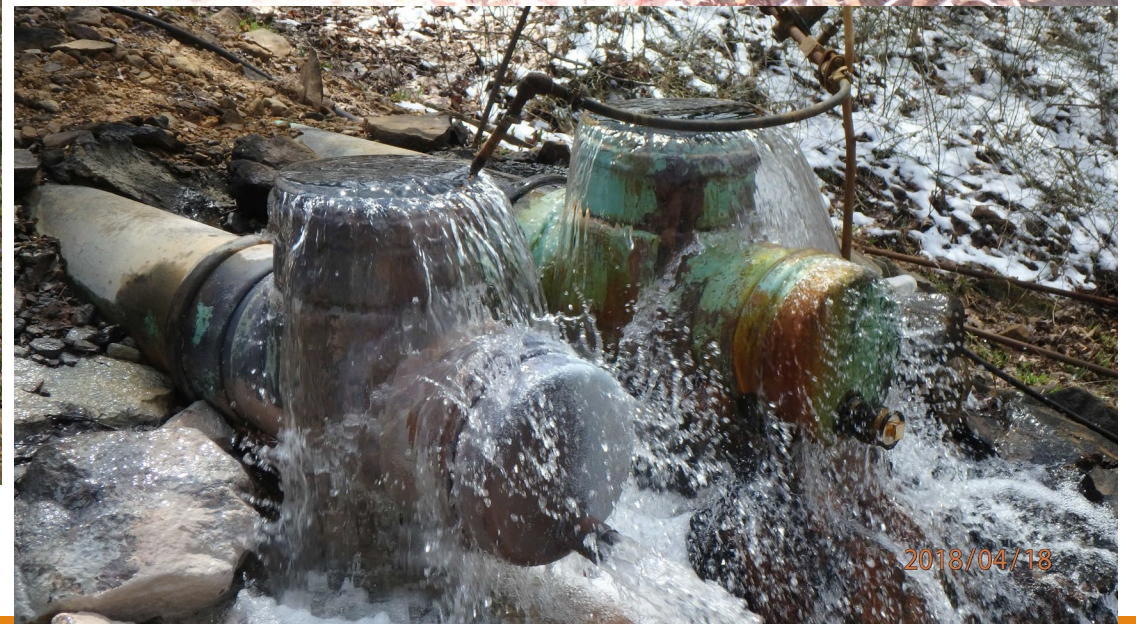
# F&M Coal

- In 1984, F&M Coal obtained surface coal mining permits for operations within the headwaters of Left Fork Sandy Creek.
- By 1989, substantial increases in acidity and total iron concentrations within Left Fork Sandy Creek.
- In 1992, the mining permits were revoked and coal mining operations ceased. OSR was responsible for the land and water reclamation liabilities abatement.
- The same year, the Laurel Mountain-Fellowsville Area Clean Water Association (LMFACWA) was formed. Through litigation, they were awarded damages from F&M Coal's insurer. The Laurel Mountain Trust, established between LMFACWA and WVDEP, spans a 90-year term with an initial joint investment of nearly 3.5 million dollars (USD).

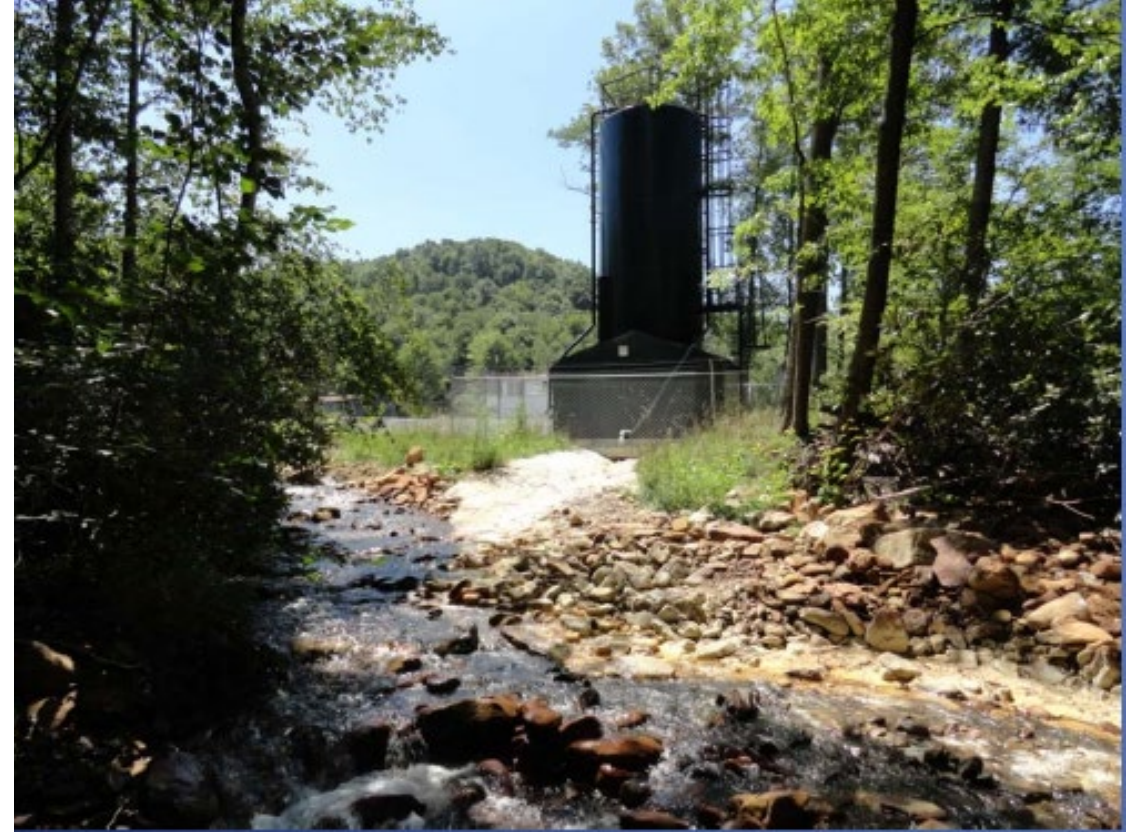
Birds Creek South Fork Outlet (WVDEP AML)

In the late 2000s, a watershed AMD treatment initiative was undertaken in the Three Forks Creek watershed lead by WVDEP AML. The innovative approach involved utilizing in-stream dosers to calcium oxide (CaO) to elevate the pH. The primary aim was to improve the water quality of the Three Forks Creek to facilitate the return of benthic macroinvertebrates and fish species.

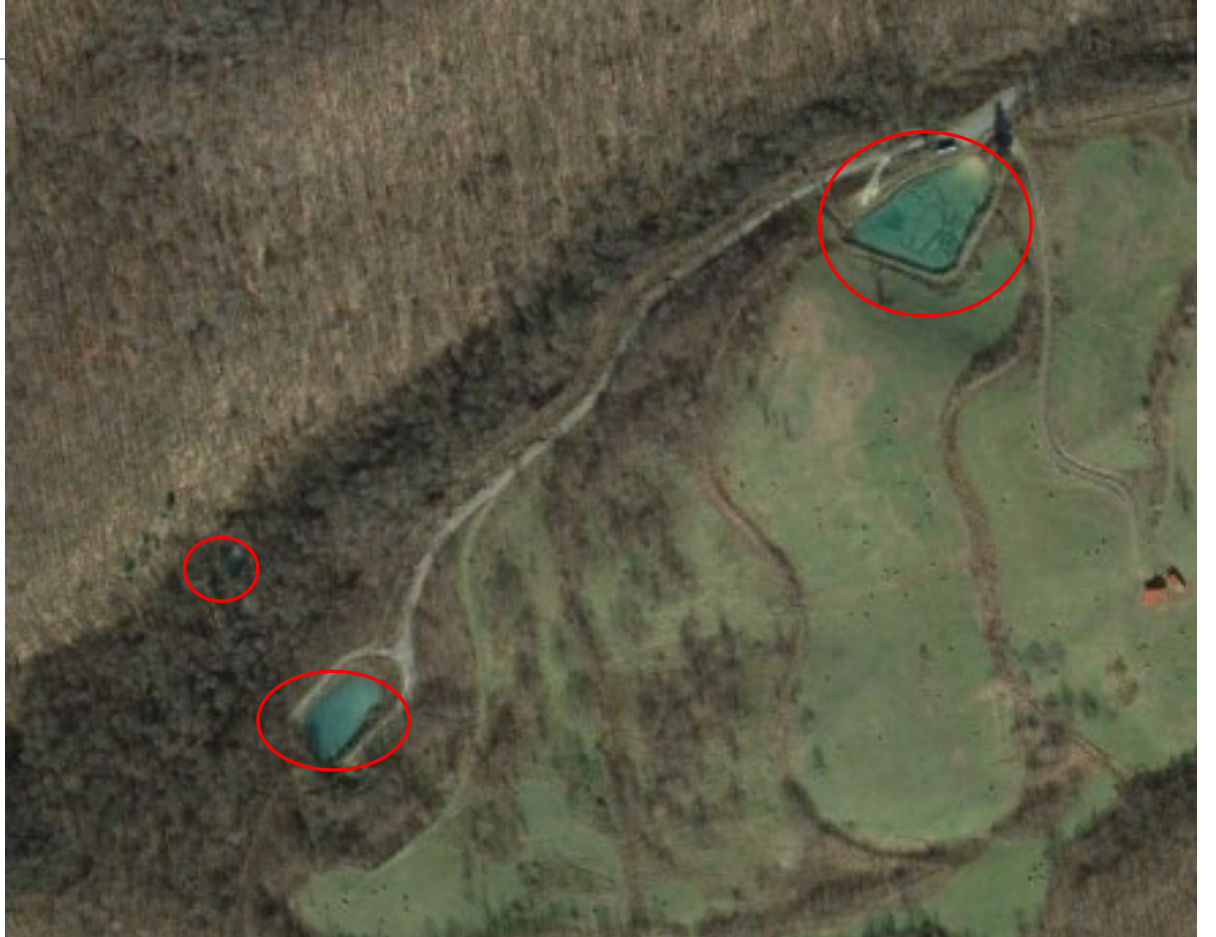
Between late 2017 and spring 2020, extensive construction took place at F&M Coal mining permits to retrofit AMD treatment.

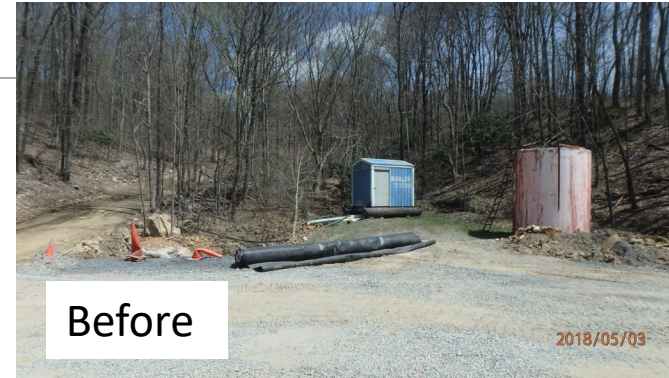
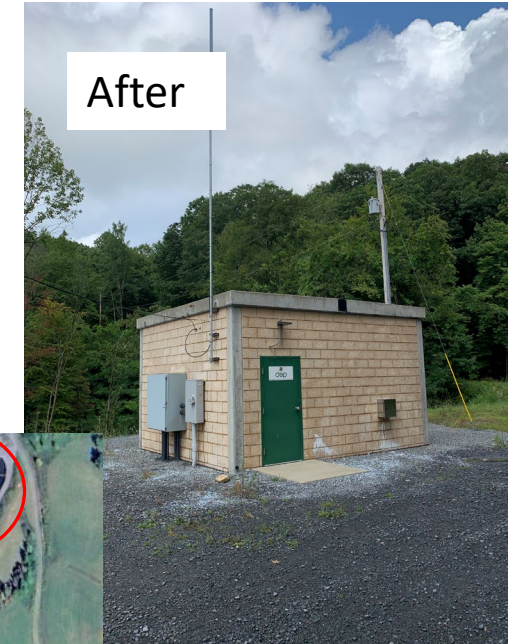
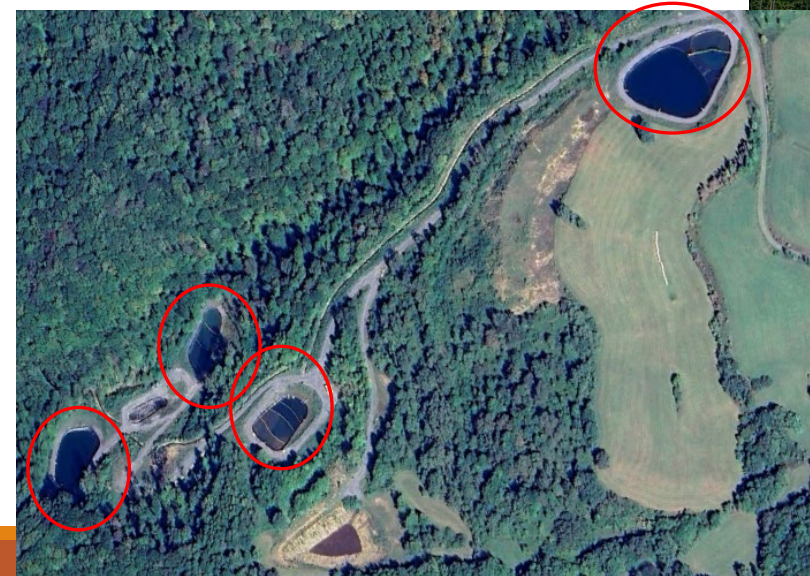
# F&M Coal (S-57-84) Before and After Retrofit

Buildings A and B each address distinct locations within the permit area.

- Building A handles mine water from underground mine portal and S-1073-86
- Building B addresses AMD from the bottom of the pit location on S-57-84 and cracks in rock outcroppings above Left Fork Sandy Creek.
- Both buildings utilize lime slurry for AMD treatment, adjusted based on pH monitoring. After two years, trials switched to sodium hydroxide for more adaptable treatment based on variable AMD flows. Treated water passes through settling ponds and limestone aggregate filters before discharge, with sludge pumped into a centralized cell.

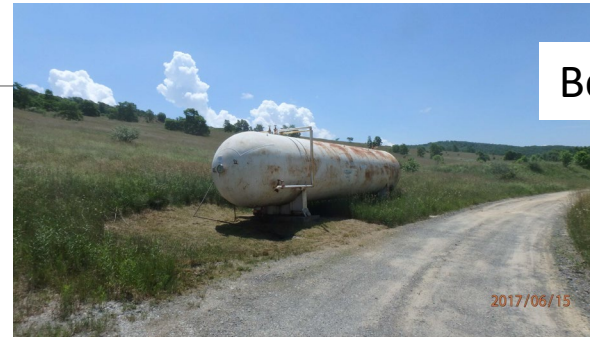
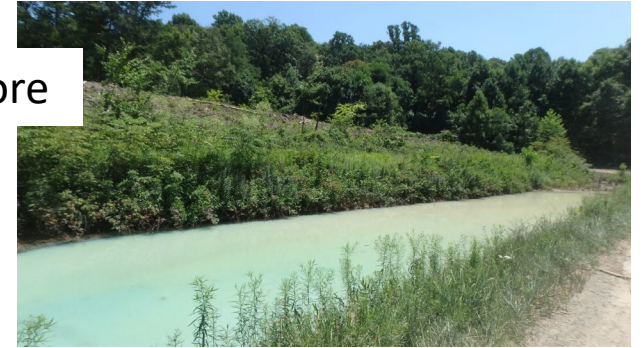
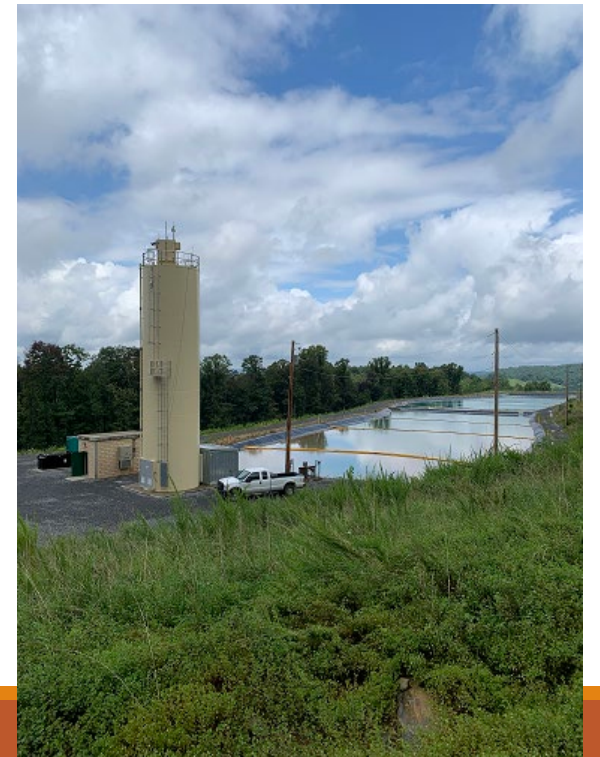
# F&M Coal (S-1044-87) Before and After Retrofit

At S-1044-87, the main silo employs a high-density lime slurry system, treating AMD from the pit, an open ditch collecting various seeps around the reclaimed pit, and a lift station.

Building C treats AMD from underground mine portals. Both buildings utilize lime slurry, with Building C receiving it from the main silo. Treatment is pH-controlled, with lime slurry pumped from storage tanks to mix tanks where it meets the AMD. Treated water undergoes settling in ponds and limestone aggregate filters before discharge, and sludge is regularly pumped into cells around the permit.

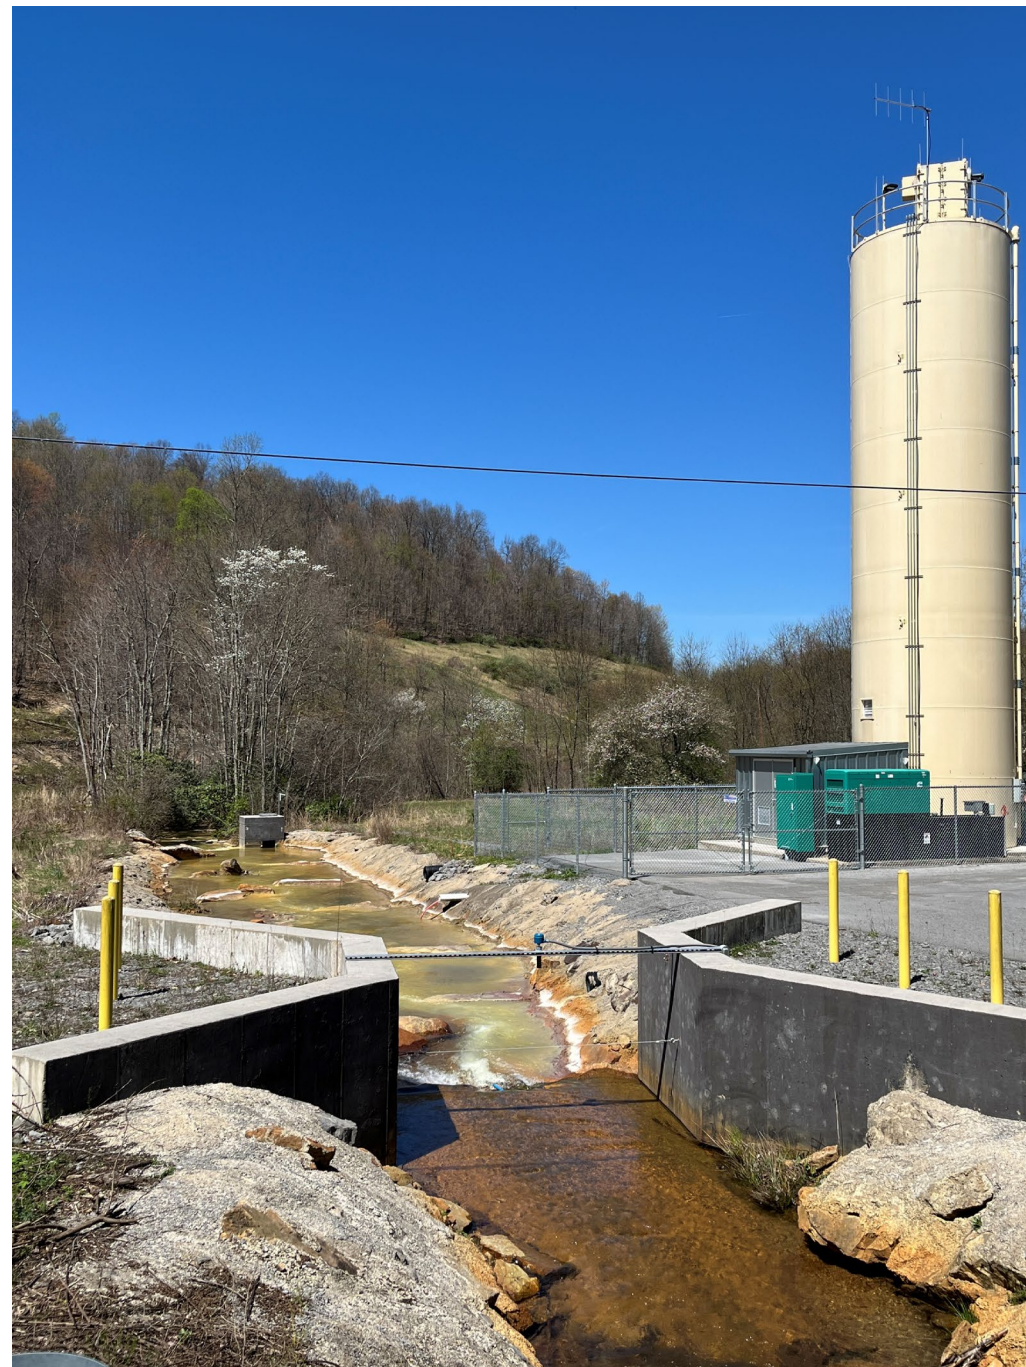
# LFLS In-Stream Doser

- The LFLS in-stream doser employs a high-density lime slurry system, differing only in the absence of a rapid mix tank from the main silo at F&M Coal.
- Lime slurry is pumped directly into the stream, with pH control approximately 150 feet downstream.

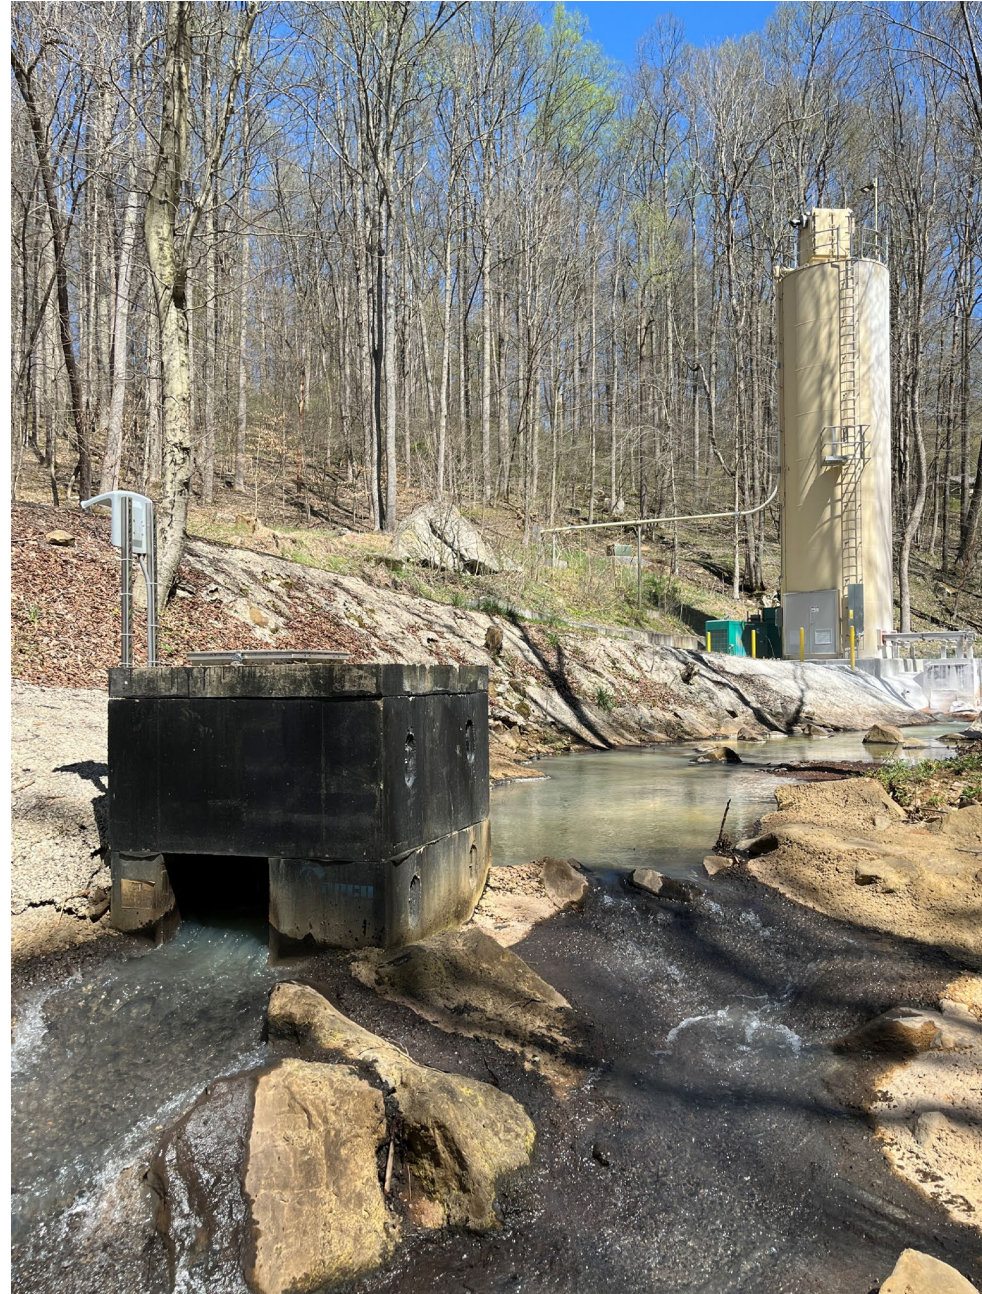
# Maple Run In-Stream Doser

- The Maple Run in-stream doser is a hydrated lime mechanical feed system with a smaller silo.
- The chemical is fed directly into the stream, concentrating the flow for efficient mixing. Downstream, the pH-controlled system mirrors the LFLS in-stream doser.

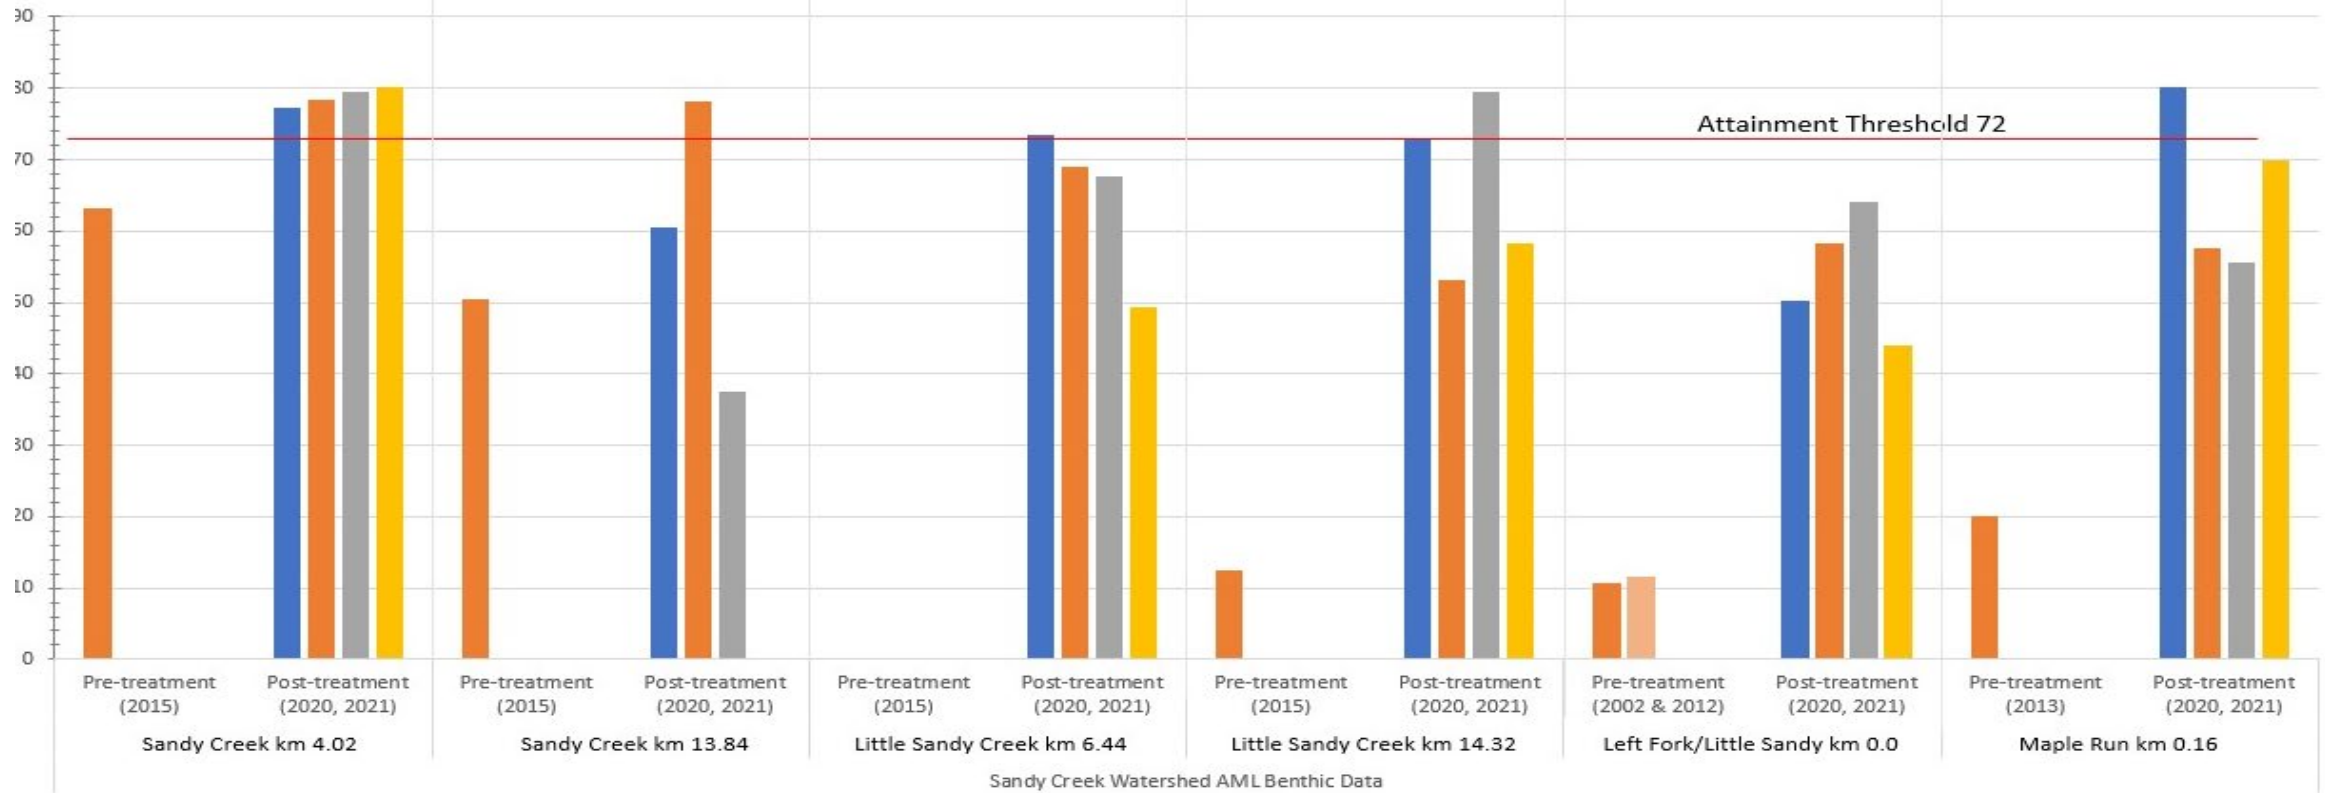
## WVSCI – Sandy Creek Watershed Stations

- **WVSCI** is an Index of Biotic Integrity (IBI) that summarizes the health of the aquatic life community using samples of the benthic macroinvertebrate community.
- Water treatment facilities at F&M Coal, operational since spring 2020, consistently discharge below NPDES limits. LMFACWA monitoring below the facilities observed increased benthic macroinvertebrates since construction was completed in 2020. At an April 2022 event with local a 4-H (youth development organization) chapter, LMFACWA conducted benthic surveys indicating improvements in pollution intolerant species and increased species diversity. Although not fully restored to pre-mining conditions, the watershed exhibits enhanced ecological attributes.
- Data collected by WVDEP WAB and prepared by Jeff Bailey.

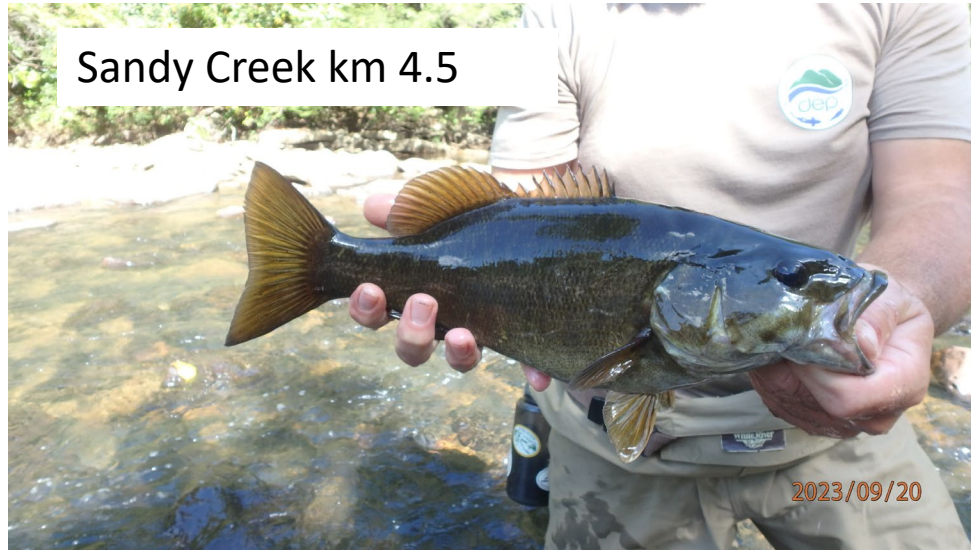
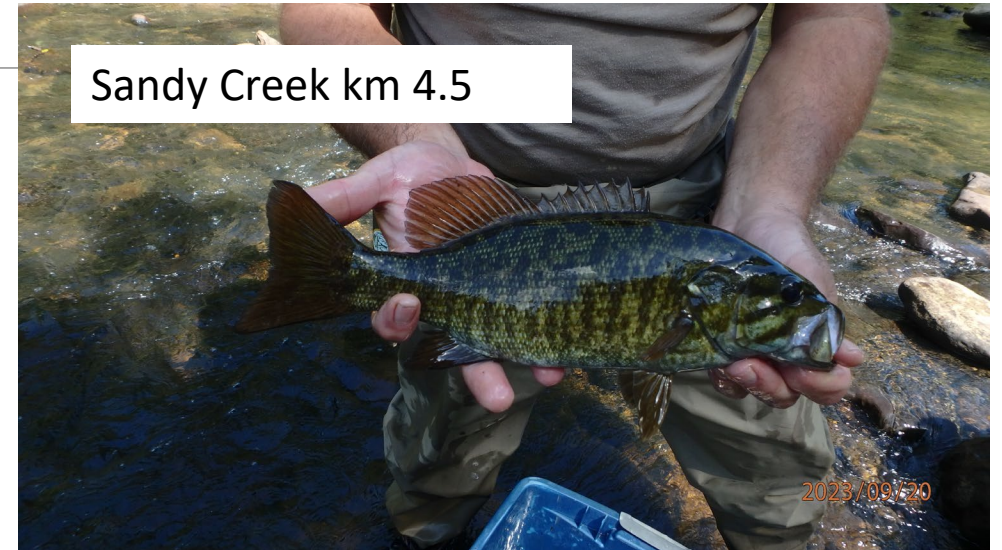
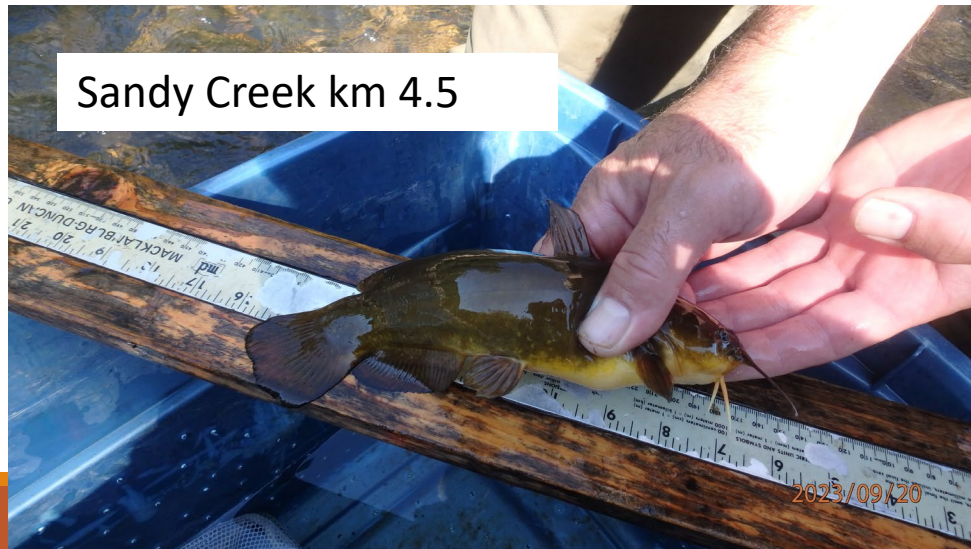
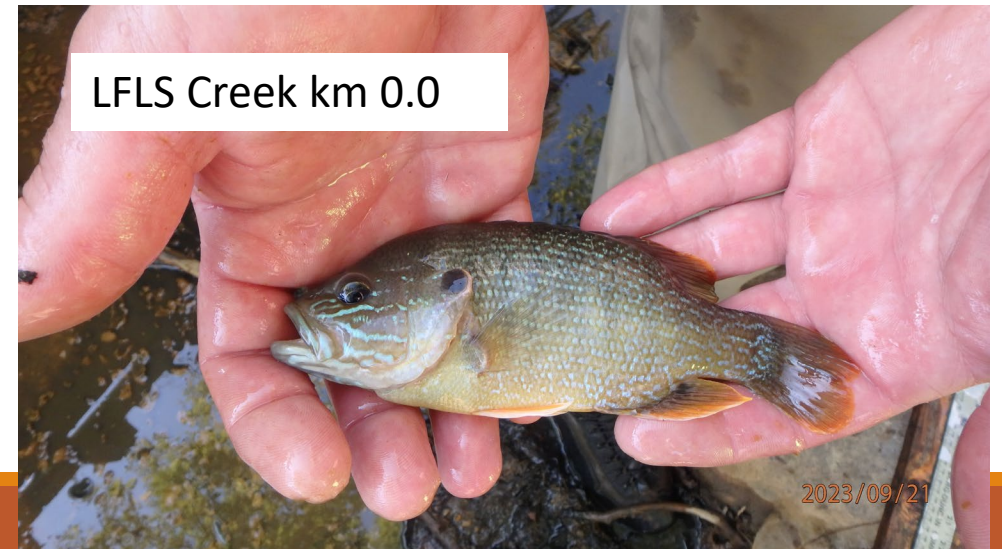
# Fish of Sandy Creek and LFLS Creek

- Significant fish community improvements have been demonstrated at all sample stations when comparing pre- and post-treatment samples.
- No fish were observed at any sample station in 2013 and 2015 except for Sandy Creek at Mile 8.6. That sample station was surveyed as a baseline control because it is upstream of the Little Sandy Creek watershed AMD sources.
- 2023 data from Sandy Creek at mile 2.5 has not been fully identified and is highlighted in blue. Only field data is displayed in the table.

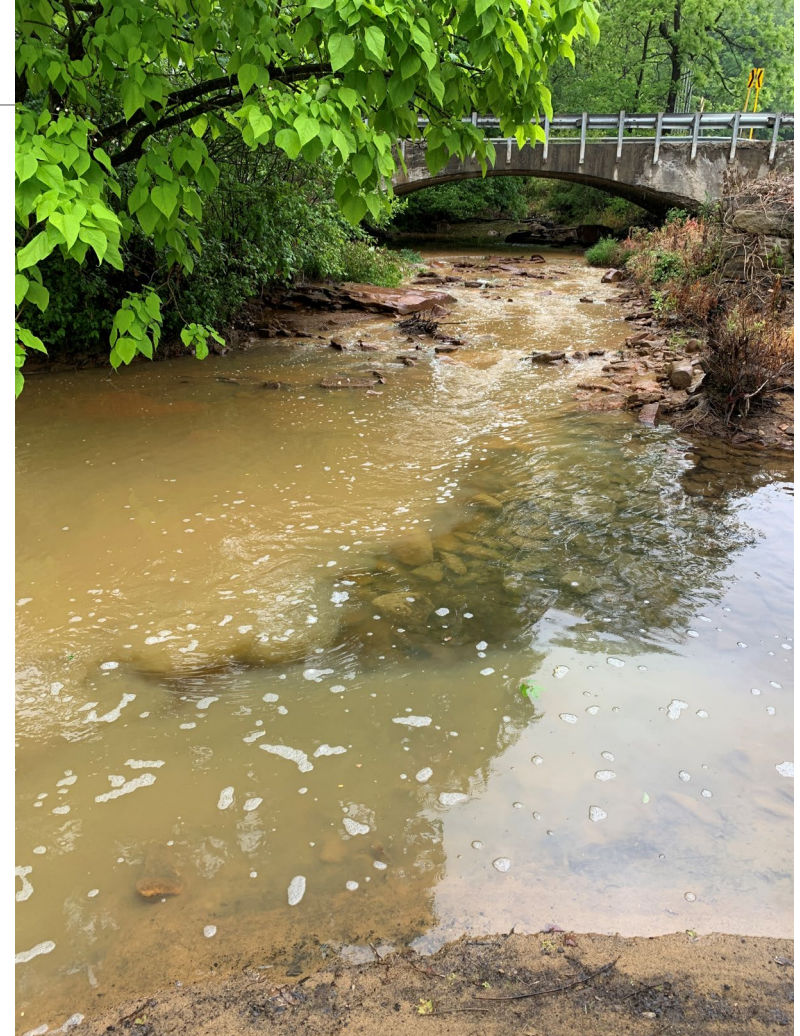
OSR, in collaboration with WVDEP AML&R, is constructing an in-stream water treatment facility to address this issue. The facility will settle sludge and return clear water to the stream. Sludge will be disposed of in underground mine workings.

- Visual challenges persist in these streams due to sludge embeddedness from in-stream dosing.
- A known issue of in-stream treatment is the precipitation of metals with the stream channel below the dosers.
- Not anticipated as the high flow events to periodically flush out the stream are as variable through each season, specifically during the summer when the lowest stream flows occur.

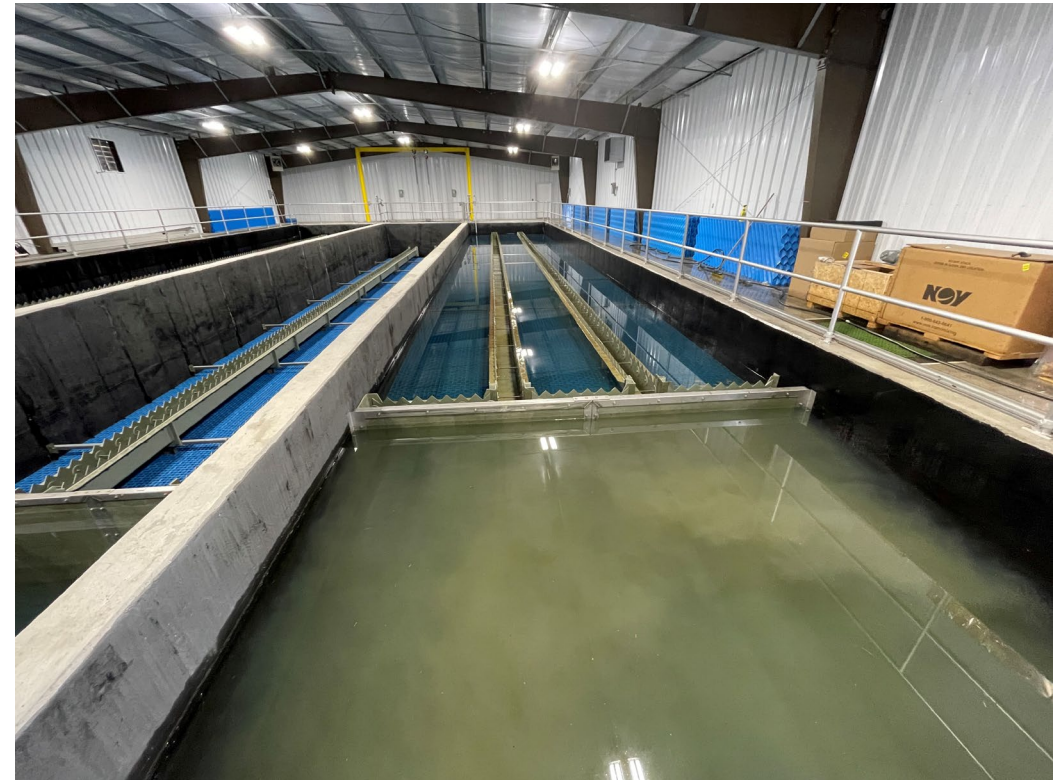
Rectangular clarifiers at Buffalo Coal (S-2003-88) which is like the design for LFLS clarifier.
