Cooperative Mine Land Reclamation Operations & Comprehensive Managed Watershed Planning

Michael Haney, P.G. PADEP BAMR

Todd Coleman, Minetech Engineers

Branden Diehl, Earth Wise Consulting, LLC

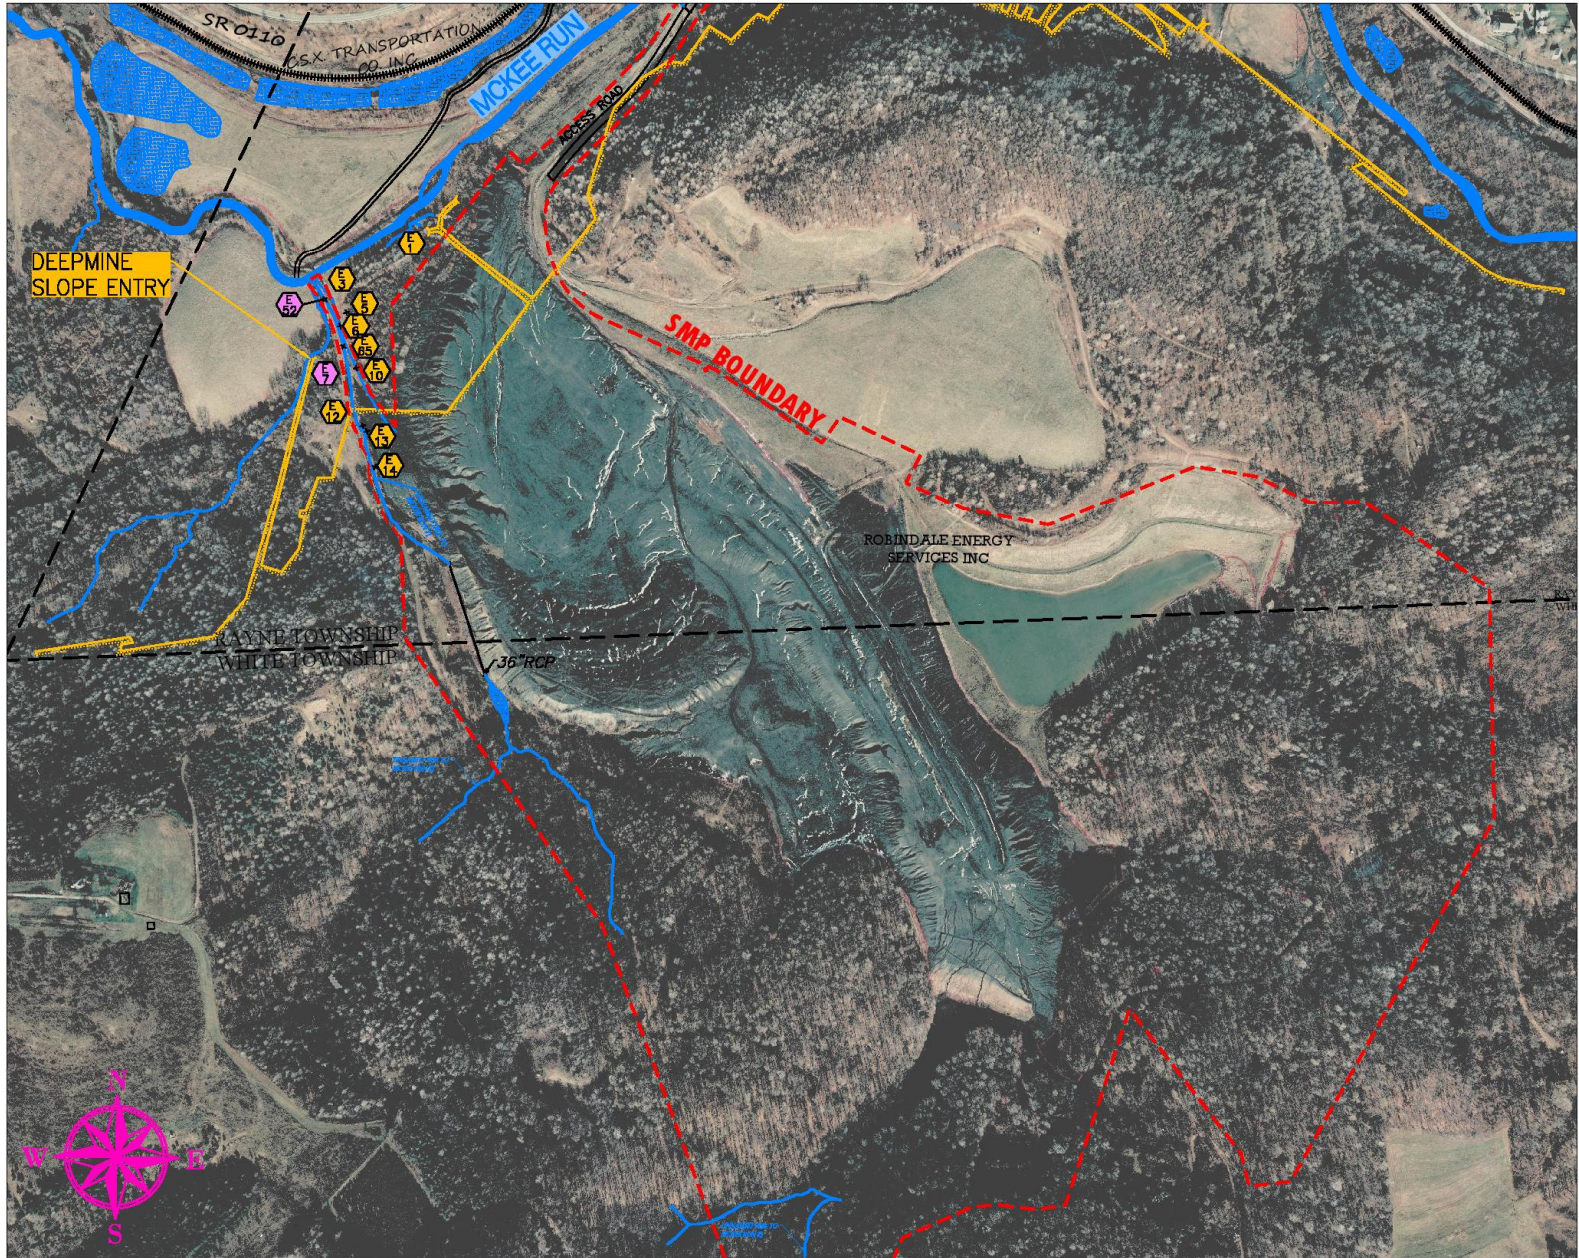
Surface: ERNEST REFUSE PILE

- 94 acres (38 ha) of accumulated coal refuse
- high BTU's, low sulfur concentrations
- Estimated volume = 11.4 million cubic yards (MCY) (8.6M m³)
(~94 acres at avg 100' (33 m) depth)
- Pronounced valley fill, interrupting surface drainage topography, unlined, uncontrolled E&S
- Overlying & Up-dip of the easternmost Ernest 2 & 3 Mine workings, to the south of McKee Run

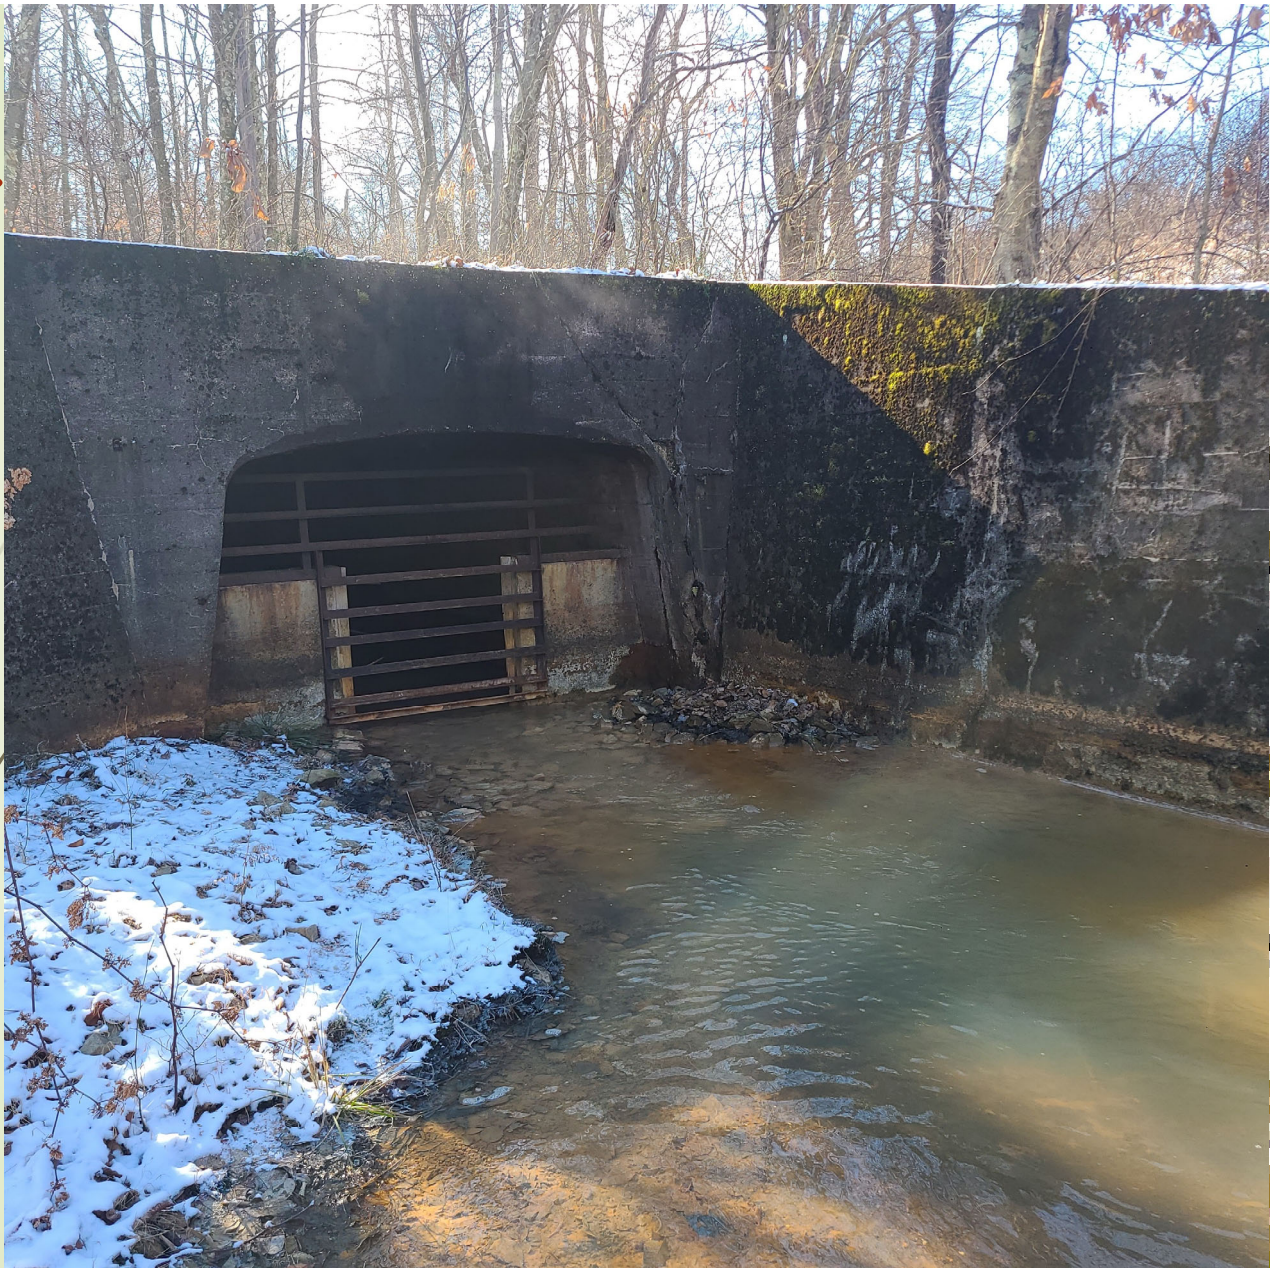
The Ernest Mine Portal

- ▶ Upper Freeport coal Mine Complex drift entry, free-flowing
- ▶ Up-dip of and higher topo elevation than Fulton Shaft (10 feet, 3 m) distance 1.4 miles (2.25 km)
- ▶ Estimated flow ~630 gallons per minute (post 2018) = ~907,200 GPD ; ~331,055,000 MGY
- ▶ Loading Rate ~ 77,500 Lbs. per year of iron, aluminum, manganese (McKee Run)
- ▶ Post 2014 chemical shift change in loading rate: 89% net reduction in Fe, Al, Mn – induced by refuse removal
- ▶ March 2018 Flow shift reduced average flow rates by ~ 50%

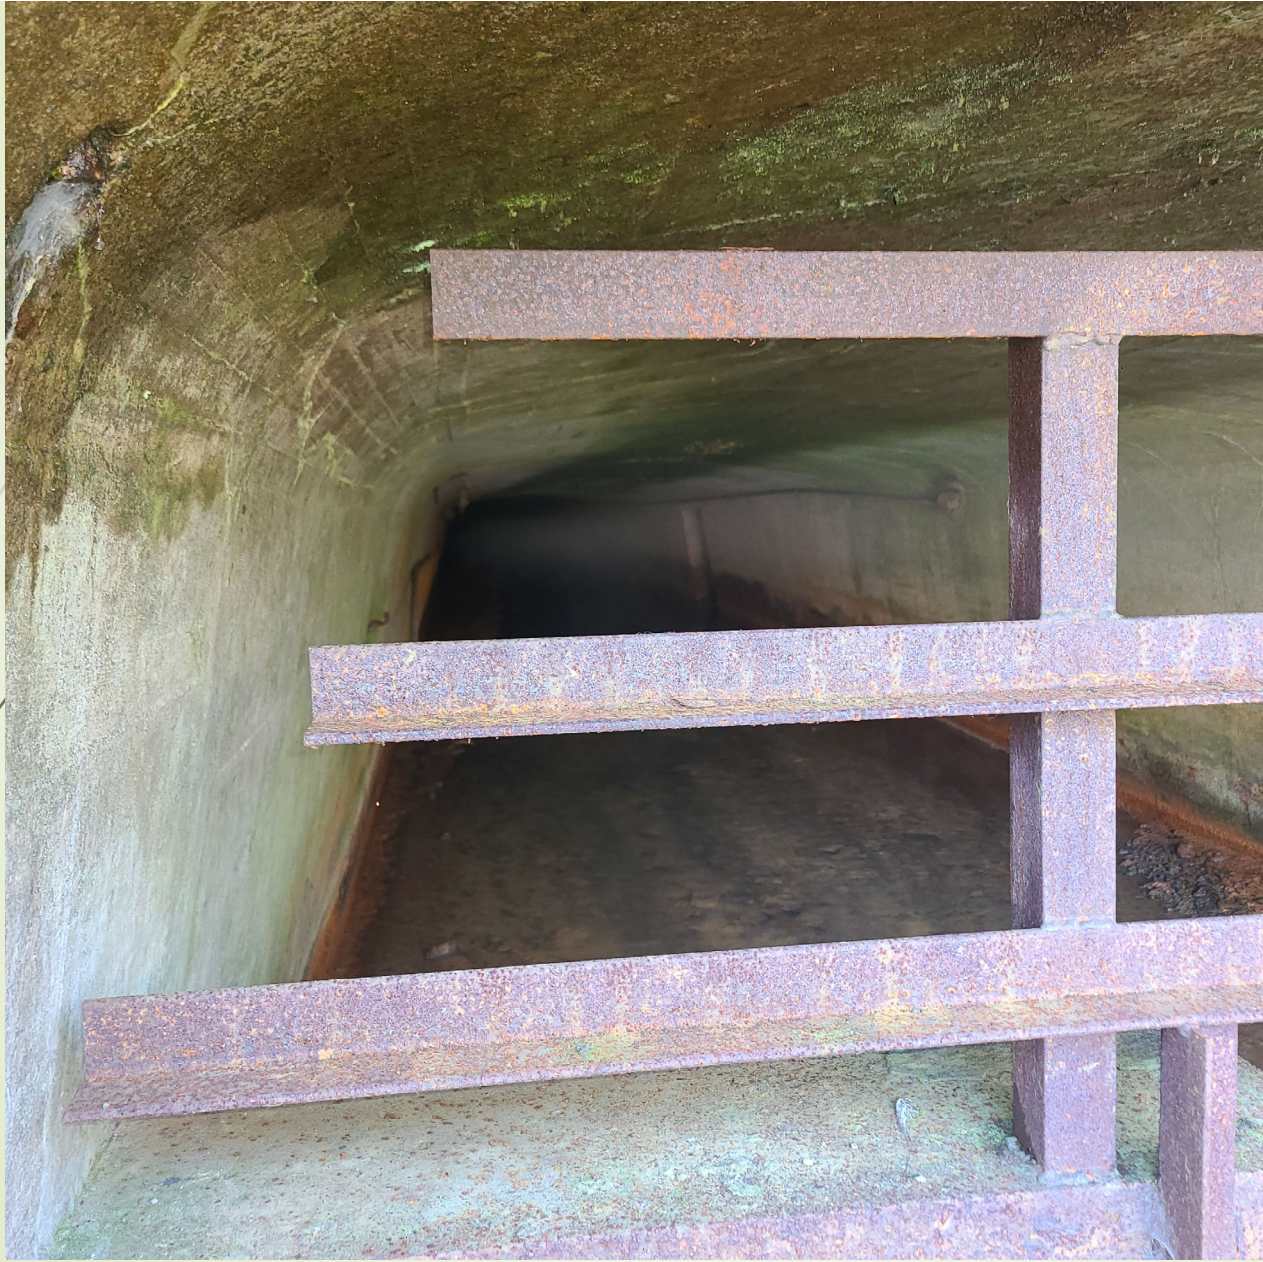
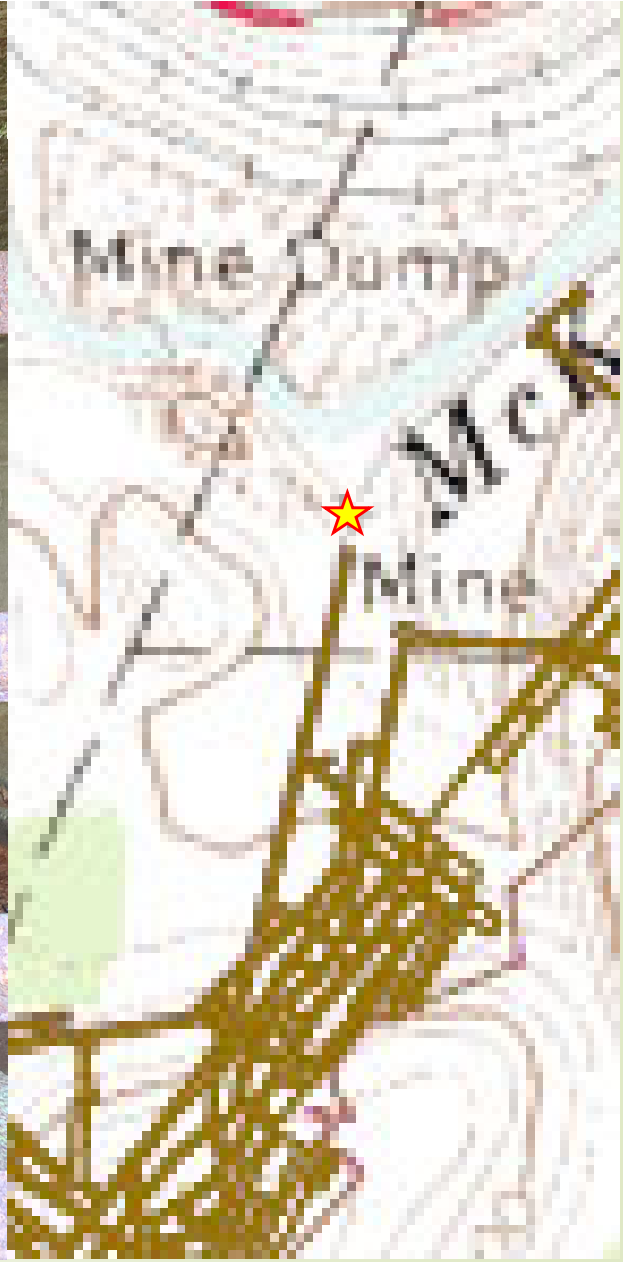
Ernest Mine Portal Chemistry

Pre-Reclamation Averages

- ▶ pH = 4.6
- ▶ Iron (mg/L) = 83.6
- ▶ Aluminum (mg/L) = 26
- ▶ Manganese (mg/L) = 2.7
- ▶ Acidity (mg/L) = 306.2
- ▶ Sulfate (mg/L) = 751
- ▶ Total Suspended Solids (mg/L) = 45

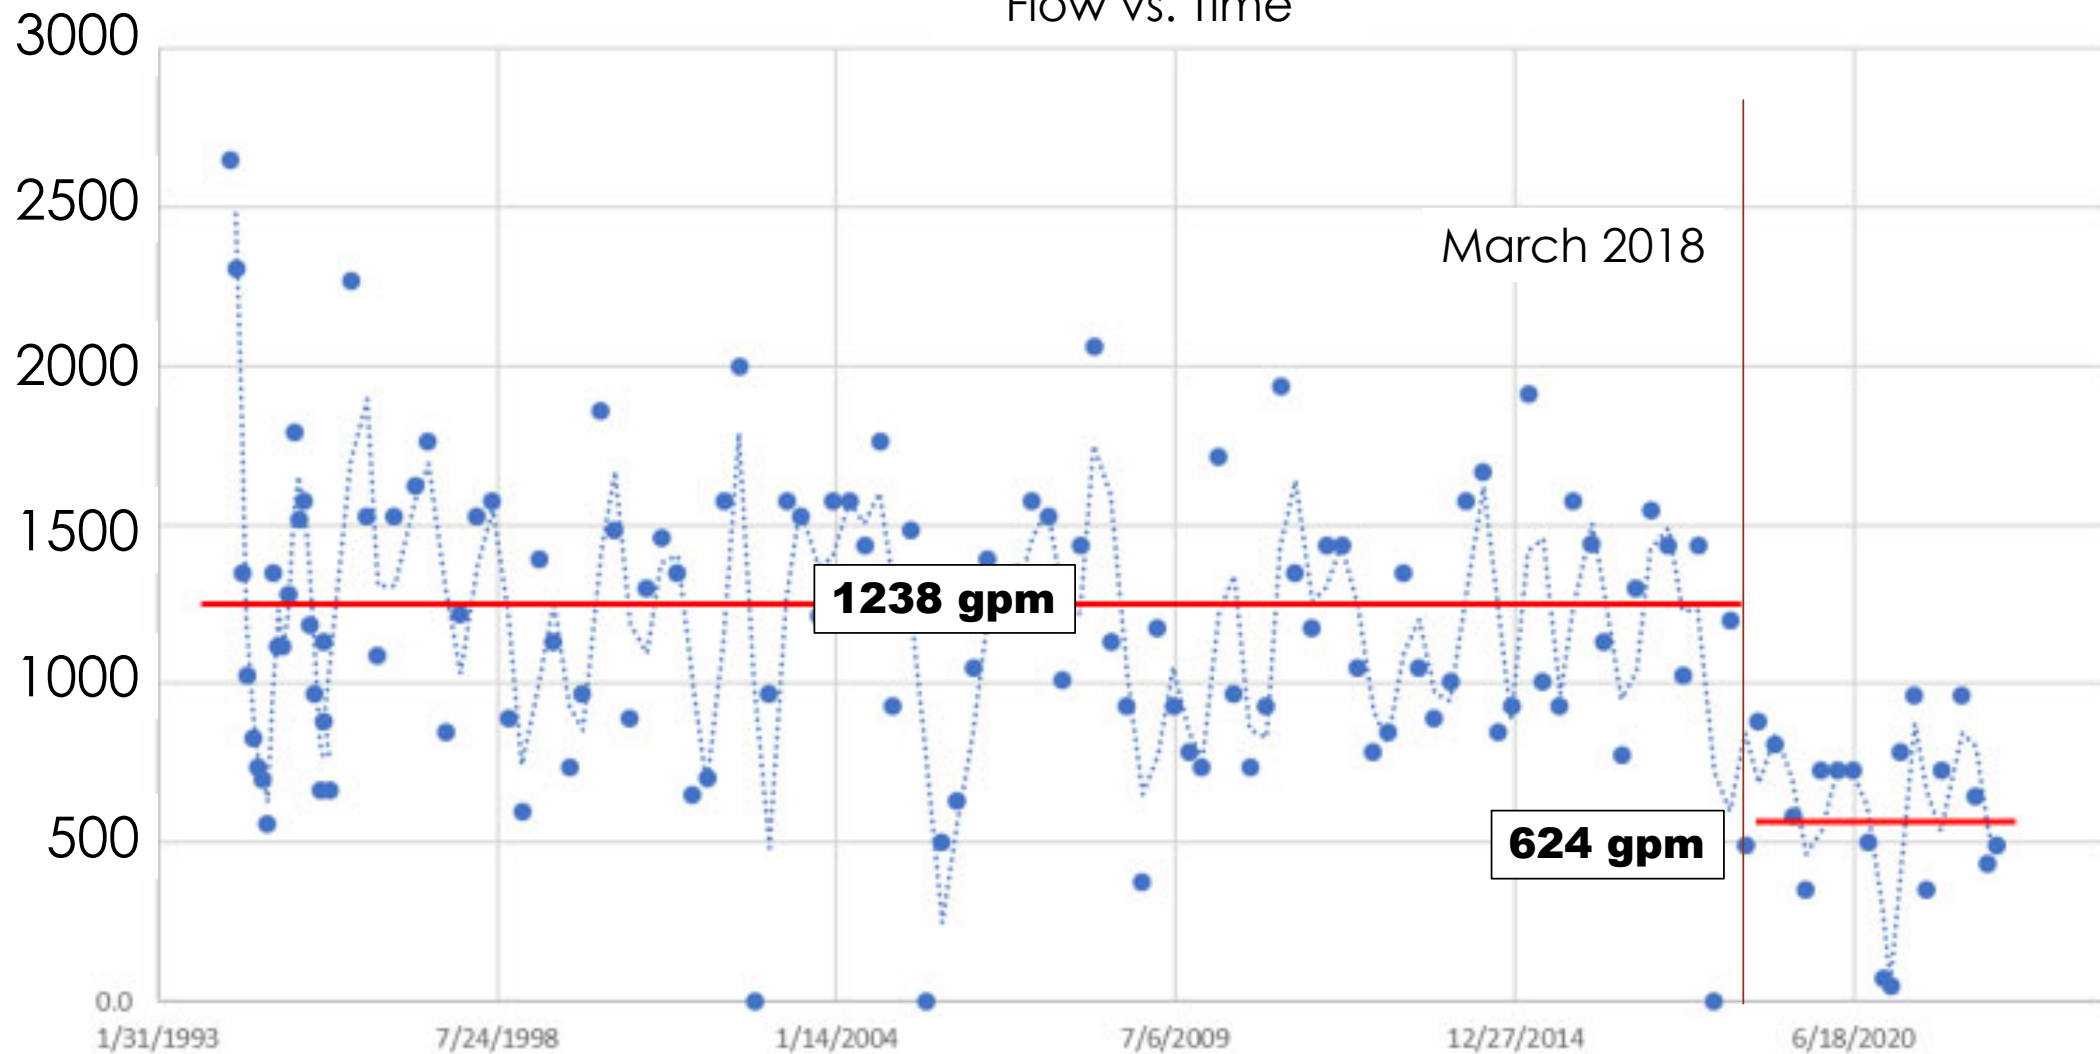
Ernest Mine Portal Flow vs. Time

- **March 2018**
 - **Torrential downpour in mid-March overwhelmed the Erosion and Sedimentation structure capacity**
 - **Erosional scouring = sedimentation blockage of the Ernest Portal, backflow into mine workings**
- Ernest Portal flow reduced by **50%**
- Fulton Run flow Increased to **~215%***

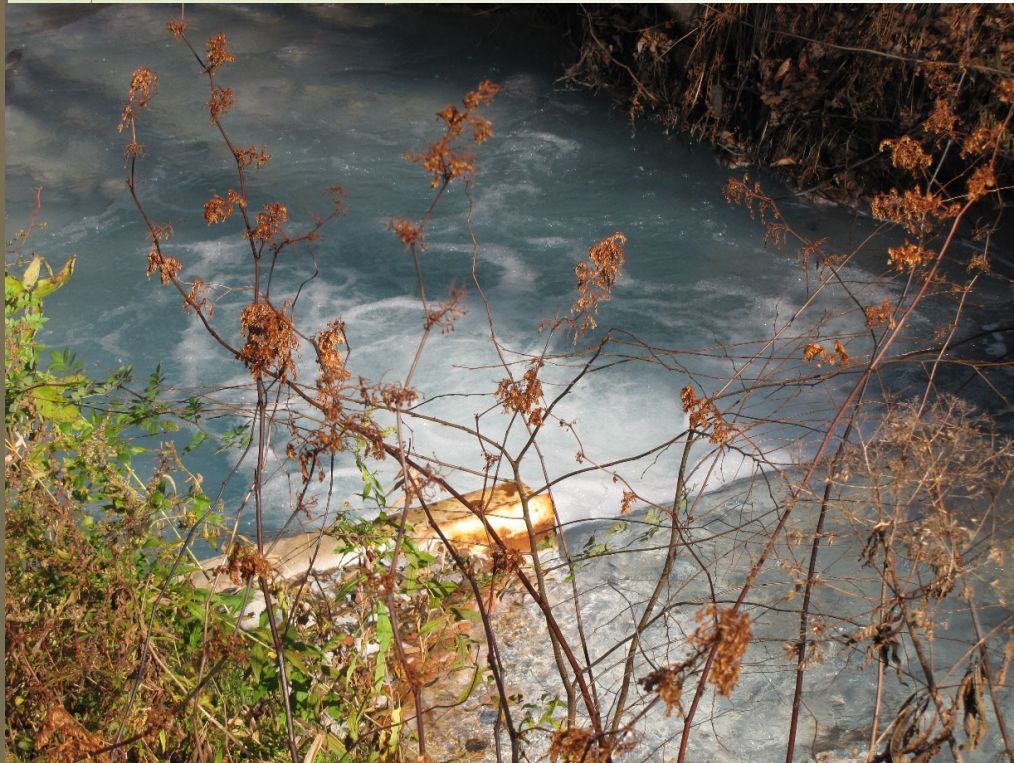
St. Michaels AMD Treatment System Cambria County PA

- Treats up to 10,000 gpm
- Industry built
- Reduces loadings by 33 to 40 %
- Fe from 150+ mg/L to 1.5
- Jump started full watershed restoration
- End-of- mining strategy
