Justine I. McCann and Robert W. Nairn

International Mine Water Association Meeting

April 23, 2024

# Metal Loads Accounting at a Legacy Mine Site: The Tar Creek Superfund Site, Oklahoma, USA

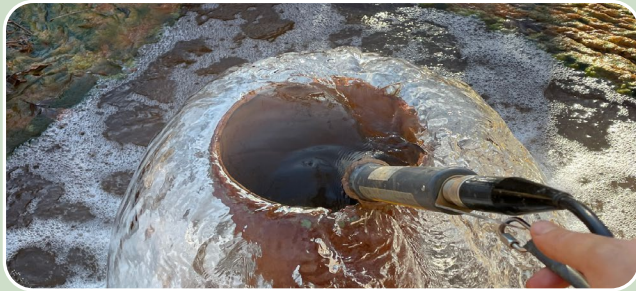
## Groundwater

- Diversion of Lytle Creek
- Surface water deemed “irreversibly damaged”
- Plugging of potential threats to drinking water

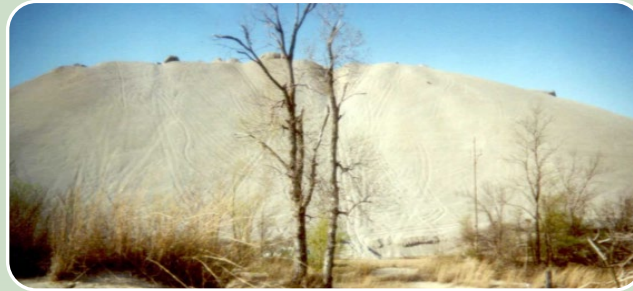
## Mine, Mill, and Smelter Waste

- Removal of waste
- Reuse programs

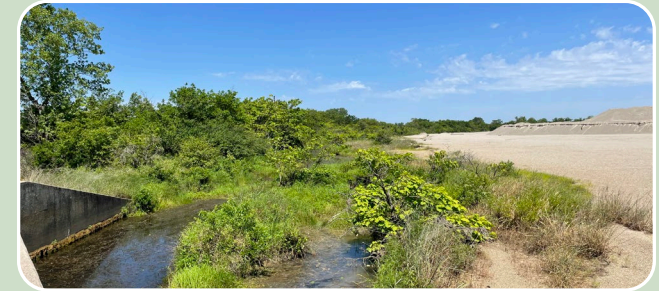
## Surface Water and Sediments

- Remedial investigation ongoing
- Interim measures

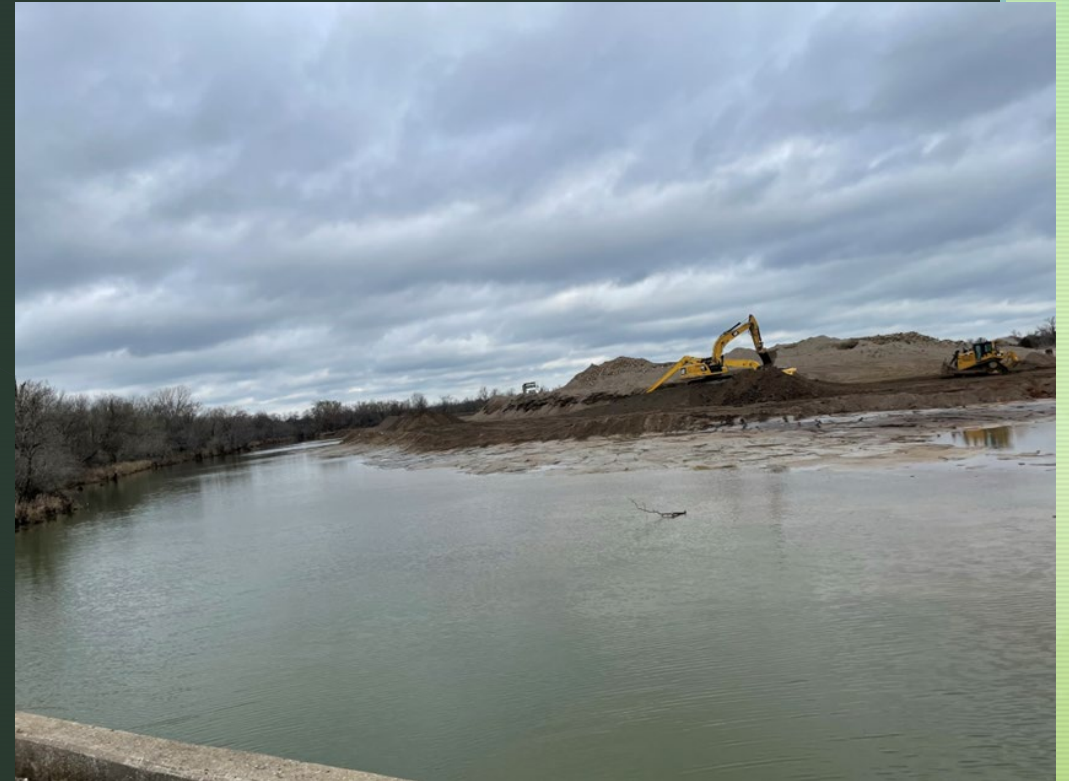
- **Artesian discharges**
  - Passive treatment
  - Identifying inflows and outlets
- **Surface piles of mine waste**
  - Mine waste runoff study
  - Sieving operations
  - Dig and haul
- **Sediment and surface water**
  - Removal of mine waste from stream

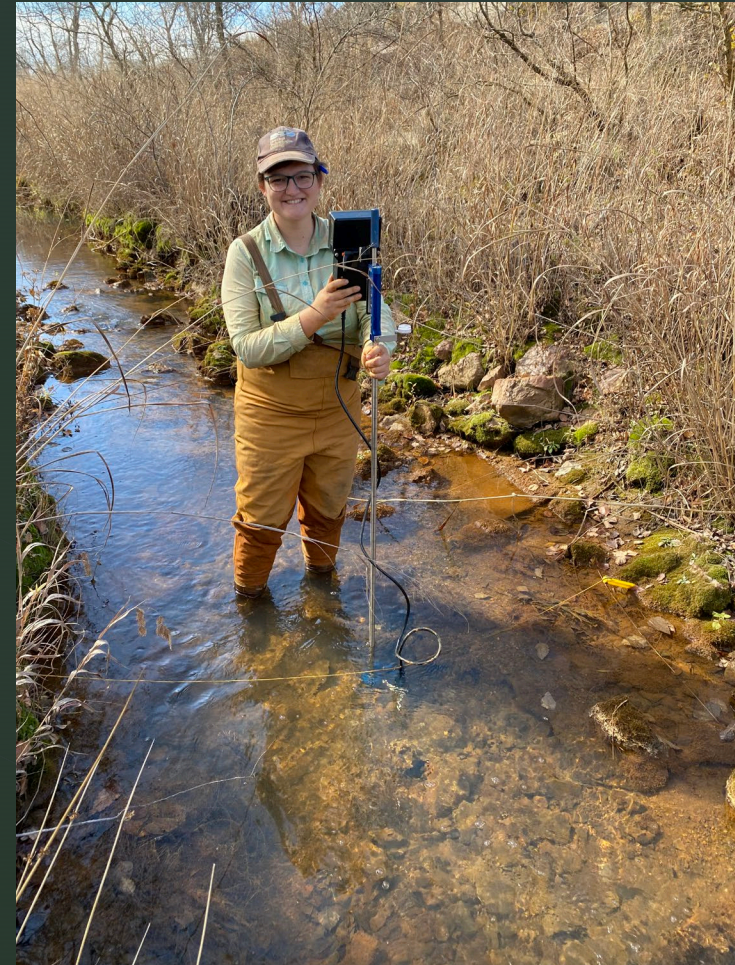
- Flow measurements -- acoustic doppler velocimeter
- Metals concentrations via ICP-OES
- Loads = concentrations x flows
- Expected load = upstream load + tributary load

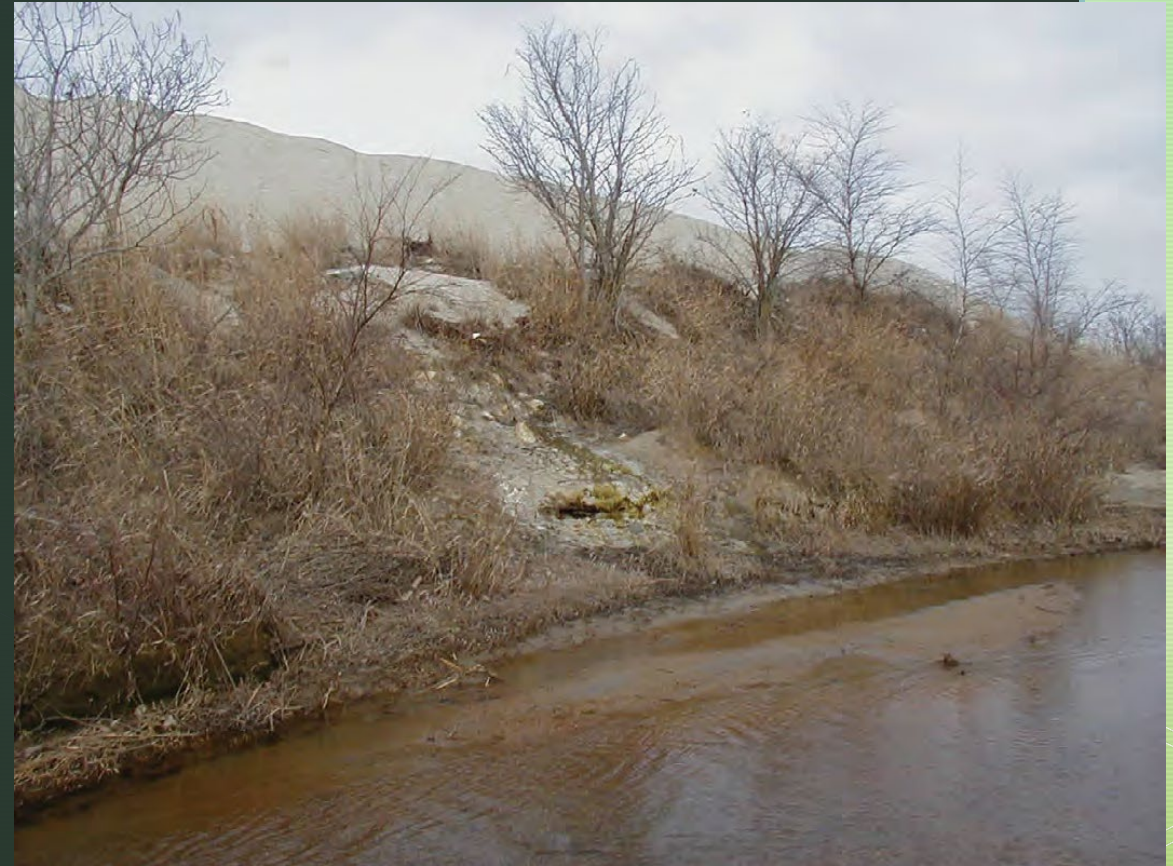
From Cope et al. 2008

- **Pile north of TC-1**
  - Relatively intact
- **Area north of TC-2**
  - Site of current interim measure
- **Bases north and south of TC-4**
  - Processed for asphalt aggregate
- **Area south of TC-6**
  - Fine tailings impoundment
