Reclamation of two kyanite mine tailings ponds using different surface topographies

Gwendelyn Geidel

School of the Earth, Ocean and Environment

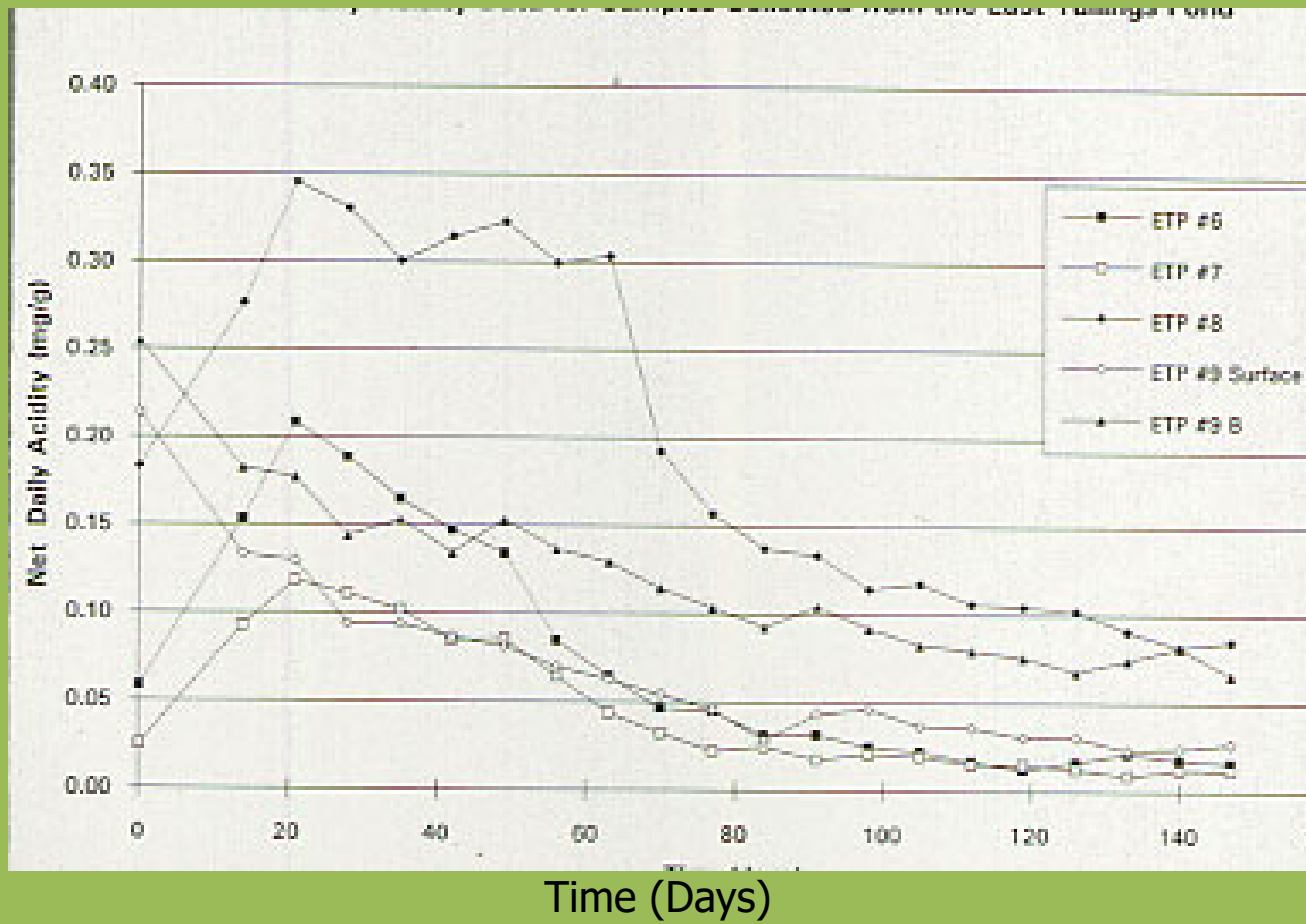
Details of Ridge and Furrow (RAF) Technique - ETP

The surface configuration of a scarified tailings pond surface encourages rainfall to accumulate in the furrows. The less dense rainwater establishes pockets of fresh water that float within the acidic matrix. Through time the ridges become purged of acidity and fresh water zones become established.

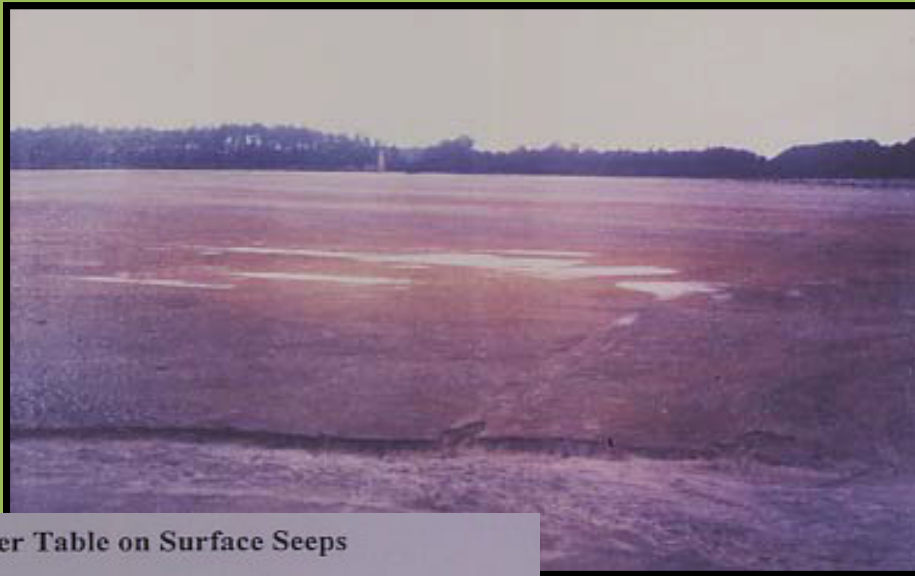
1. Improve Near Surface Water Quality and Lower Water Table

Water Table 0.1 -0.3m
During rain, water table rises as nearly horizontal plane and seeps developed when the water table elevation intercepts pond surface elevation.

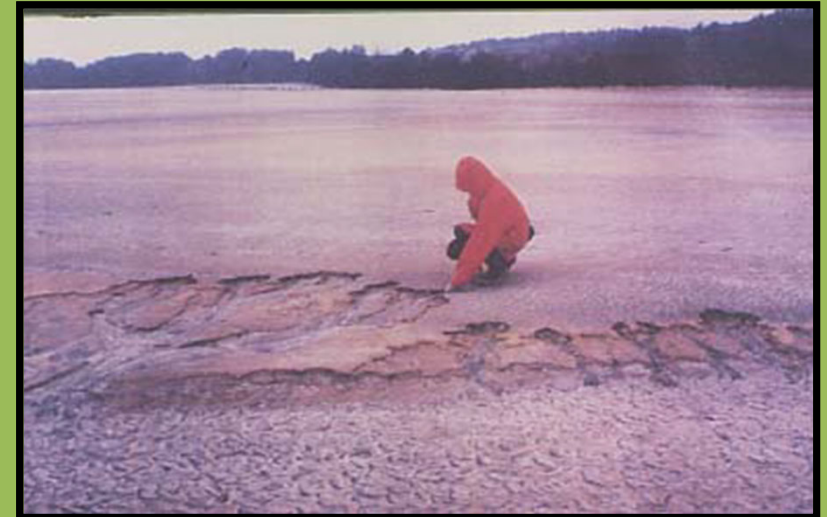
Effects of Rising Water Table on Surface Seeps

Water Table is within 8-10 inches of pond surface and during rain water table rises as nearly horizontal plane. When the water table elevation intercepts pond surface elevation, seep develops.

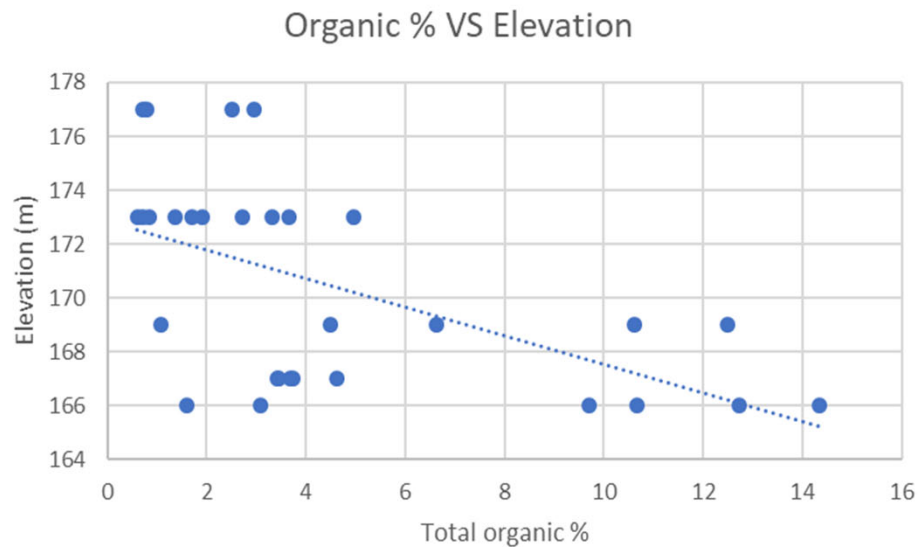
Positive correlation to water loss vs organic %

Increase in organic carbon material down slope

Increase in organic material through site progression

Larger vegetation shows increase in organic %

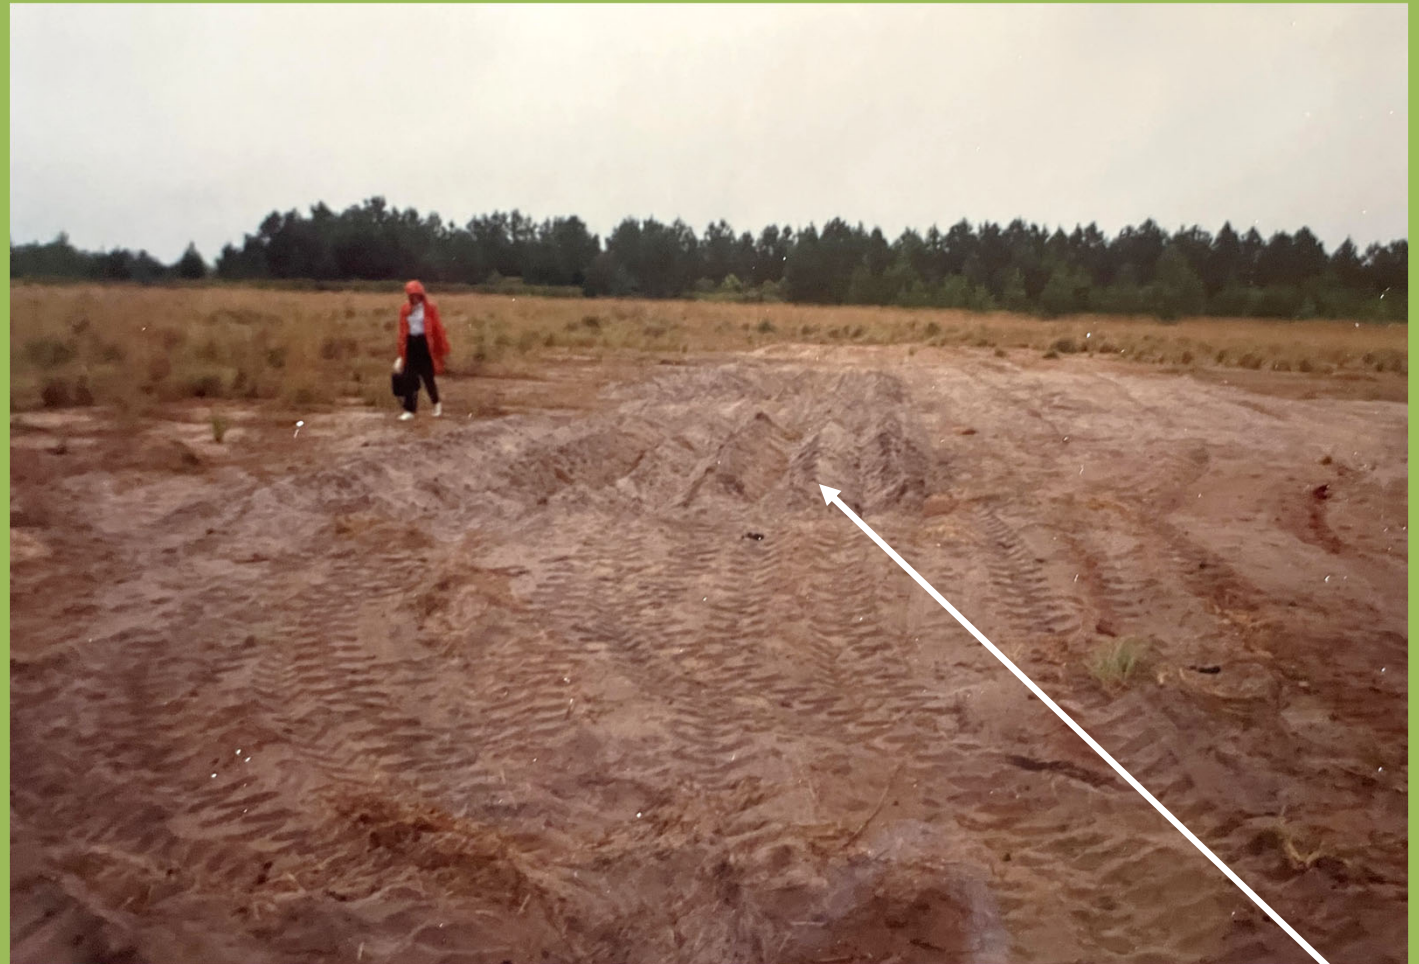
WTP –Test Plots on prior reclamation efforts.

Prior Reclamation = 2-4" soil layer placed on top of tailings in
~1992-3 and seeded. Test plots with Ridge and Furrows in 1994.

- Based on density of plant cover and predominant species (Weeping lovegrass), the soil covered WTP was scheduled to have ridge and furrows installed with lime and organic matter (straw) incorporated, then fertilized and seeded with 11 seed mix in summer 1996.

- Plans were revised by engineers and 2/3 of the WTP surface was only scarified approximately 1-2” deep, limed, fertilized and seeded. Straw mulch cover with asphalt tacking.

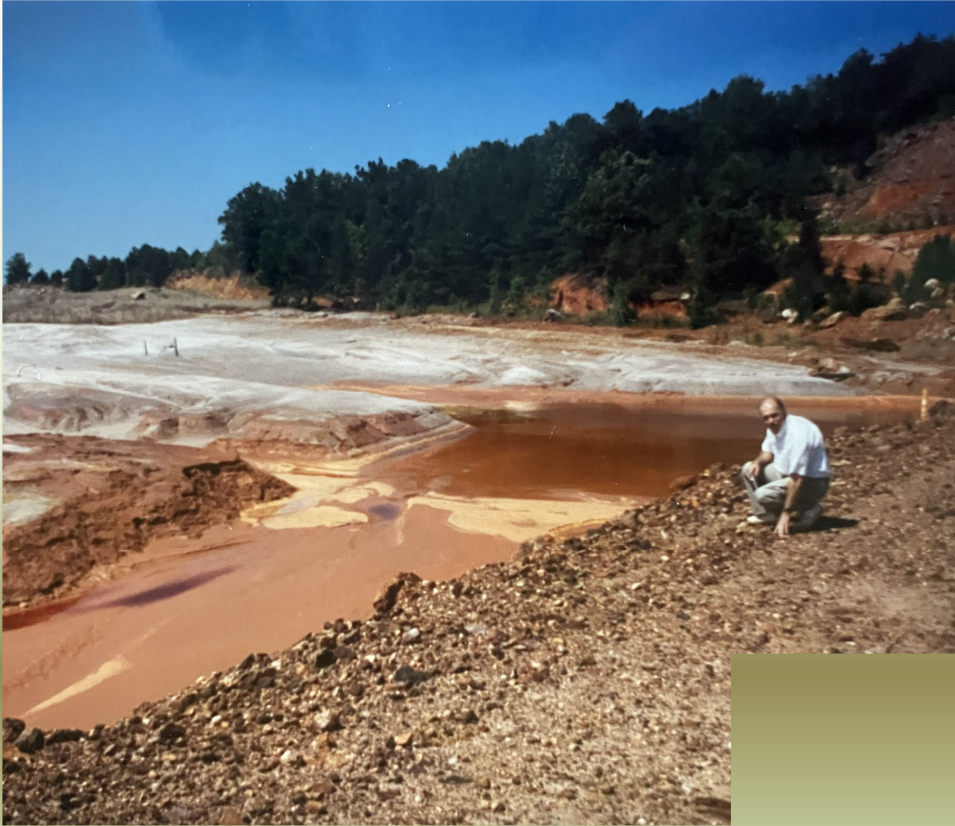
Eastern 1/3 end of WTP
October 1994

Highly acidic seeps and
water flowing from WTP.

Initial Reclamation of
western portion of
WTP in 1994

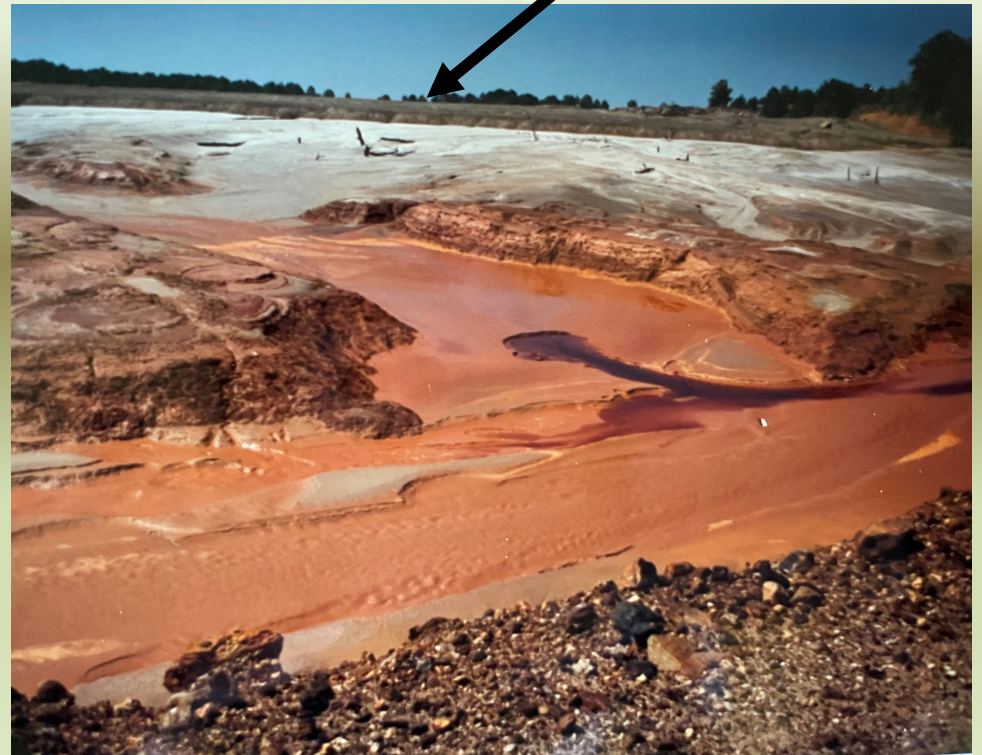
**WTP –lower 1/3
filled with tailings
from small TP, RAF
with lime & straw
incorporated. Then
fertilizer, seed and
straw mulch layer**
