# **The Long-Term Evaluation of Mine Seals Constructed in Randolph County, WV in 1967**

**U.S. Bureau of Mines  
Pittsburgh Research Center  
Cochrans Mill Road, P.O. Box 18070  
Pittsburgh, PA 15236**

## **ABSTRACT**

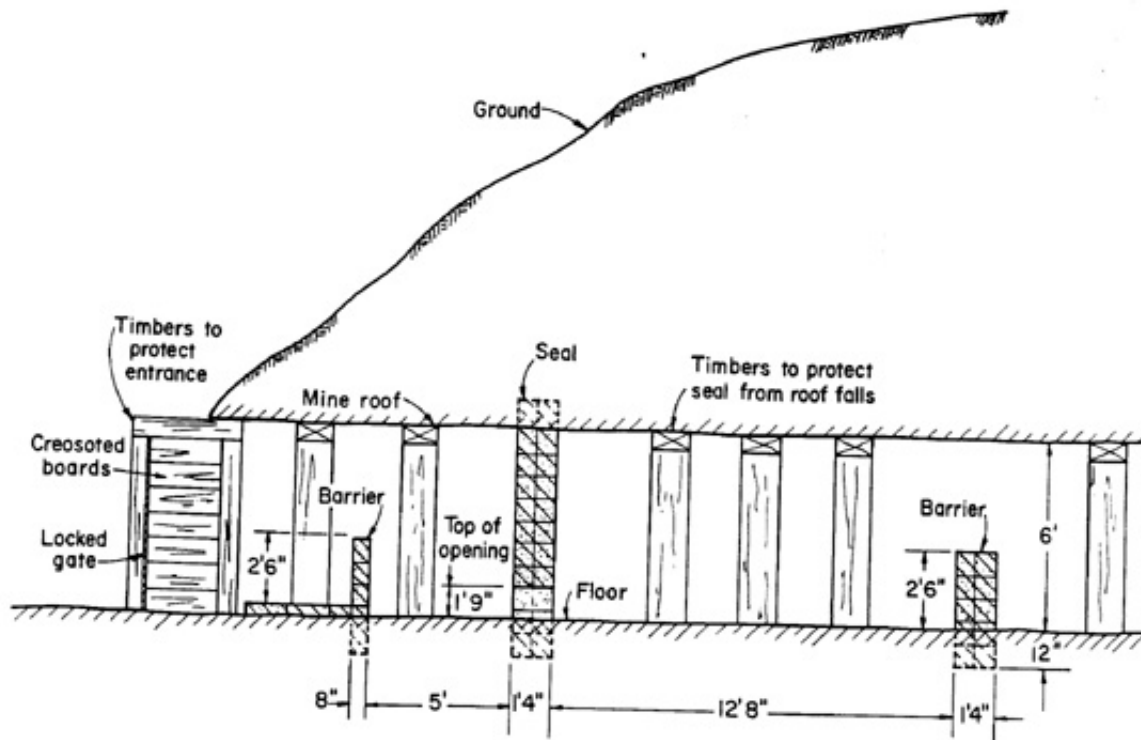
FIGURE 2. Cross section of a block wet seal (6).

The dry and wet seals consisted of two courses of fly ash blocks which were covered with urethane foam to prevent deterioration by the acidic waters. Dry seals had one wall and wet seals were made of two or three walls. Two blocks were removed from the bottoms of the wet seals to allow water to pass. A typical block wet seal is shown in Figure 2. Clay seals consisted of compacting the clay against the openings.(4)
