Mitigation of Environmental Impacts Resulting from Mine Pool Build-up: A Case History

Ronald Mullenex, CPG, CGWP^a

Sr. Vice President, Marshall Miller & Associates

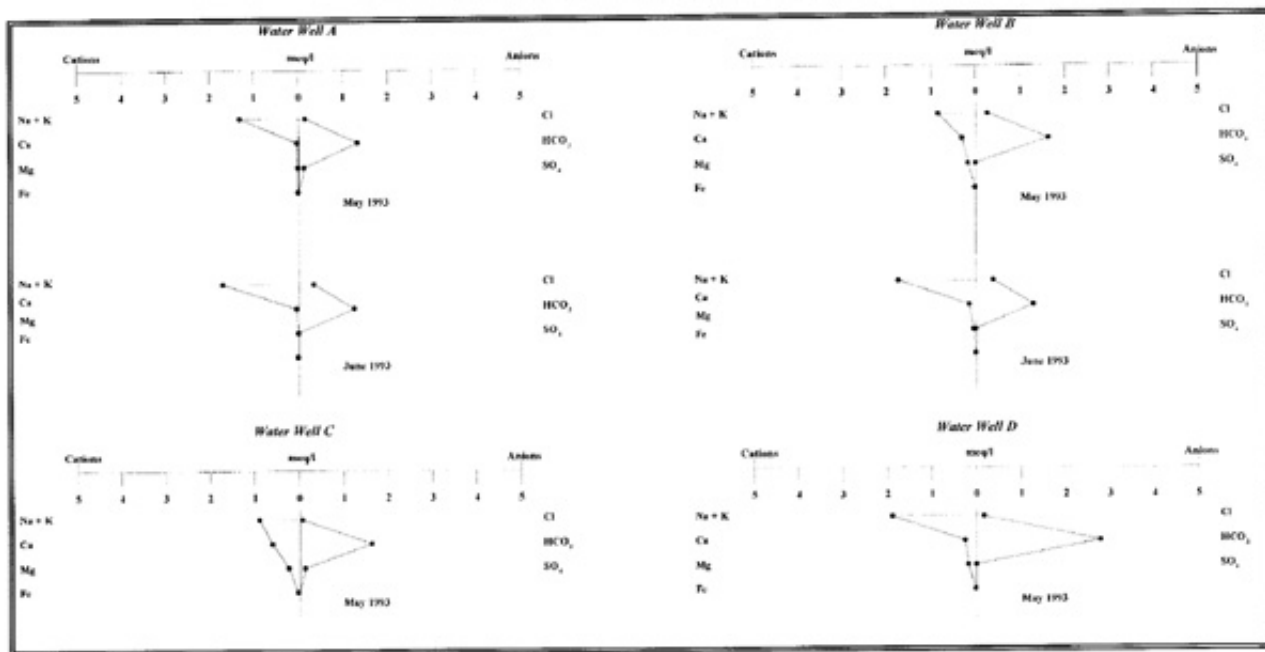
Figure 1
Background Water Quality, Deep Ground Water

Natural ground water occurring at depth in the subject area is characterized as a sodium - bicarbonate dominant ionic facies. In samples collected from the site, such ground water is typified by the following Stiff diagrams:

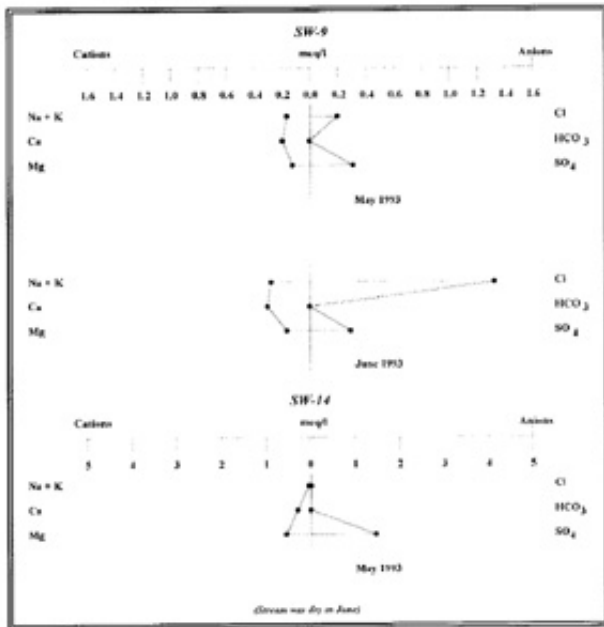
Figure 2
Background Stream Water Quality

Surface water under background conditions and on the headwater stream reaches contains less total dissolved solids than ground water which has spent substantial time in contact with minerals in the rock, as would be expected. Available analyses from such settings include those from stations SW-9 and SW-14 along the stream (*see Figure 4*). These analyses show very low bicarbonate content, but exhibit sulfate ionic dominance. Cationic dominance is fairly evenly distributed among sodium, calcium, and magnesium ions, as shown on *Figure 2*.

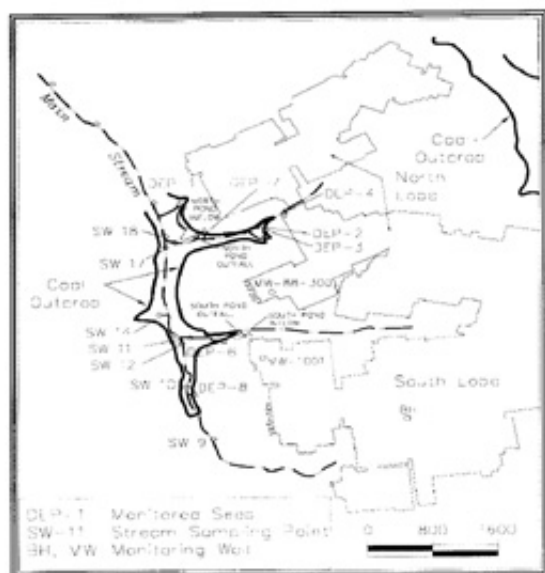
Figure 4
Mine and Data Collection Locations

As is shown on *Figure 4*, the mine consists of two major lobes, one lying south of a tributary hollow (south lobe) and one lying north of that hollow (north lobe). The northern lobe is further subdividable at a narrow "neck" of four entries utilized to advance beneath a shallow cover area in another tributary hollow.

Station SW- 10 is on the main trunk of the stream, at a point just downstream of the inflow from DEP-8 (see Figure 4). Comparison of SW-10 characteristics in the low-flow seasons of 1993 (before south lobe dewatering) and 1994 and 1995 (after dewatering) reveals a continual decline in the calcium and sulfate dominance that so strongly characterized the stream prior to mine dewatering, and an increase in bicarbonate. (The present increased levels of sodium and chloride at SW-10 suggest possible contribution by septic system effluent from a nearby residence.) SW-10 now appears to be completely unimpacted by water from the mine pool.
