#### Crossville Coal Passive Treatment System

Redesign of a non-functioning iron and manganese treatment system

Rick Mann, PG, OSMRE LFO Adam Ramsey, PE, OSMRE LFO Wesley Smith, PG, OSMRE LFO

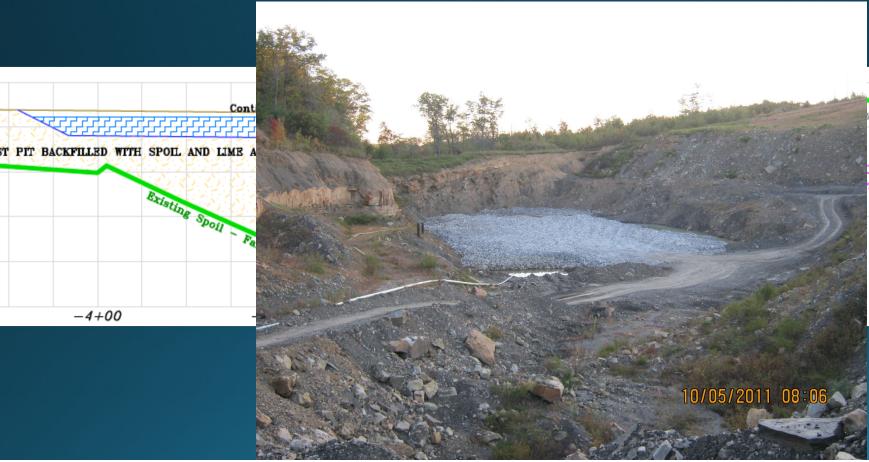
#### Previous Treatment System

- Completed in 2014
- Started failing
  1 year after
  completion.

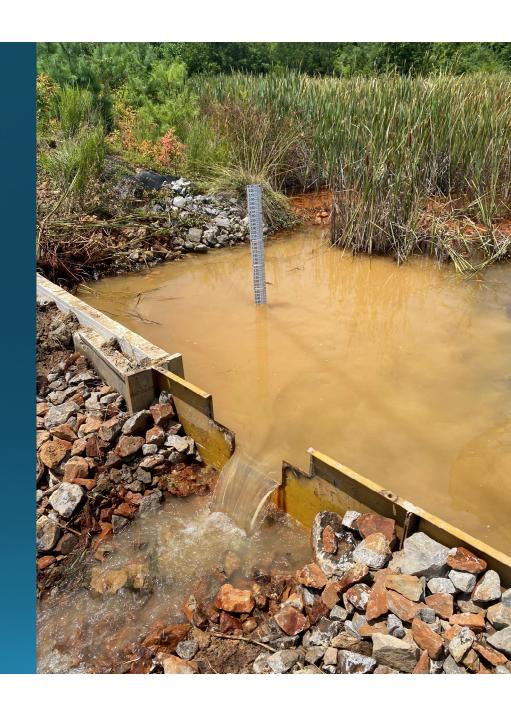
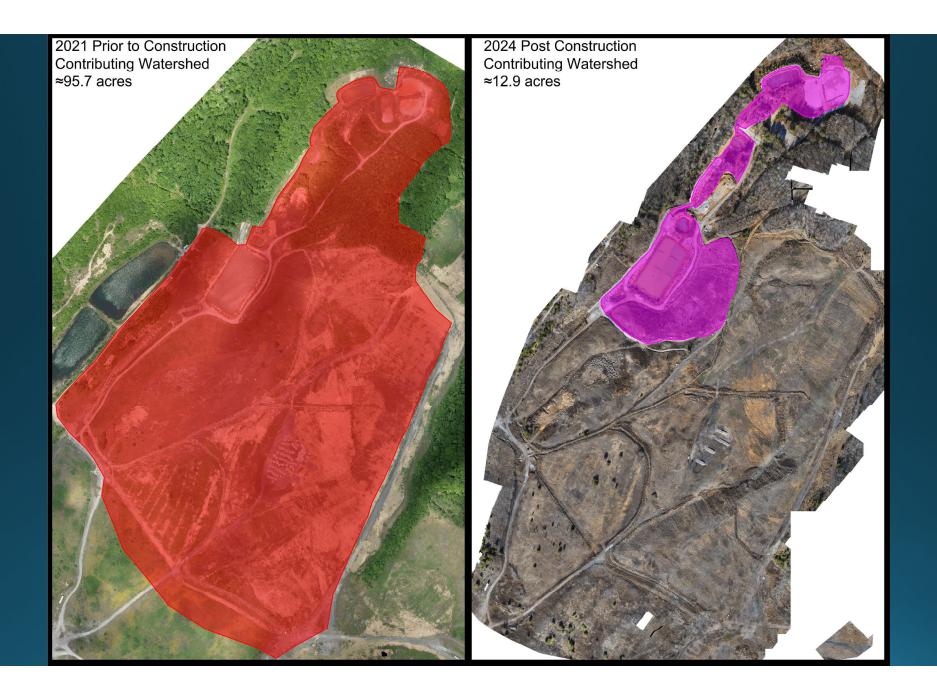
#### •Flow

- Average flow of 219 gpm (829 L/min)
- Flows as high as 1,276 gpm (4,830 L/min) observed after precipitation
