THE NORTH BRANCH OF THE POTOMAC RIVER: RESULTS OF TWO YEARS OF LIME DOSING

Joseph E. Mills

Maryland Department of the Environment Bureau of Mines 160 S. Water Street Frostburg, Maryland 21532

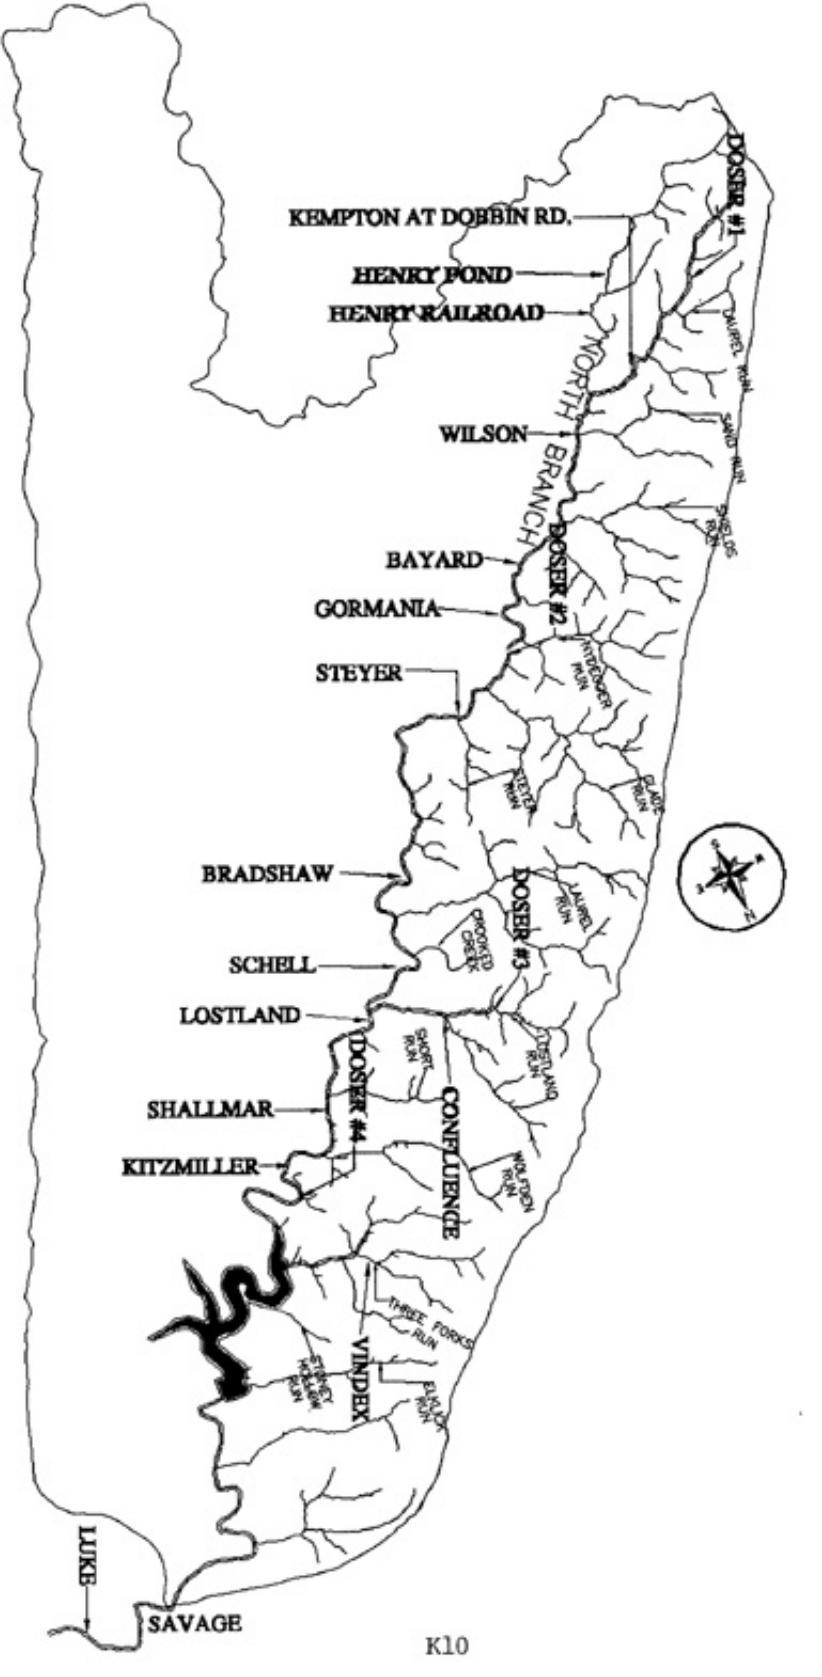
NORTH BRANCH SAMPLING STATIONS

Sixteen stations were monitored for water quality during the pre-doser and post-doser phases of the project (see Attachment 1). Stream water samples were collected in syringes for closed pH and in cubitainers for analysis of acid neutralizing capacity (ANC), iron, manganese, aluminum, calcium, magnesium, sulfate, sodium, and conductivity.
